REHABILITATION OF ABANDONED MINING LANDS TRUST FUND

PROPOSED SHAFT SAFETY PROJECT 2006/2007

LEFROY GOLDFIELD

PROJECT OUTLINE AND COST ESTIMATE

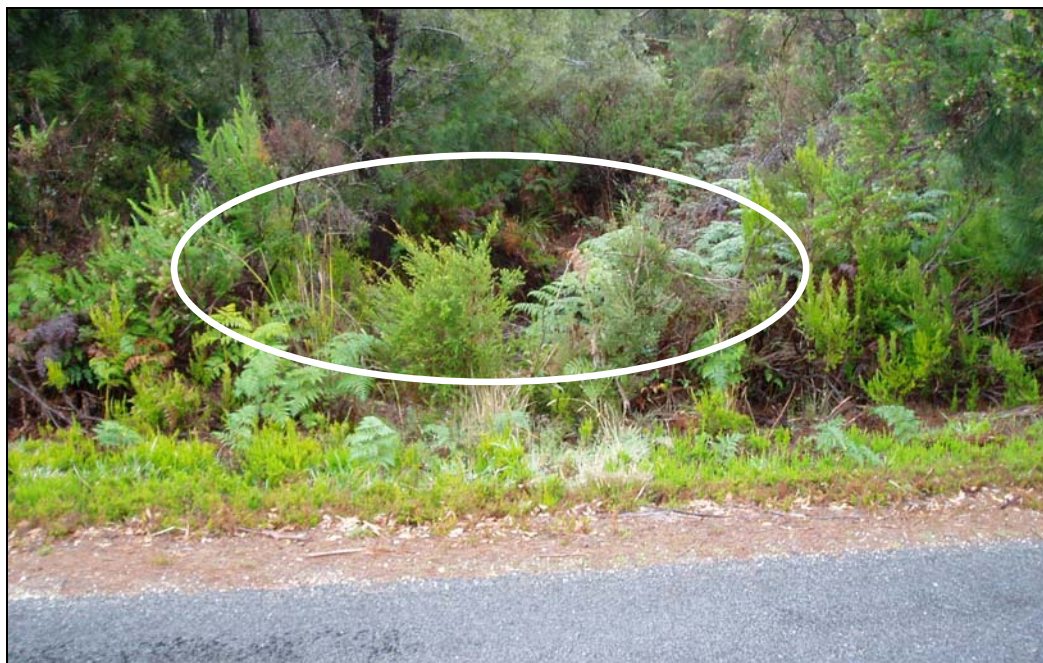
The Pinafore Main Shaft is approximately 12 metres off the western edge of Beechford Road (Fig. 1-3). It is recorded as being a 2400 mm x 1800 mm shaft, sunk to a depth in excess of 360 metres (Montgomery, 1897). Ground surrounding the shaft opening has collapsed forming a depression approximately six metres deep and roughly 10 m diameter, meaning that the edge of the depression comes within 6 to 8 metres of the edge of Beechford Road.

Figure 1. Proximity of shaft to Beechford Road.

A low barrier fence could be installed; however, fencing this shaft is problematic because of ground surface features. The openly visible location may also attract members of the public to this potentially dangerous shaft. It is proposed to seek engineering advice on how to best seal this shaft.

An additional option is to install 'Armco' style guardrail along roadside beside shaft. A quote of \$6,900 (inc GST) has been given for 20 metres of guardrail at this site.

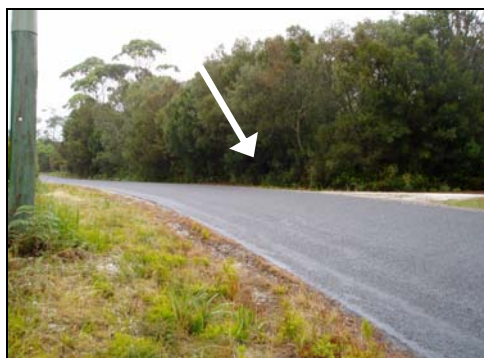
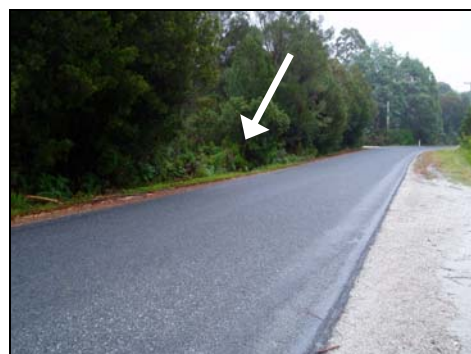
Figure 2 & 3. Northern (left) and southern (right) approaches to Pinafore site – shaft location indicated by arrows.

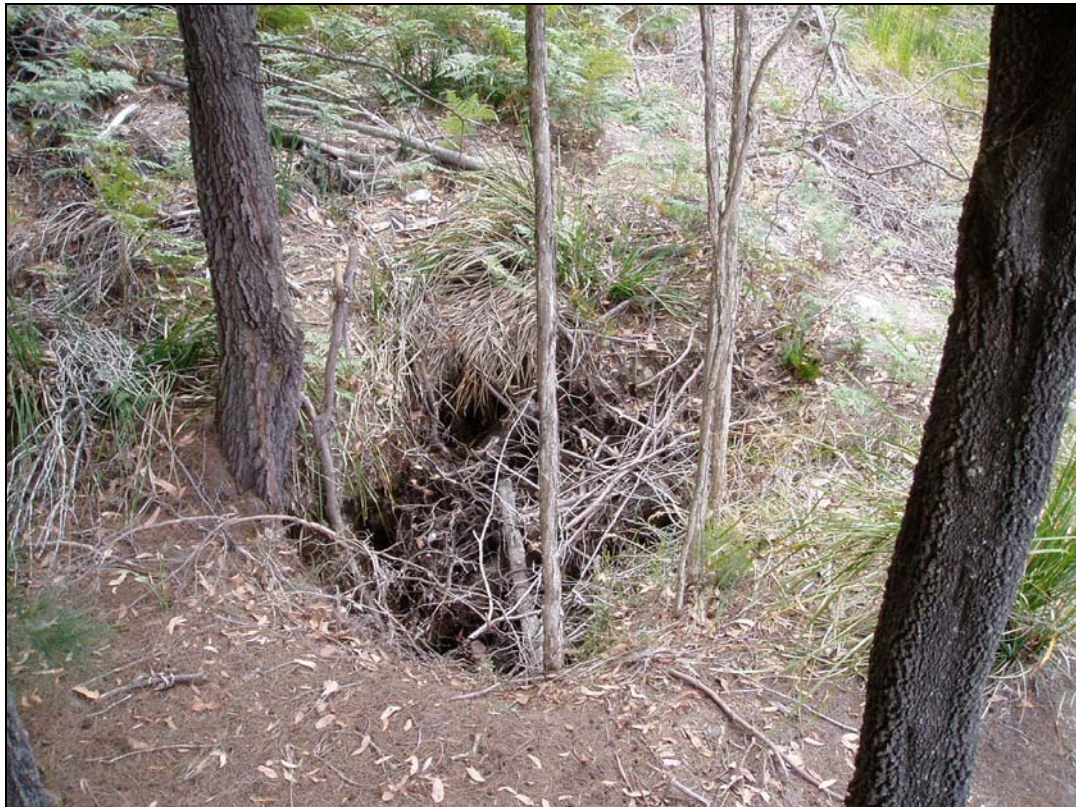
These workings are close to houses in Lefroy (Map 2) and anecdotal evidence suggests that the area is used as a pedestrian thoroughfare. The Morning Star Main Shaft was fenced in 2006 but a number of open, deep shafts on these workings were not identified when planning the 2005/06 works program. Access for earthmoving equipment is complicated by regrowth over tracks and the arrangement of historic features.

Figure 4. Shaft on Golden Era line, 2500 mm x 2000 mm and open to 8 metres.

For these reasons it is proposed that the workings are surveyed to both identify heritage issues and inform practical considerations for safety work, such as machinery and equipment access. This will also assist in targeting all relevant hazards so that safety work may be carried out in an effective manner.

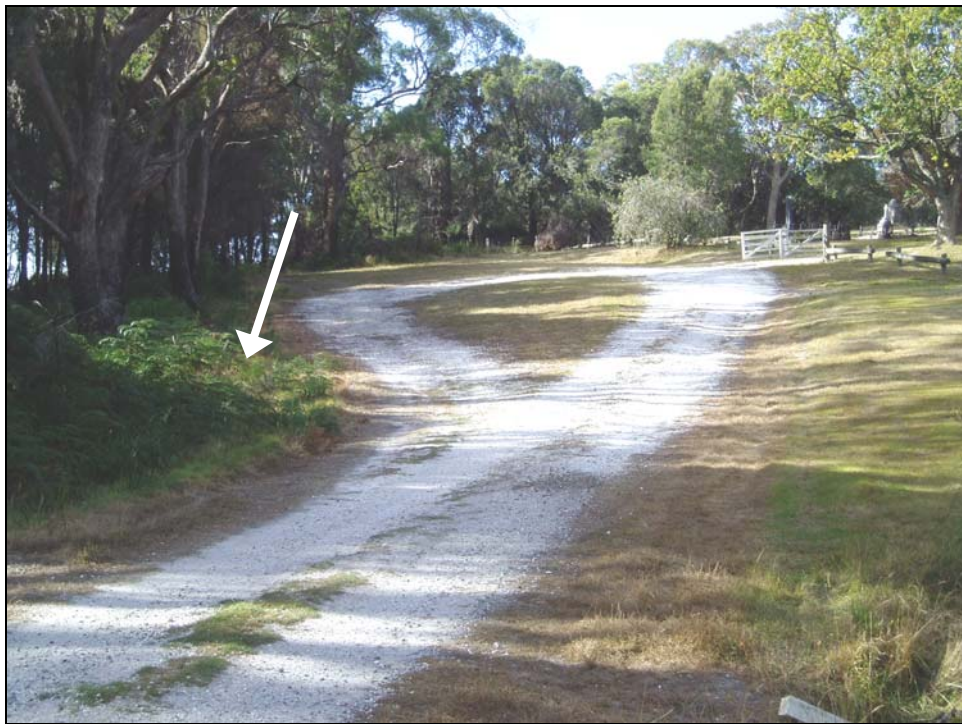
The Native Youth Main Shaft became apparent following the creation of a vehicle track by Lefroy Resources for exploration work. This shaft is open and should be capped. Other open shafts on these workings are not known, though many shallow workings, subsidence and pits do present a real risk of injury, particularly in the area opposite the Lefroy cemetery (Map 1). It is proposed that a thorough survey be undertaken to account for any major hazards. Signage alerting to unstable ground and pits could be erected on the entry road to the cemetery (Fig.5).

Figure 5. Approach to Lefroy Cemetery. Extensive shallow workings are on the left hand side of the road, the cemetery is on the right. Suggested location of signage indicated by arrow.

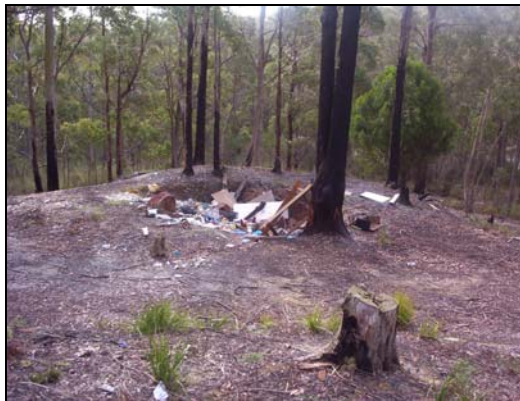
Five major shafts (3 on the Volunteer Line and the Brisbane and Reward Main Shafts) are collapsed, leaving openings of approximately ten metres diameter and depressions of between six and twelve metres deep. One Volunteer shaft and the Reward shaft are choked with refuse (Fig. 6 & 7). An agreement has been reached with the George Town Council to waive tip fees for 50 m³ of refuse if MRT collect and transport the rubbish.

Figure 6. Volunteer shaft. The collapse is approximately 10 metres diameter. Anecdotal evidence is that rubbish is supported by two car bodies wedged into the shaft.

- Fence with a low steel pipe barrier similar to that used on the Volunteer Main Shaft (Fig.8) (estimated total cost for five of \$10,000).
- Steel dropper and wire fence (estimated total cost \$2,500)
- Seek engineering advice to explore the option of capping.

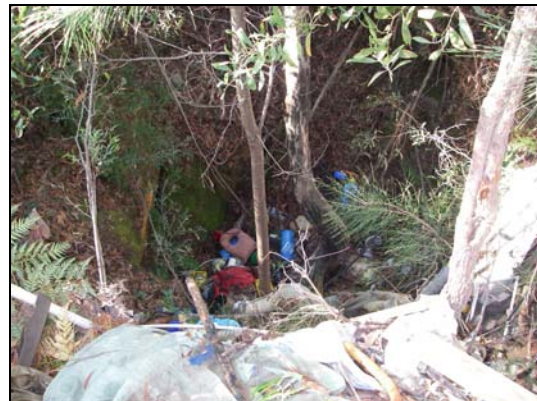
Figure 7. Reward Main Shaft. The collapse is approximately 10 metres diameter and 8 metres depth to rubbish.

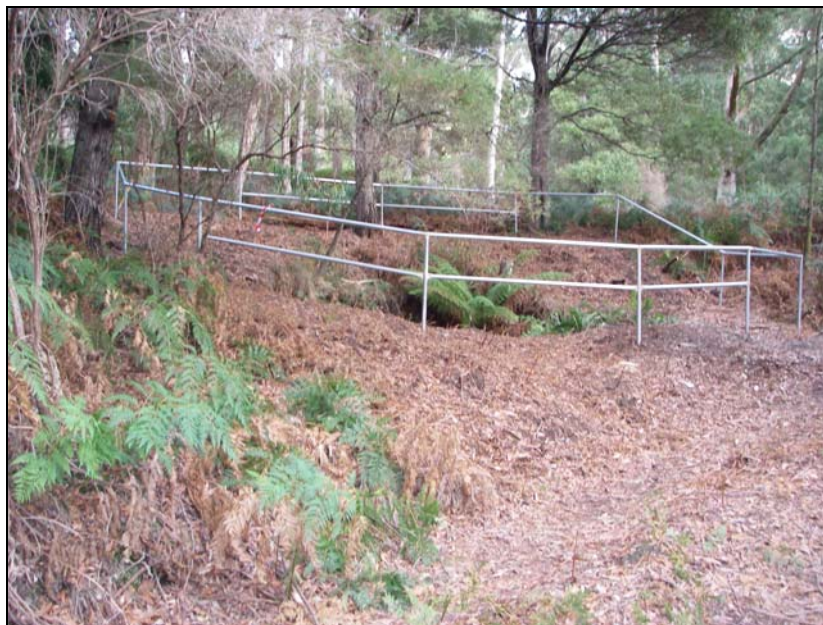
Figure 8. Partly completed fencing around the Volunteer Main Shaft
