DEPARTMENT OF MINES — TASMANIA	
LANDSLIP AT MEREDITH CRESCENT LAWRENCE VALE, LAUNCESTON	
DATE <i>OCTOBER 1969</i>	NOT TO SCALE
GEOLOGIST <i>P. STEVENSON</i>	MAPSHEET & N° <i>L'STON 39</i>
DRAUGHTSMAN <i>T.R. BELLIS</i>	
REVISIONS	FILE N° 3290

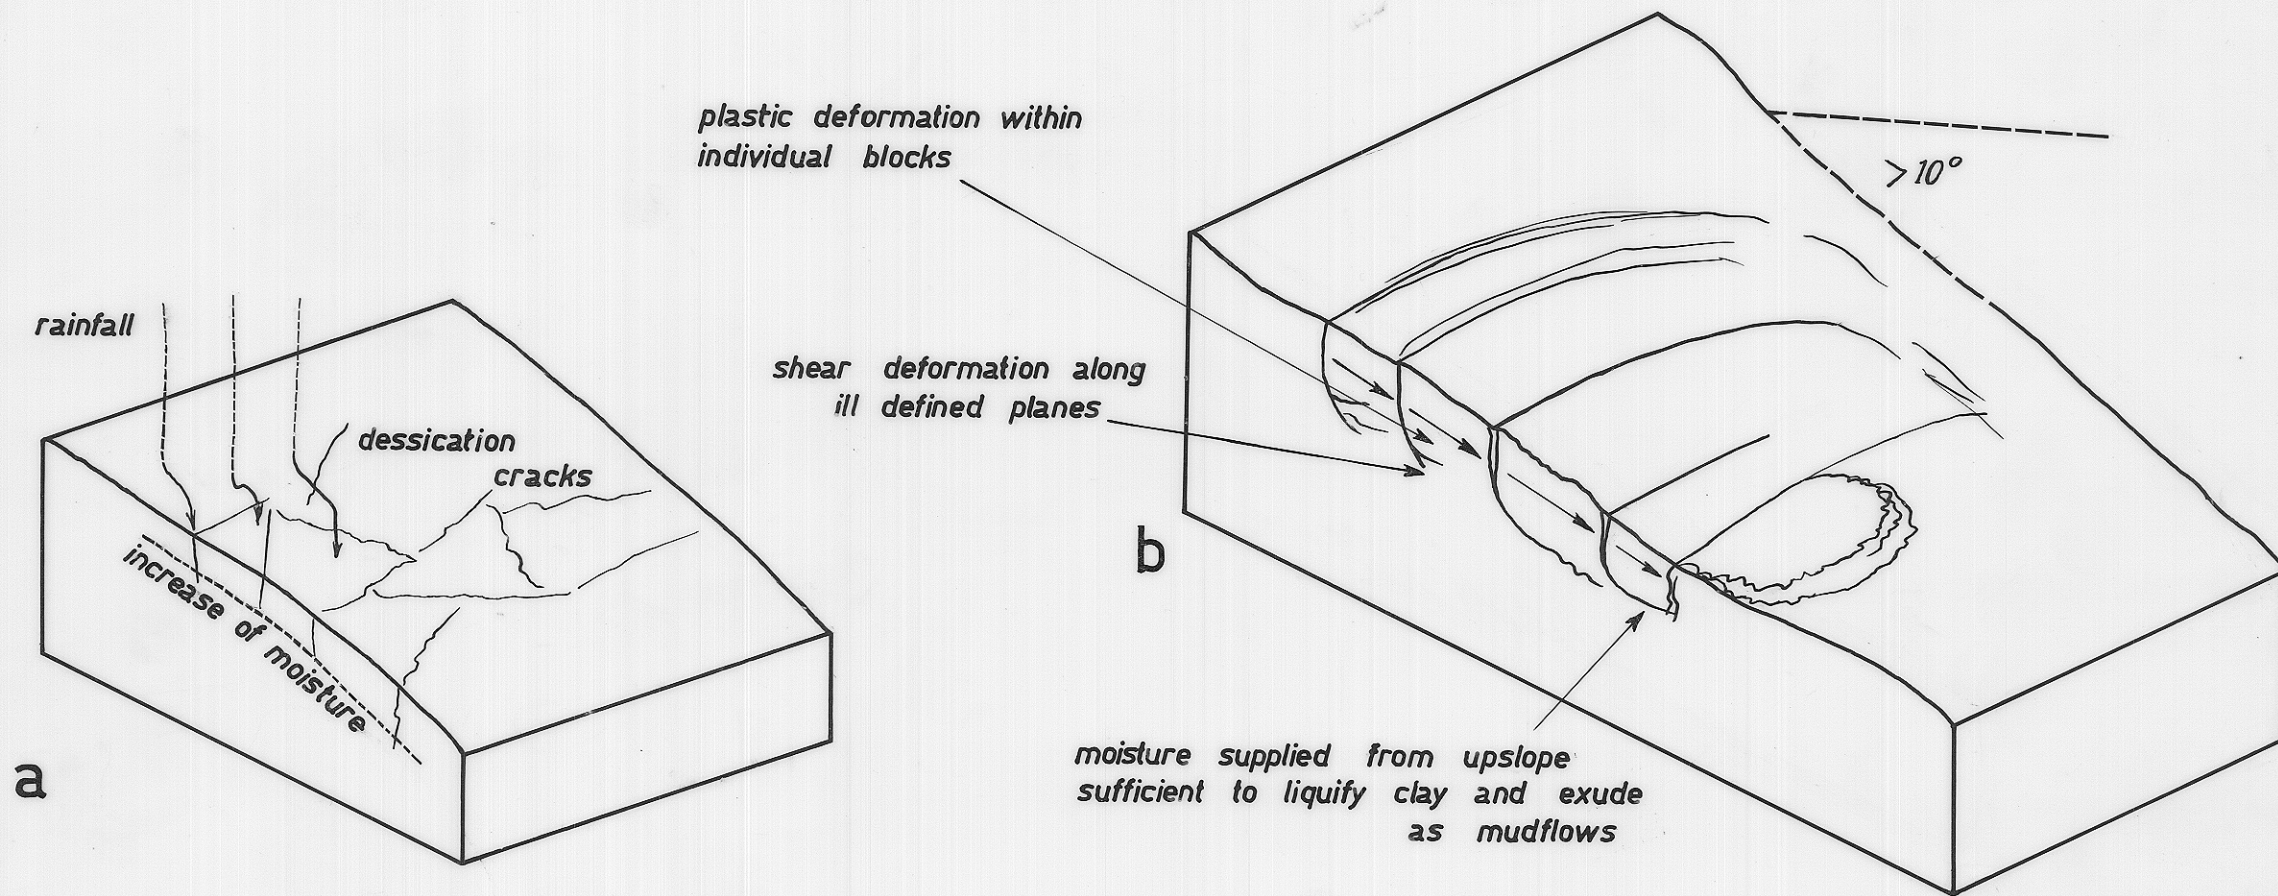
fig 25

SUGGESTED FAILURE MECHANISM

Where dessication cracks trap rain wash and form soft layers in clay. These deform plastically and cause the surface to fail in tension. In the lower parts of the slip the moisture increases and under light hydrostatic head causes mud flows

All deformation is near surface.
