LANDSLIDE RISK ASSESSMENT AND MANAGEMENT IN TAROONA

Taroona, Tasmania

HO104/3-AC

6 June 2002

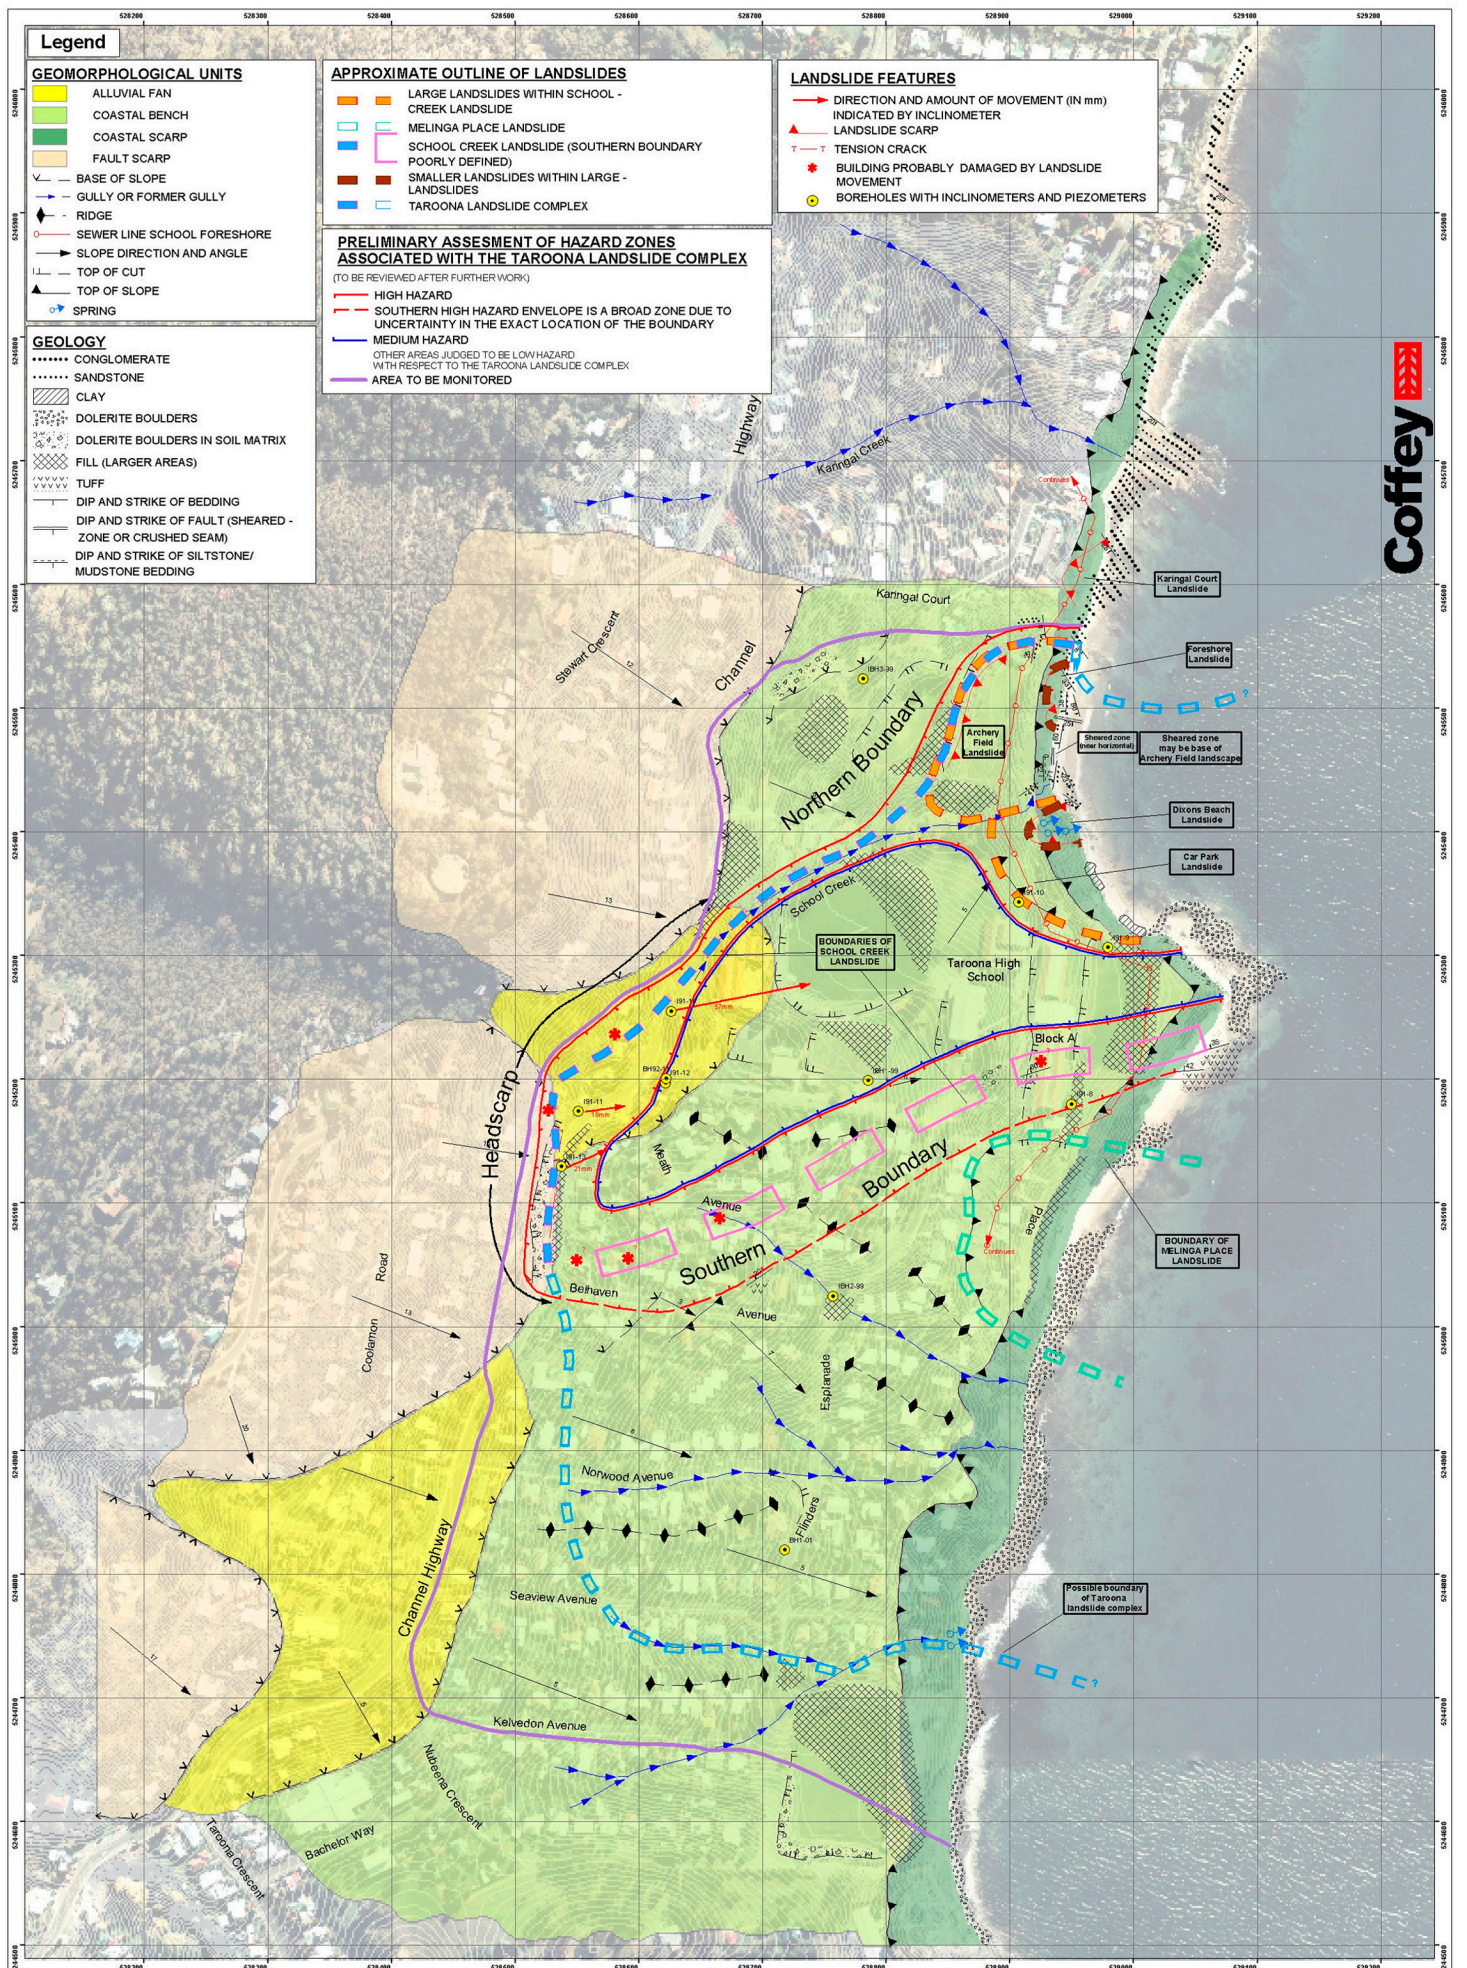
PRELIMINARY ASSESMENT OF HAZARD ZONES ASSOCIATED WITH THE TAROONA LANDSLIDE COMPLEX

The location of hazard zones shown on Figure 3 are based on the observed and inferred behaviour of the Taroona Landslide Complex. A high hazard zone encompasses the boundaries of the School Creek

Landslide (and the smaller coastal landslides) where differential movement may occur. A medium hazard zone is defined within the main body of the School Creek Landslide where overall movements may occur but differential displacements are less likely. The remainder of the Taroona Landslide Complex is judged to be a low hazard area with respect to movement of major landslides within the complex.

- HIGH HAZARD
- SOUTHERN HIGH HAZARD ENVELOPE IS A BROAD ZONE DUE TO UNCERTAINTY IN THE EXACT LOCATION OF THE BOUNDARY
- MEDIUM HAZARD
- OTHER AREAS JUDGED TO BE LOW HAZARD WITH RESPECT TO THE TAROONA LANDSLIDE COMPLEX
- AREA TO BE MONITORED

At this stage we recommend that a slightly larger area (shown on Figure 2 and 3) be included in the monitoring and management program. This larger area reflects the present uncertainty in some of the boundaries. Further work may enable the area to be monitored to be reduced.
