Report on Works undertaken ~
2002 – 2003 Financial Year for the
REHABILITATION OF MINING LANDS TRUST FUND

Project:: rehabilitation of land alluvially mined for tin in the vicinity of
Gladstone and South Mount Cameron, North East Tasmania

Report by: Revel Munro

November 2003

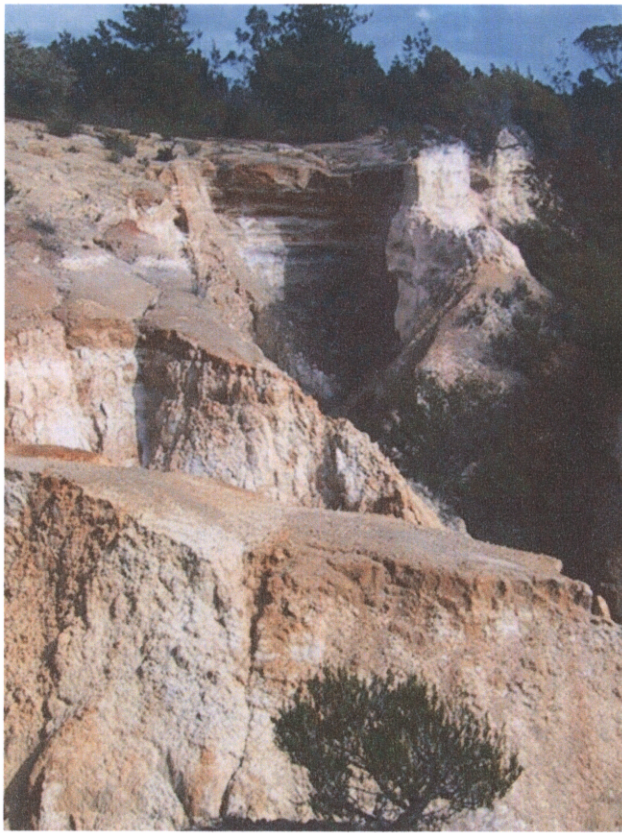
Photographs before and after ~ Clay Pit Area~ **N2 South East Gully' 2003.**

Intensive treatment [Reshaping, cereal stubble, jute matting, seed and fertiliser] – 0.36 ha

Remedial treatment [Scarifying, seed and fertiliser] – 0.87 ha

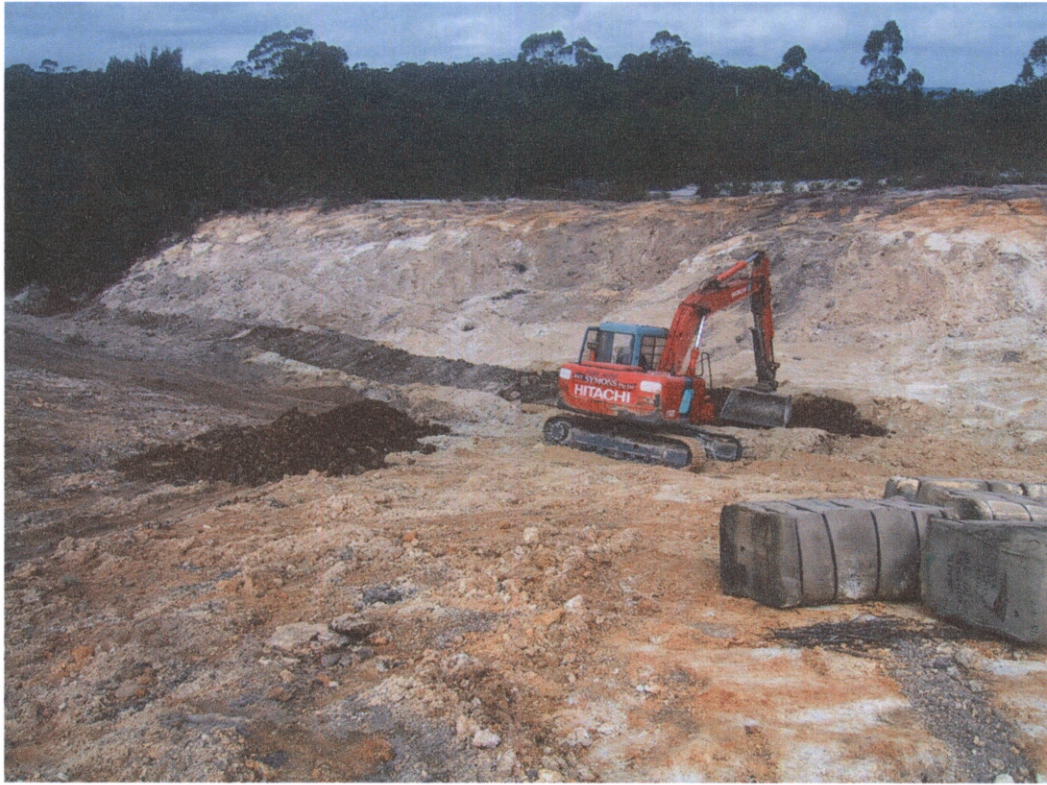
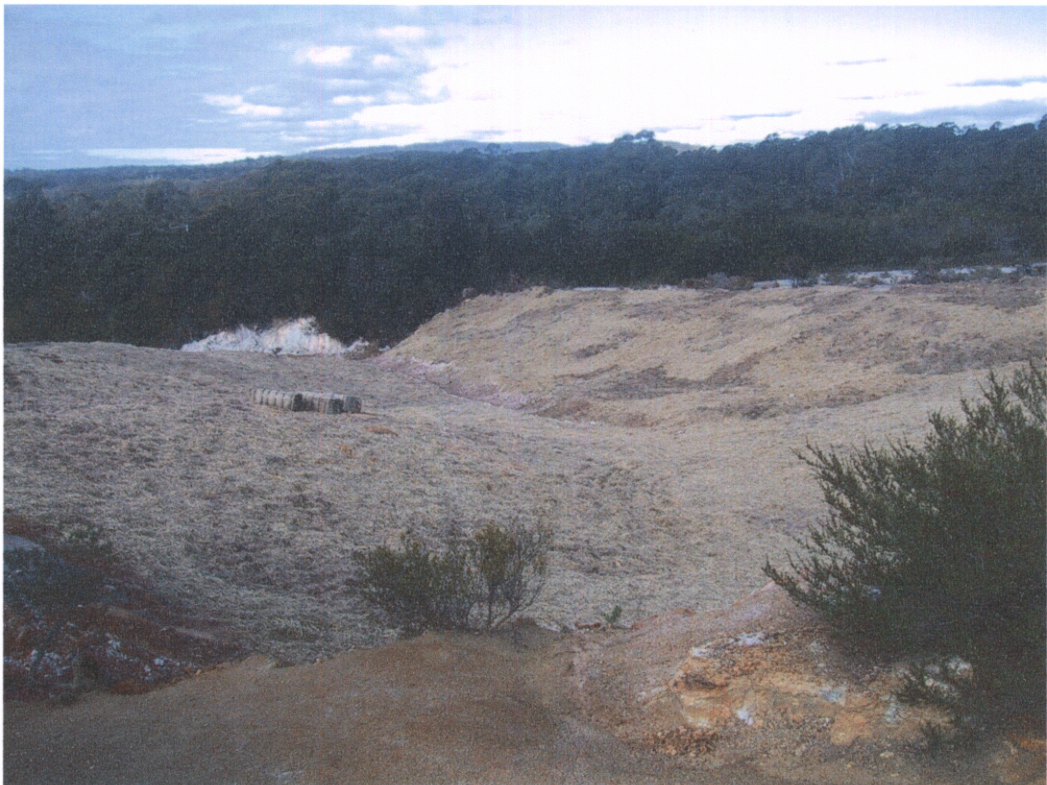
'Tail Race Gully' ~ Stages of treatment ~ construction of rock drains (above), finished gully (below)

Intensive treatment [Reshaping, cereal stubble, jute matting, seed and fertiliser] – 0.87 ha

Remedial treatment [Scarifying, seed and fertiliser] – 0.34 ha

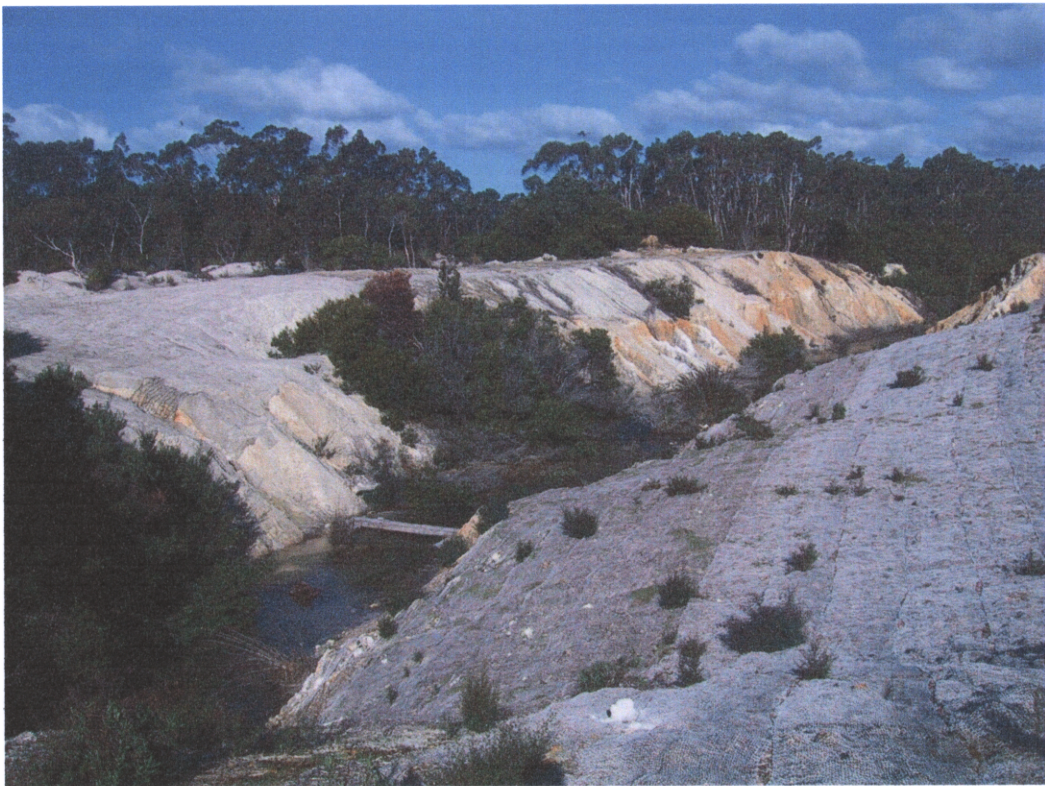
Photographs of Cat Gully.

The area to the east of the Cat Gully drain [excavated by dragline in about 1968] was a bare area containing high kaolinite content, actively eroding spoil, [i.e. now 35 years old].

Above, Existing treatment on West side showing sporadic revegetation and 2003 treatment area on eastern side.

An area of 0.55ha has been landscaped by the excavator, seeded, 'hayed' and fertilised this year. Only 0.1ha of this amount has been covered with the last of the jute matting stock.

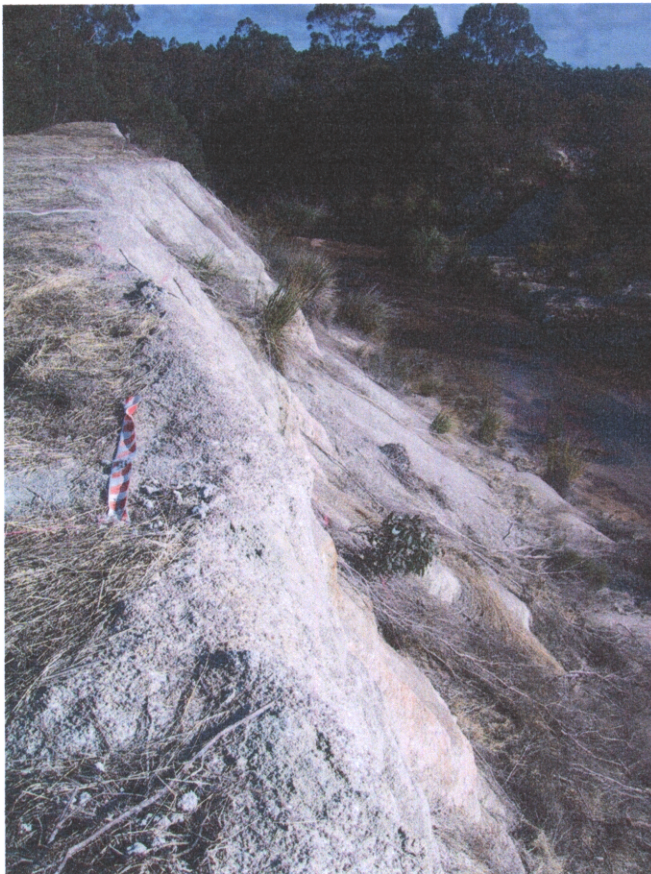
Reshaping of the surface has only been partially undertaken. On the basis of cost and disturbance to adjoining undisturbed lands some steep batters still remain. Cut scrub has been laid over these steep batters. It was necessary to tie branches to the face in many places. Strong winds have since disturbed some of these works.

Left, Truncated spoil heaps with brush placed on steep slopes

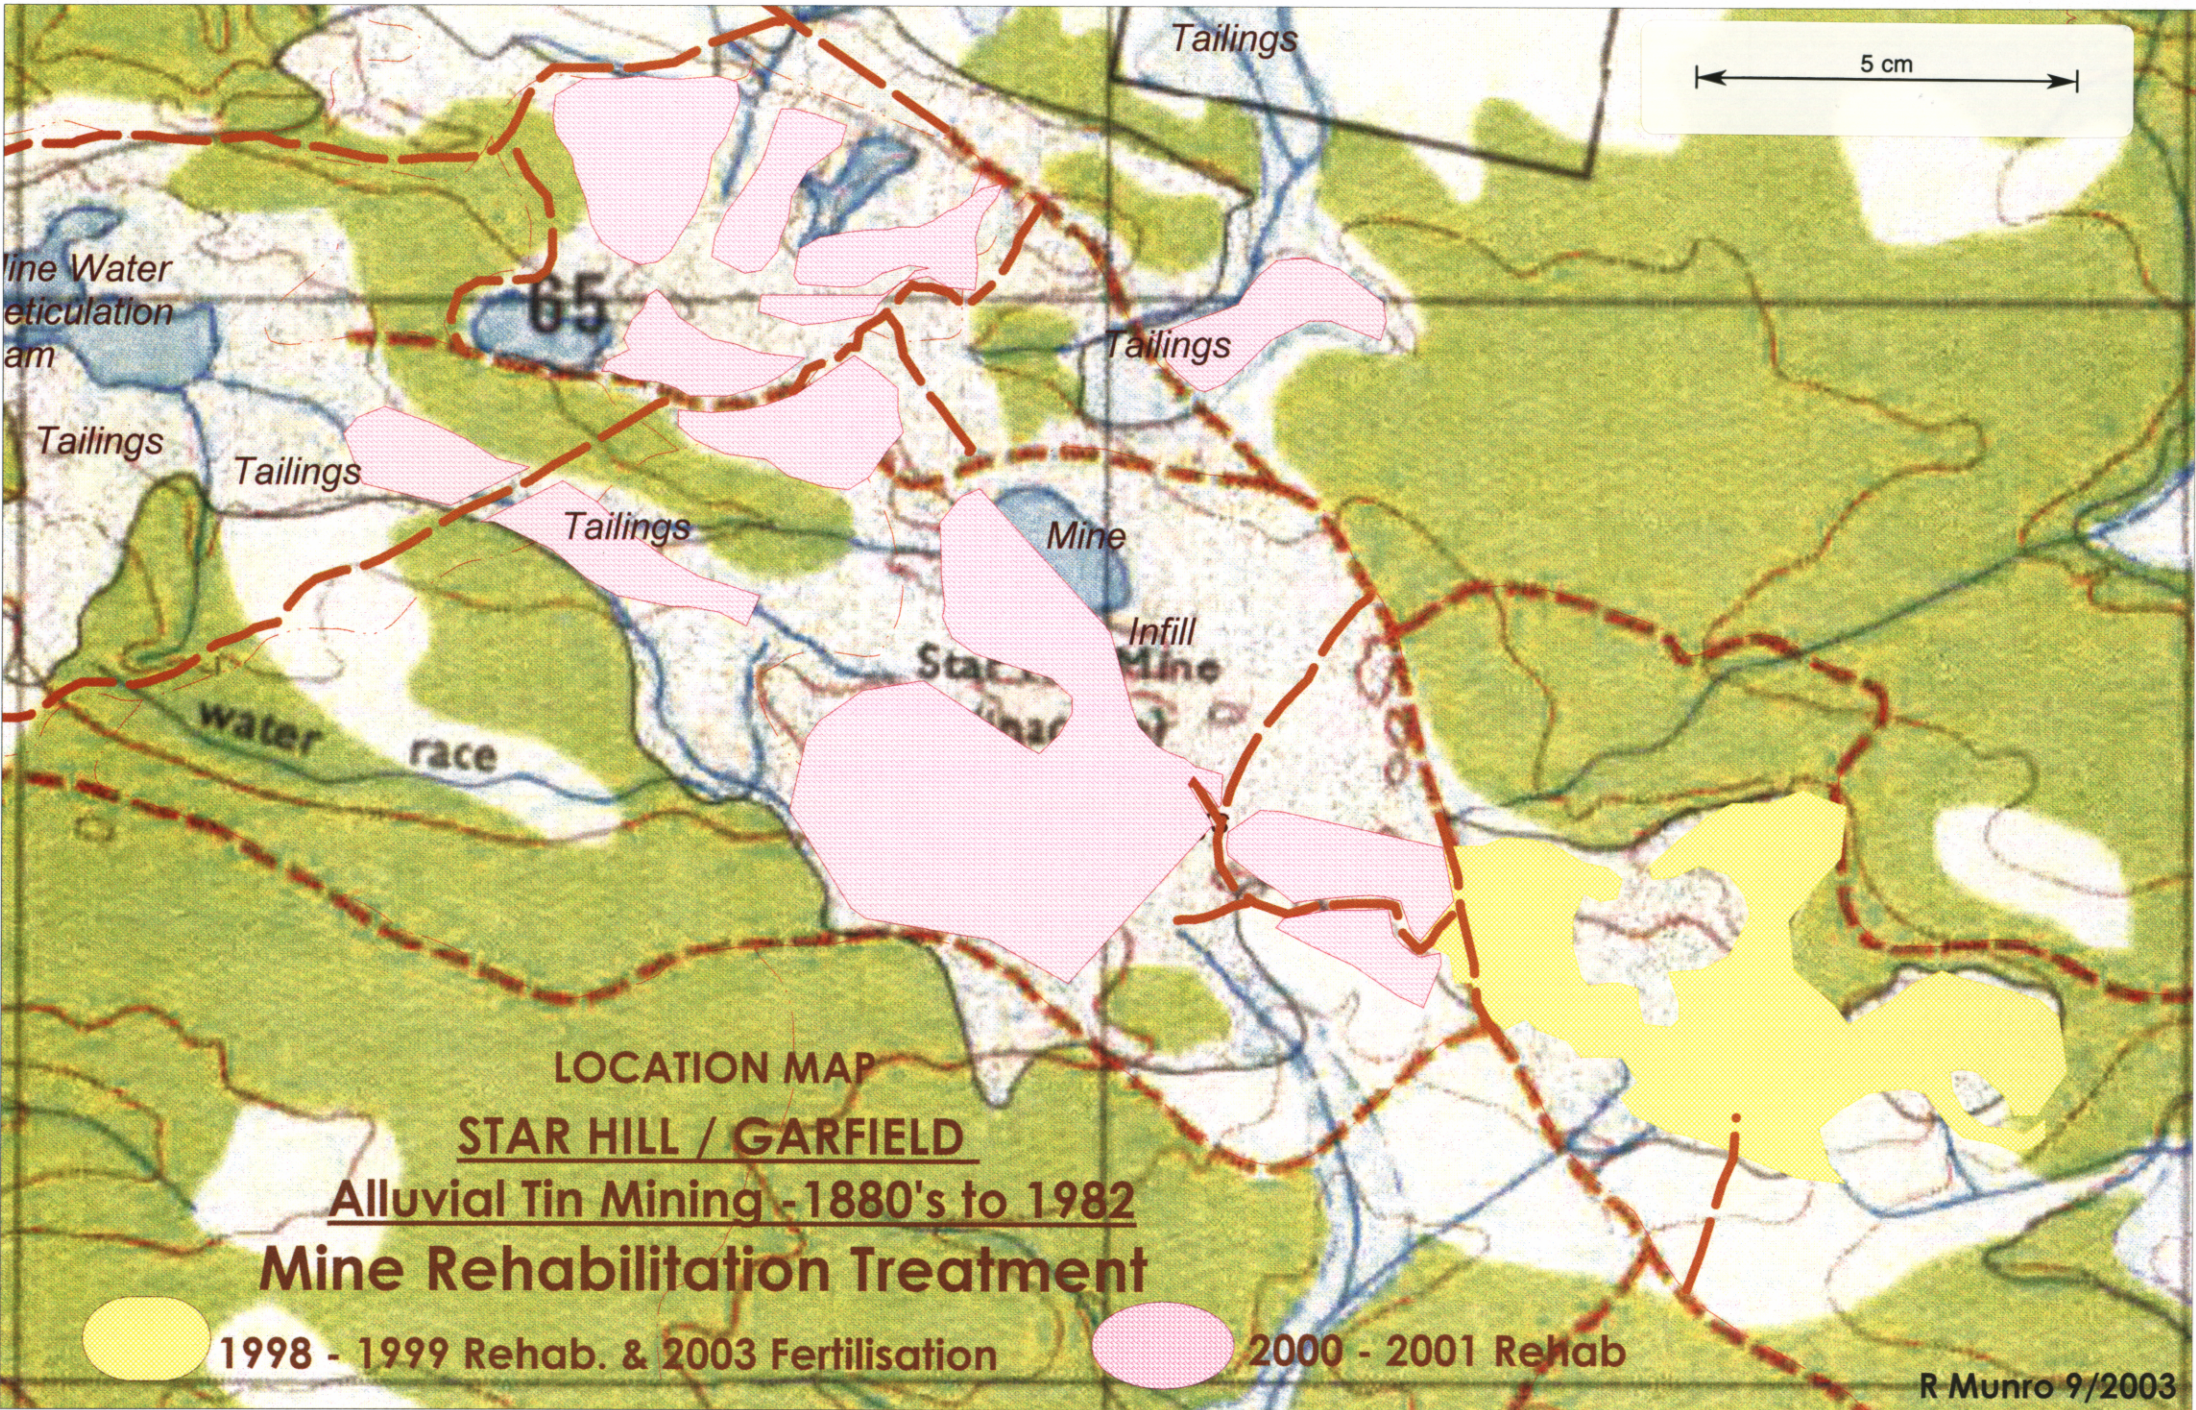
fig 3.

As reported previously, the results of the last (second) rehabilitation phase (2000 – 2001) to date have been assessed as disappointing. Rilling has been extensive, especially where ripping and direct seeding did not follow contours. In the first phase, rapid plant colonization was able to stem an initial erosion phase. In the case of the second phase, seedling germination and/of survival has been poor. There is evidence of intense native animal browsing pressure. There is scope for further monitoring with a view to either undertaking remedial works, that may include additional fertilizing of the surviving seeding.

All the splendid revegetation of the first rehabilitation phase at Star Hill has been hand fertilised (2 ton of 3.15.13 high analysis **Impact** product) during the period. The area for hand fertilising is quite irregular and is estimated as 9 ha in area. (Coloured yellow on the attached figure 3) The works took the equivalent of five person days. The use of a four wheel bike aided the distribution of bagged fertiliser.

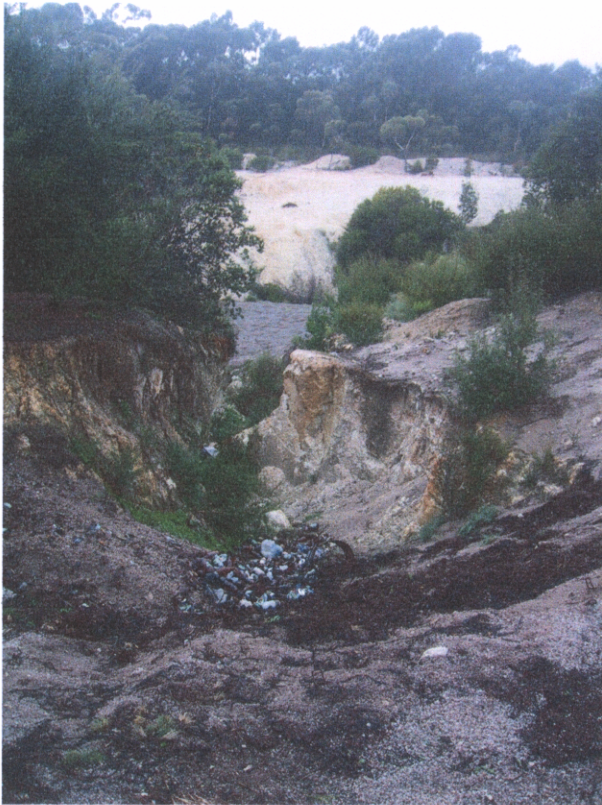
Left~ Rubbish dumped in rehabilitation area ~ Action was taken! (Note: about six car bodies on the mine site were also buried).

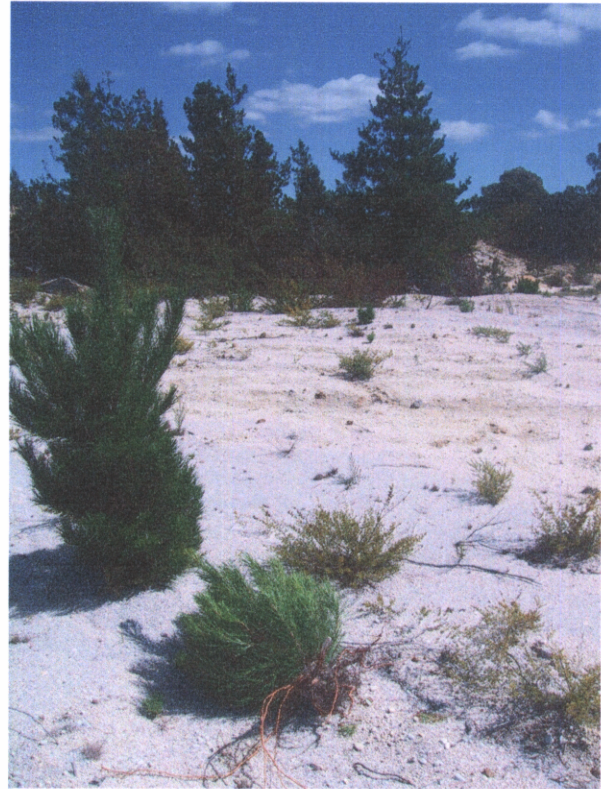
On a 1.5 ha portion of Phase 2 tailings, (adjacent to where the bulldozer was bogged) an exercise in *Pinus radiata* removal was undertaken. ~ In three hours 1100 seedlings up to 1m in high were pulled from this area. A number of "seed" trees were also felled. It is estimated that the scale of the pine problem stemming from 'mine rehabilitation' in 1982 is some 20 times the scale of this exercise.

Below~ 'Pulled' pines at Star Hill Phase 2 site.

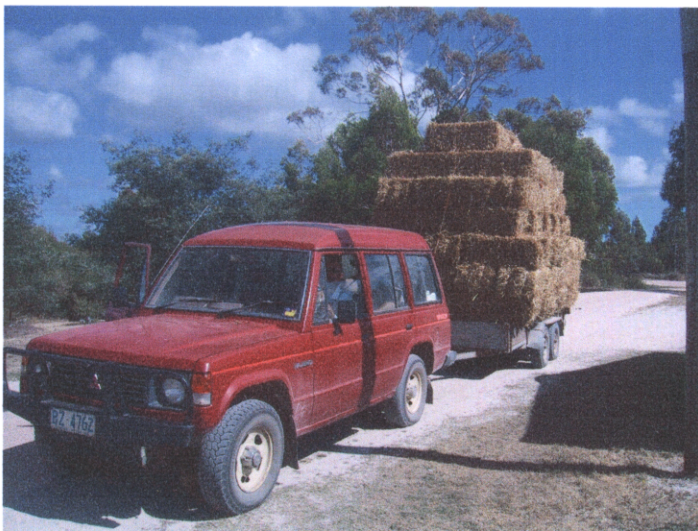
Left~ Bales heading to South Mt Cameron

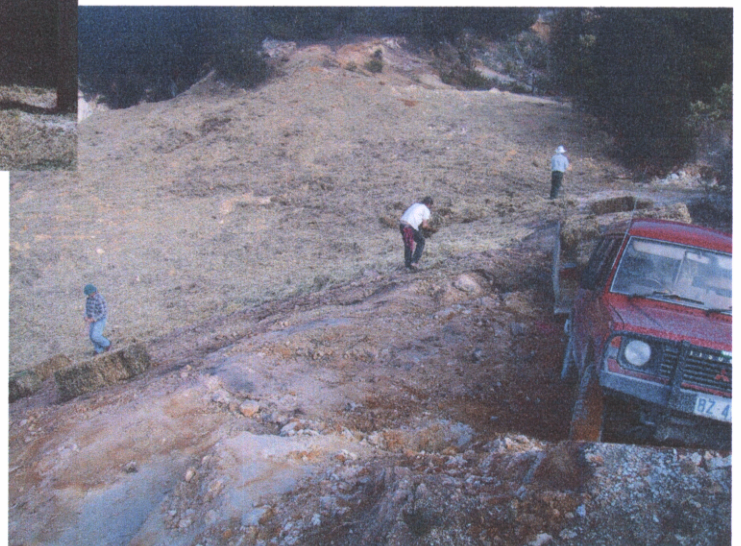
Below ~ Straw being applied at the Tailrace site
