REHABILITATION OF ABANDONED MINING LANDS TRUST FUND

PROPOSED SHAFT SAFETY PROJECT 2006/2007

# **BACK CREEK GOLDFIELD**

PROJECT OUTLINE AND COST ESTIMATE

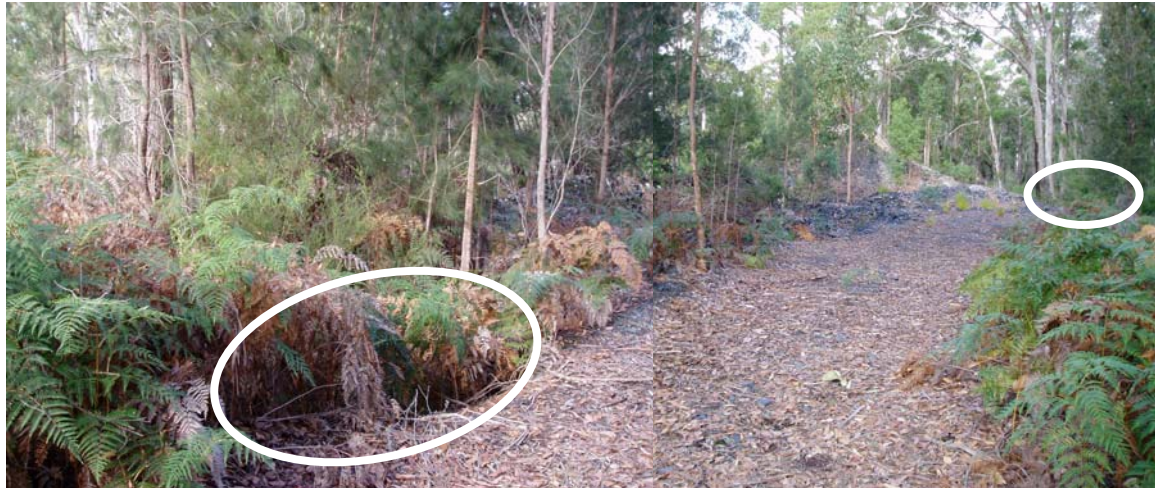
Two main shafts — both collapsed but recorded as being sunk to 800 feet (Montgomery, 1897).

**Figure 1.** Deep Lead site showing two open shafts. The main shaft is in the background (circled).

- Provide hazard sign at the junction of Back Creek Road and Ringwandls Road (Map 2).
- Cap three of the six Union Mine shafts with pre-cast concrete panels. Provide viewing grates to the three main shafts. Viewing grates are recommended because of perceived heritage value of these shafts.
- Cap six shafts on Red Lead with pre-cast concrete panels.
- Cap two shafts on Deep Lead with pre-cast concrete panels.

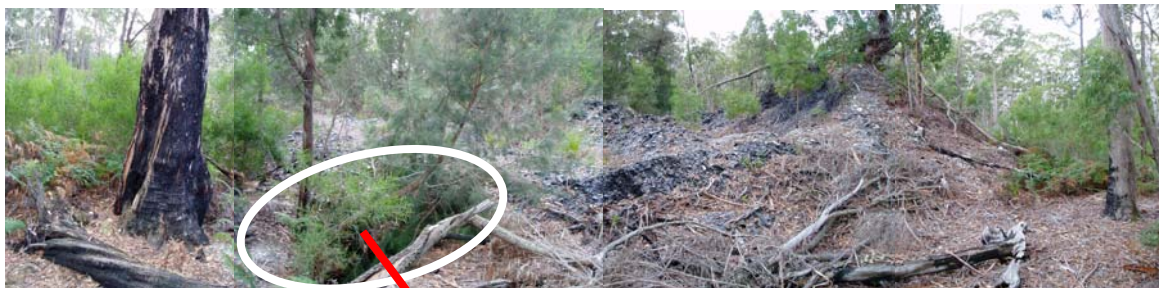
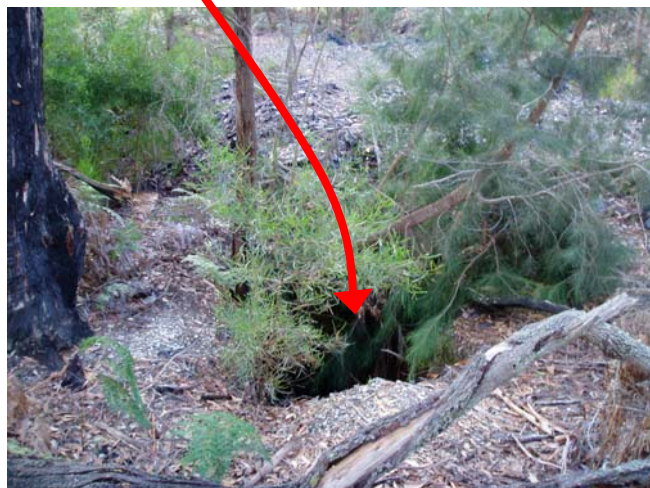
**Figure 2 & 3.**  
Deep Lead Main Shaft.

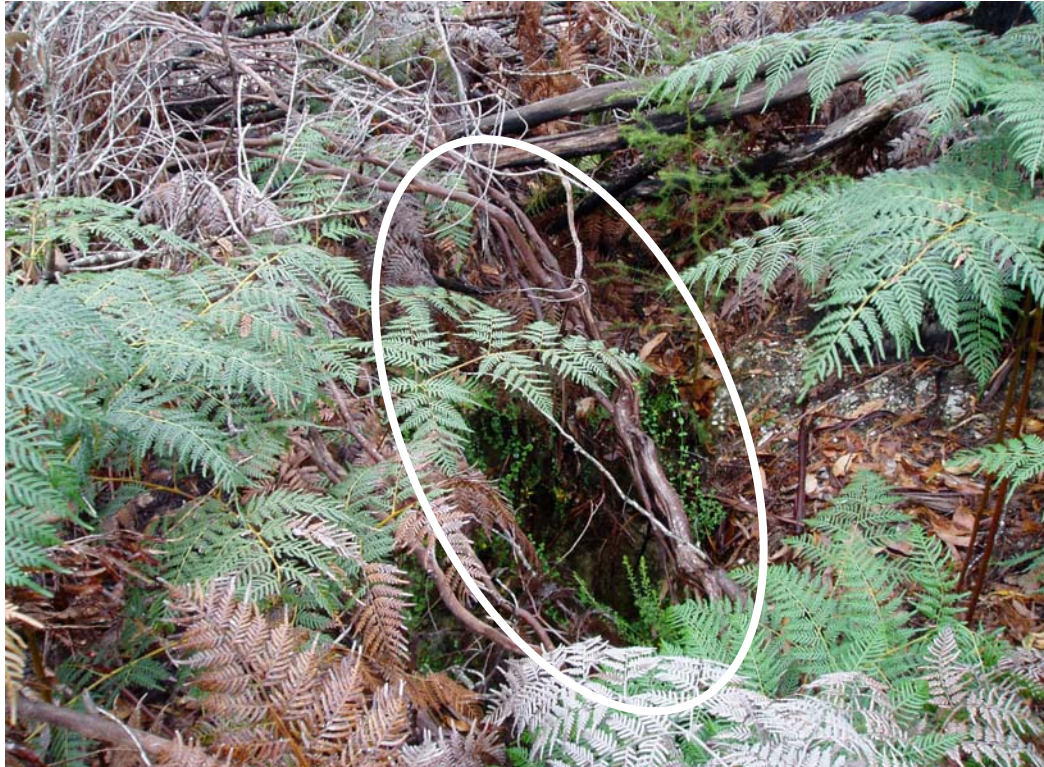
Although relatively remote, the Union Mine site is easily accessible by 4WD. Three of six deep shafts are very obvious – positioned on prominent mullock heaps with clear area around them – while another three are concealed by vegetation with no obvious indicators of their presence.

**Figure 5.** Example of an obscured shaft at the Union Mine. This shaft measures 2200 mm x 1200 mm and is open to a depth of 12 metres.

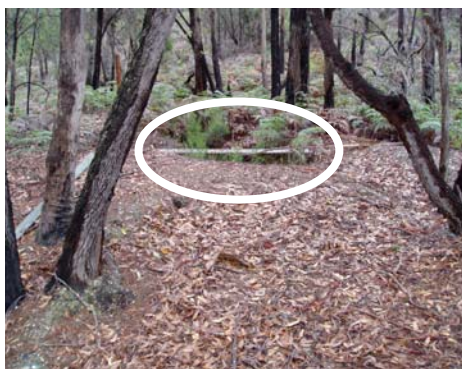
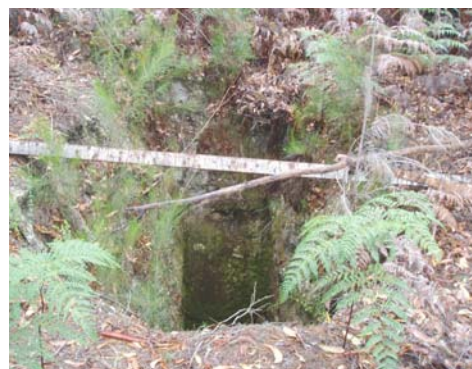
**Figures 6 & 7.** Two views of the Union Mine main shaft. This shaft is open to 11 metres and measures 3200 mm x 4200 mm at ground level. There are drives off the two long sides at the 11 metre level.

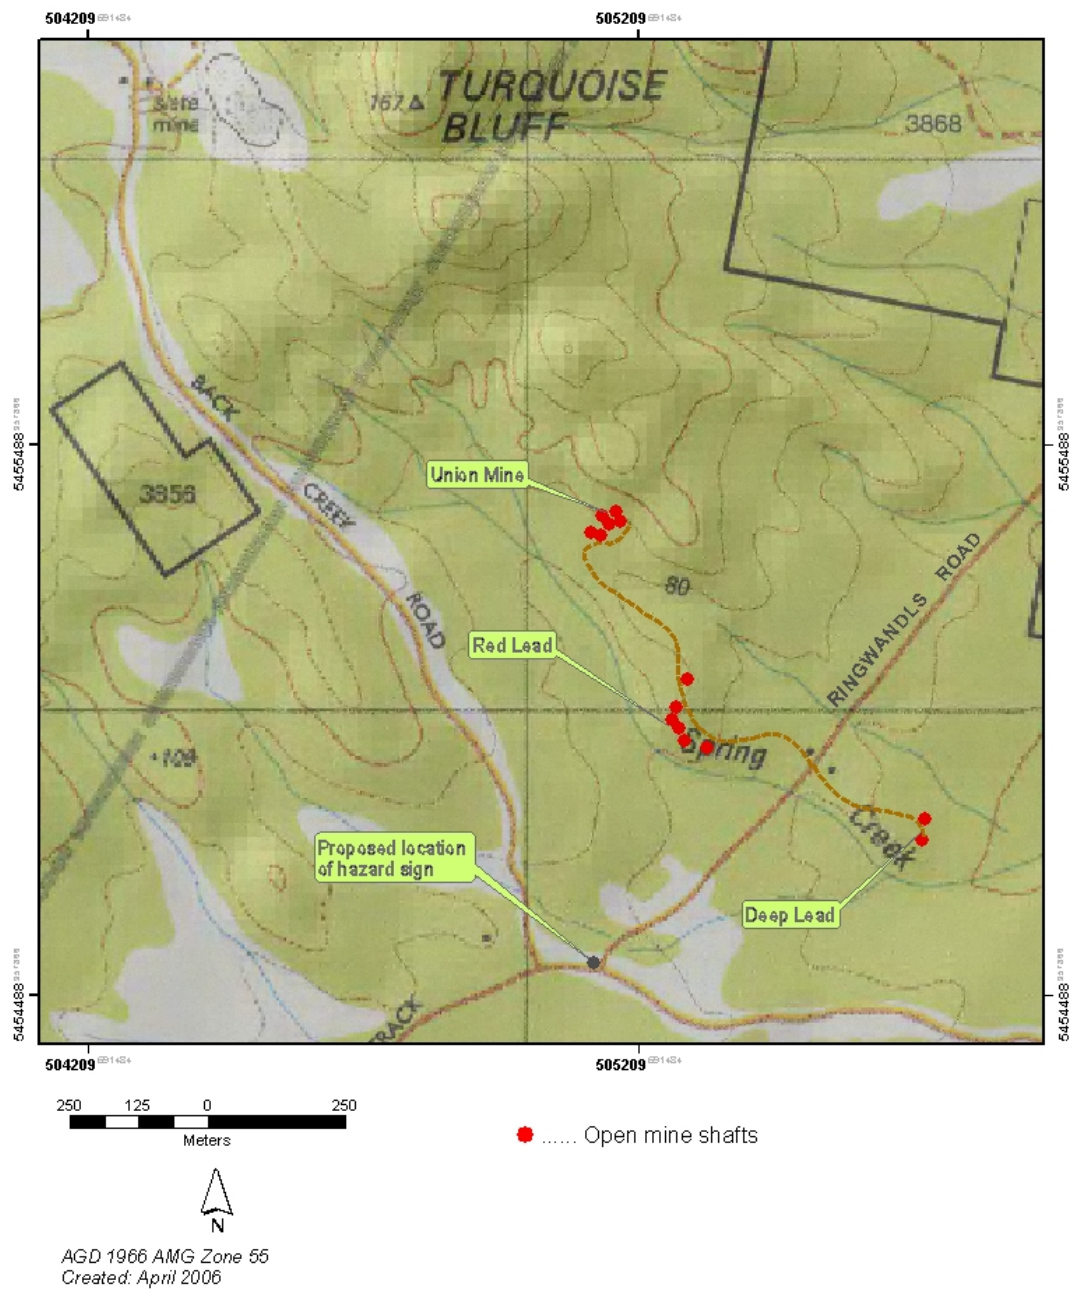
**Map 2. Back Creek: open mine shafts identified for 2006/07 safety program.**

Three separate sites comprising 14 shafts have been identified as high risk hazards (Map 2). A combination of capping and grating is recommended to make these safe. Hazard signage at a strategic entry point to Back Creek is also recommended (Map 2). The total proposed budget for this work is \$45,000.
