## REHABILITATION OF ABANDONED MINING LANDS TRUST FUND

### Lefroy Goldfield North East Tasmania

#### Safety program

#### Progress report June 2006

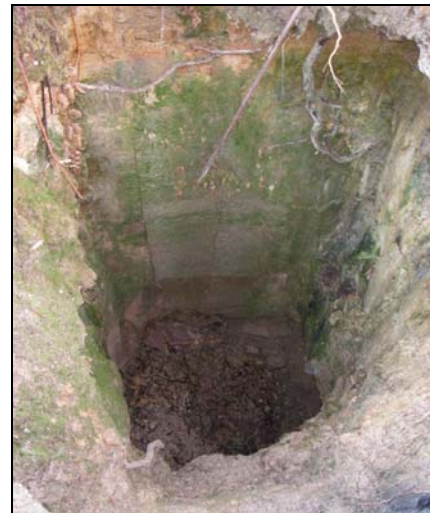
Hazards (shafts and adits) were selected based on public safety criteria set out in *Tasmanian Geological Survey Record 2001/04: Strategy – The rehabilitation of abandoned mining lands (Revision 1)*, specifically the **risk** (depth of shaft; extent of excavation) and **exposure** (ease of access; proximity to population). Shafts were targeted for work by their being open to a depth greater than three metres and typically within 40 metres of a road or track (Fig.1).

**Figure 1.** Shaft of the Monarch Mine. Fifteen metres off Forestry road — 2400 mm x 3600 mm and open to 12 metres with drive off right hand side.

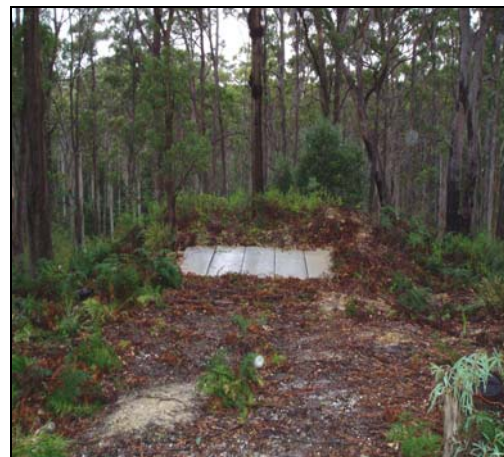
Engineering designs and installation specifications for pre-cast panels are attached. Multiple panels were used to cover shaft openings where necessary (Fig. 2). A mid-sized excavator (12 tonne) was used to prepare sites, position panels, and remediate disturbance caused during work.

**Figure 2.** Gift Main Shaft. Covered with 5 x 3700 mm x 1000 mm panels.

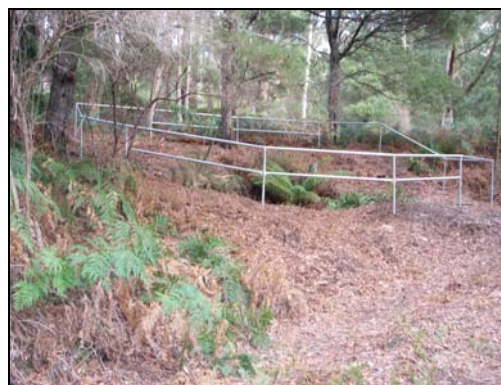
Eight shafts were fenced: seven using steel dropper and wire strand; one (at the Volunteer Main Shaft) using galvanised steel pipe barrier with an 'Armco' style guardrail. The Volunteer shaft was treated in this way because it is easily accessible to the public and beside a 4WD track (Fig.3).

**Figure 3.** Work in progress on steel rail barrier enclosing the Volunteer Main Shaft.

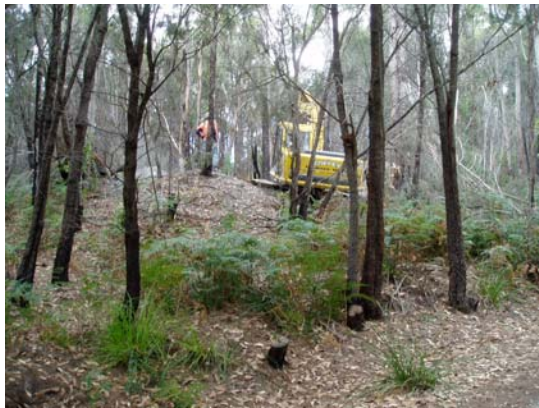
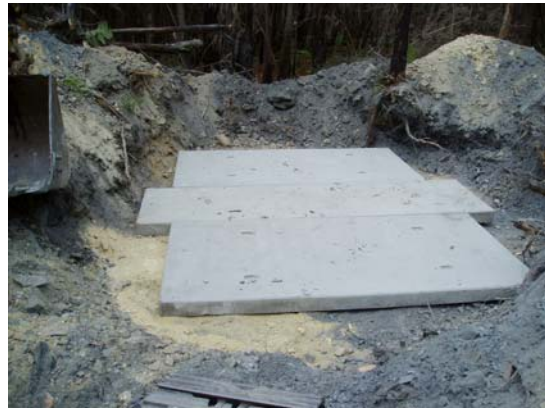
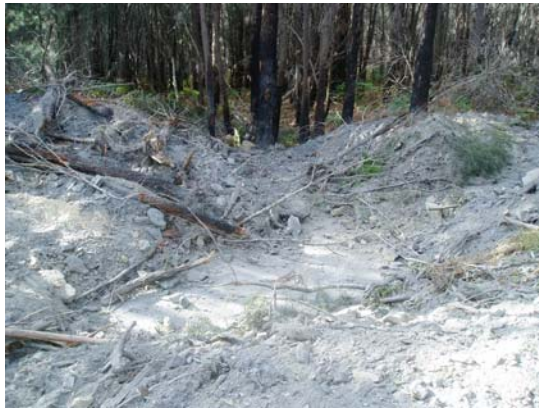
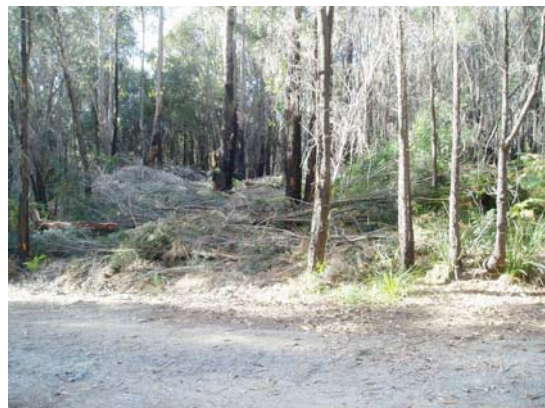
**Figures 4-7.** Work on shaft beside Volunteer Road showing positioning of panels, and slash covering access track.

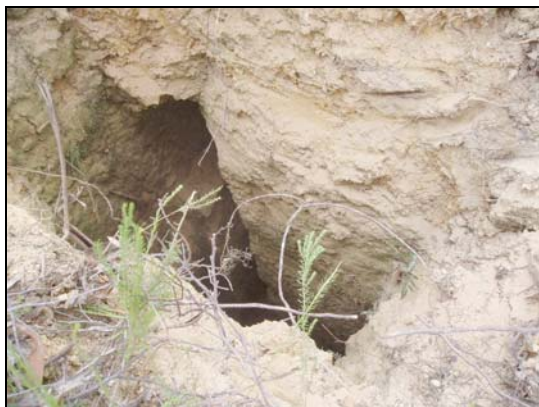
**Figure 8.** Typical small shaft with covering vegetation removed – 1200 mm x 900 mm and open to 8 metres.

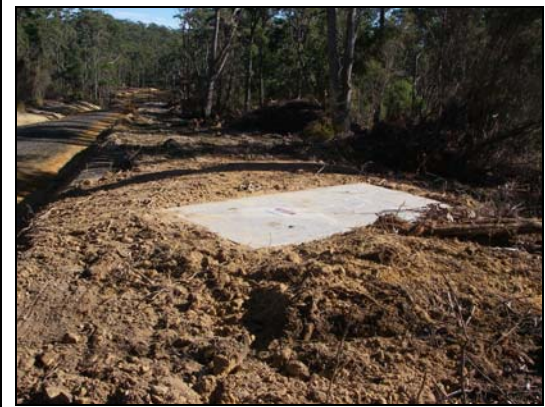
**Figure 9.** Single panel shaft beside Forestry road.
