## Section 2 — Engineering Geology

## 14. RESISTIVITY TRAVERSE OF SUSPECTED FAULT ZONE, RISDON BROOK DAMSITE

by D. E. Leaman

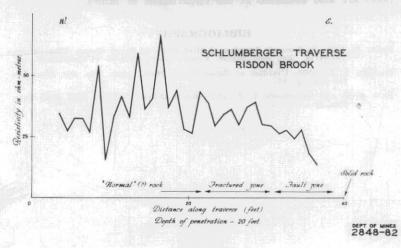
FIGURE 21

The resulting profile is shown in fig. 21. A high resistivity represents solid rock, a low resistivity crushed rock. It is therefore concluded that the rock between 0 and 20 feet on the traverse is massive but occasionally jointed, whereas that between 20 and 30 feet is extensively fractured. In the remaining 10 feet between this region and the solid rock at 40 feet extensive crushing has occurred. Thus it is considered that the fault is located within 10 feet of the marked mudstone outcrop at the E end of the traverse.
