*TR14-115-117*  
**27. Site investigation at Wrest Point, Sandy Bay**

P. C. STEVENSON

The site of the proposed new development at the Wrest Point property of Federal Hotels Ltd was examined at the request of Messrs Gutteridge, Haskins & Davey, Consulting Engineers of Hobart.

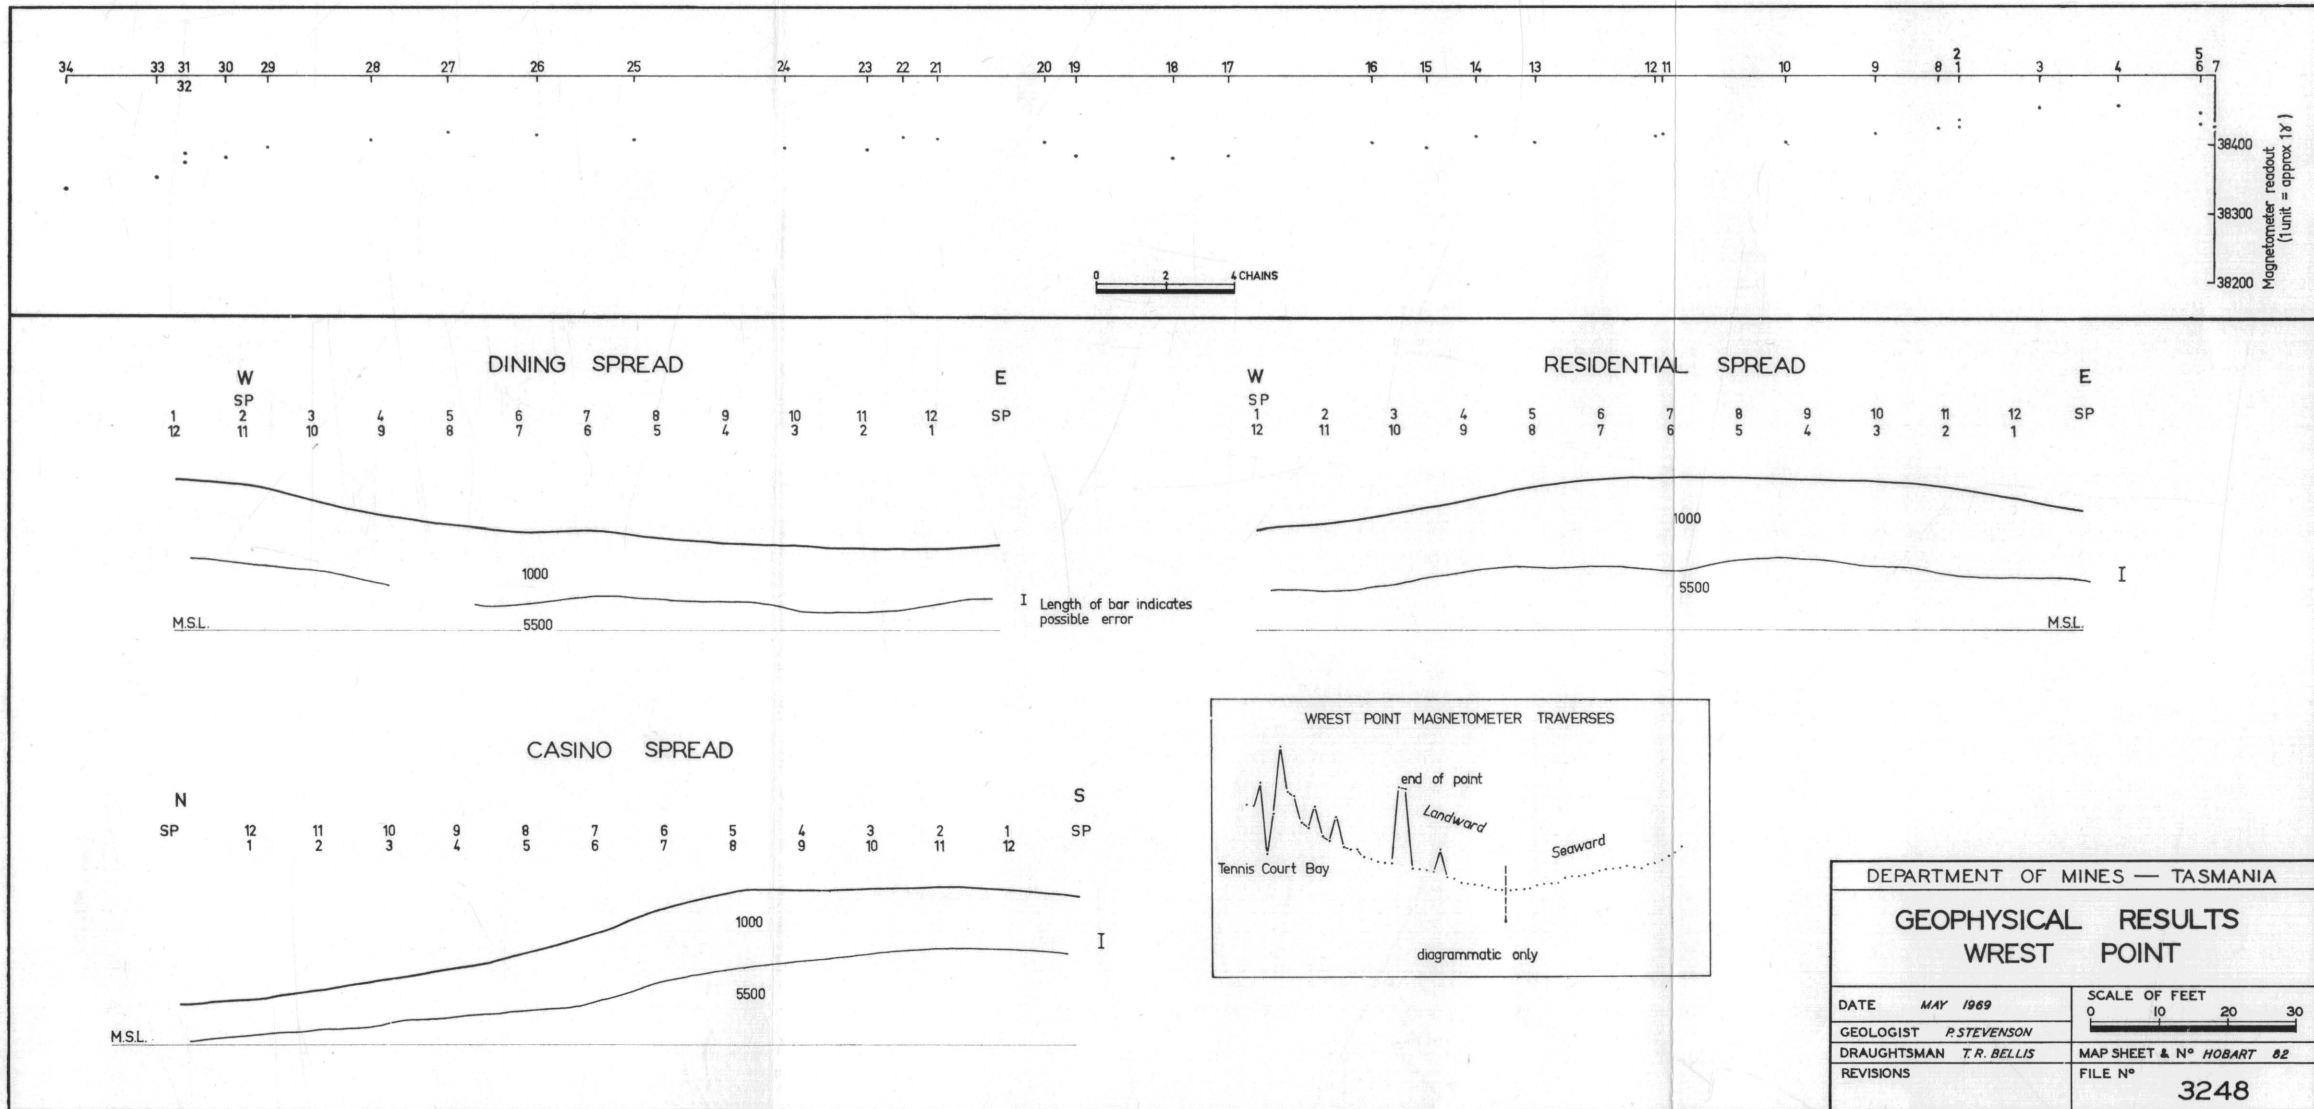
FIGURE 35

A traverse was made round the peninsula by boat and readings were taken at approximately 40-foot intervals at a constant distance of 100 ft from the shore. The station positions are shown on the photo-map (frontispiece) and the resultant magnetometer readings are plotted on Figure 35. No correction has been made for diurnal or other changes as the whole traverse was completed within about two hours. Further traverses were made on lines out into the Derwent Estuary and these gave the results as plotted.

The results of both these traverses were remarkably smooth and lacking in variation, and this, as has been mentioned, is quite uncharacteristic of dolerite bodies. In particular the readings at stations 11, 12 and 13, although close to dolerite outcrop, are not significantly different from readings at stations 1 to 7 and 32 to 35 which are known to be on Tertiary sediments. Some abrupt variations are seen, but they appear to be due to drain pipes, moorings or boats and may be ignored for our purpose.

The interpretation of the seismic results (fig. 35) shows that only two layers were detected. The upper one of the order of 1,000 ft/sec varies from 5-12 ft thick and averages about 9 ft. Its slow velocity and the auger holes show it to consist of soil, loose subsoil and fill.

The lower layer shows everywhere a velocity close to 5,500 ft/sec. This velocity is not diagnostic, and could represent either Tertiary sediments or deeply weathered dolerite, though it must be said that the velocity is low for the latter. In addition, although shot points were extended in three directions, in one to over 320 ft, no higher velocity layers at greater depths down to about 100 ft were detected.
