TR15-47-54

12. Further report on Deep Creek dam site

W.L. Matthews

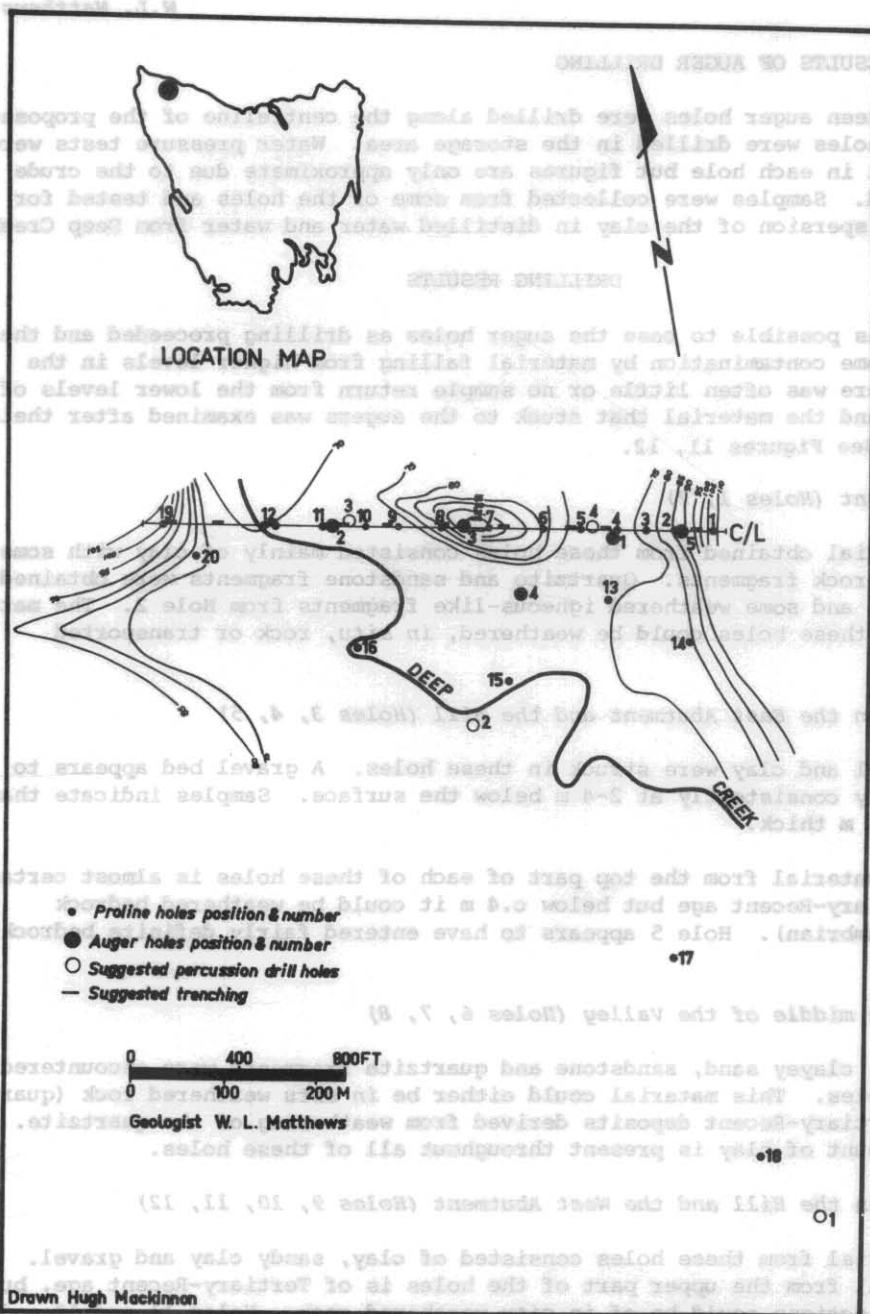
Figure 11. Drilling and trenching, Deep Creek dam site.

It was possible to case the auger holes as drilling proceeded and there could be some contamination by material falling from higher levels in the holes. There was often little or no sample return from the lower levels of the holes and the material that stuck to the augers was examined after their removal. See Figures 11, 12.

Four holes were drilled in the dam site area to determine the nature of the Tertiary-Recent beds overlying the basement rocks and to establish the type of underlying bedrock. A drive pump was used to collect the samples from the upper sections of each hole and casing was driven as drilling proceeded to prevent contamination of lower samples by material falling from above. The logs of these holes are given below. The location of the drill holes is shown in Figure 11.
