26. Geological investigation of a dam site at Craighourne Road, Colebrook

P.C. Stevenson

The dam site is located about 750 m downstream from the Craighourne road bridge over the Coal River, about 5 km south-west of Colebrook.

It was investigated between 25 February and 26 March 1970 in response to a request by the Rivers and Water Supply Commission.

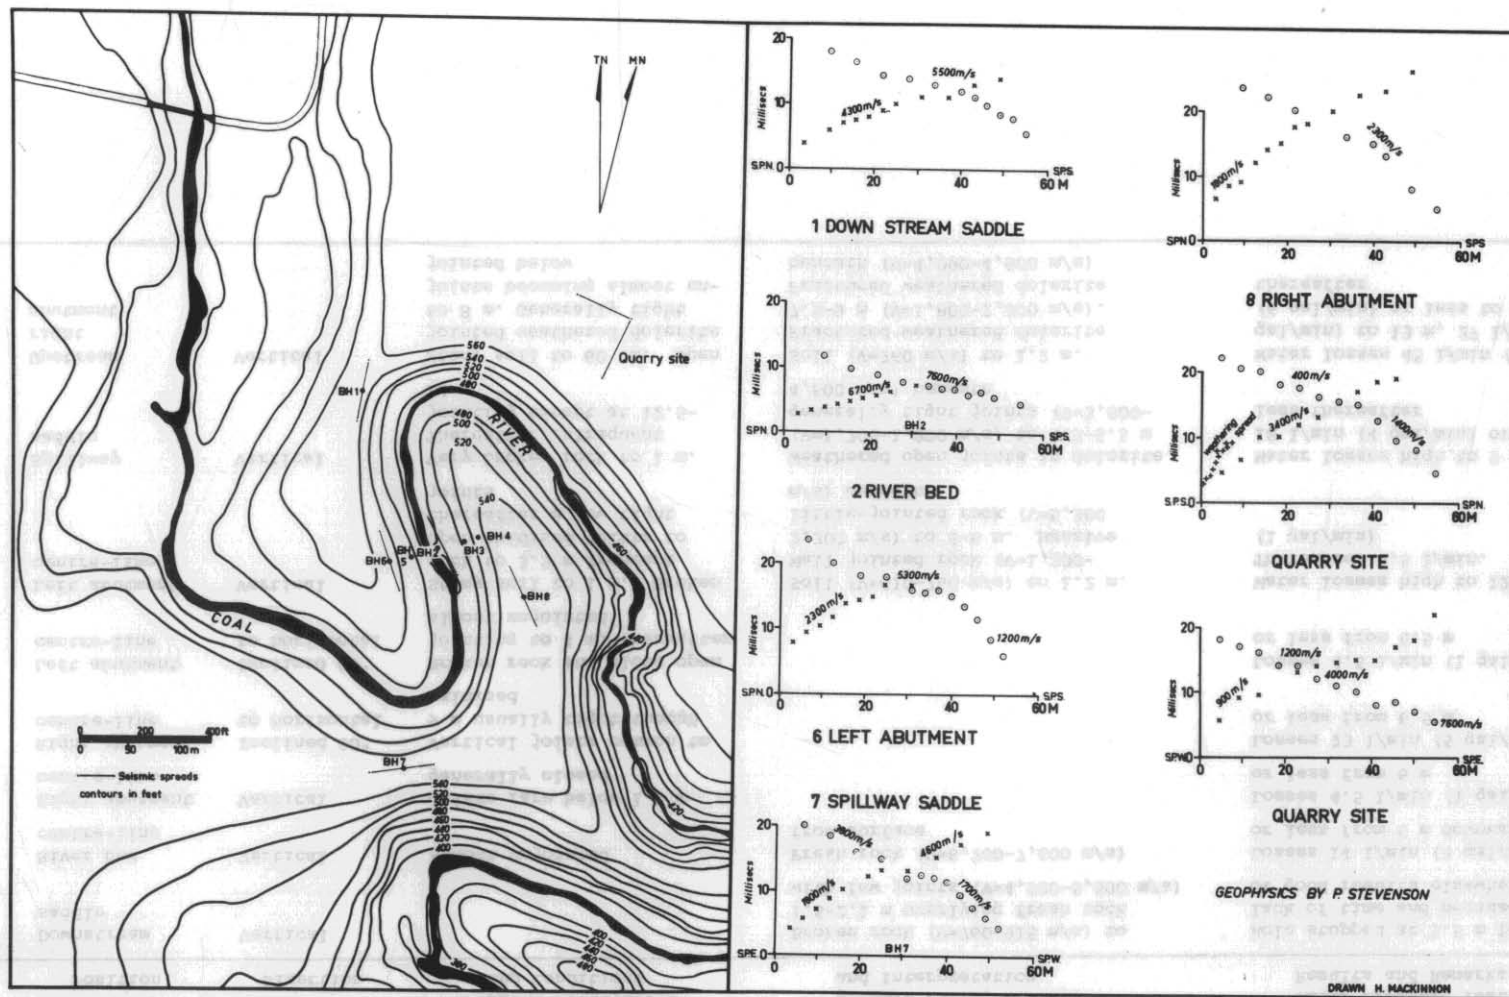
The positions of the boreholes are shown in Figure 22. The boreholes were sited (Table 1) to reveal the frequency, attitude and condition of joints and were subsequently subjected to water pressure testing to measure the consequent permeability (fig.23).

Seismic spreads 55 m in length, with 12 geophones, were fired from both ends in positions straddling boreholes 1, 2, 6, 7 and 8 with the intention of correlating seismic velocity variations in depth with the joint conditions revealed by drilling and also to ensure that the boreholes were reasonably representative of the whole rock mass.

Two further seismic spreads, not correlated with boreholes were fired, as indicated in Figure 22, to reveal the rock quality and probable cover in the quarry site to the north of the dam site.

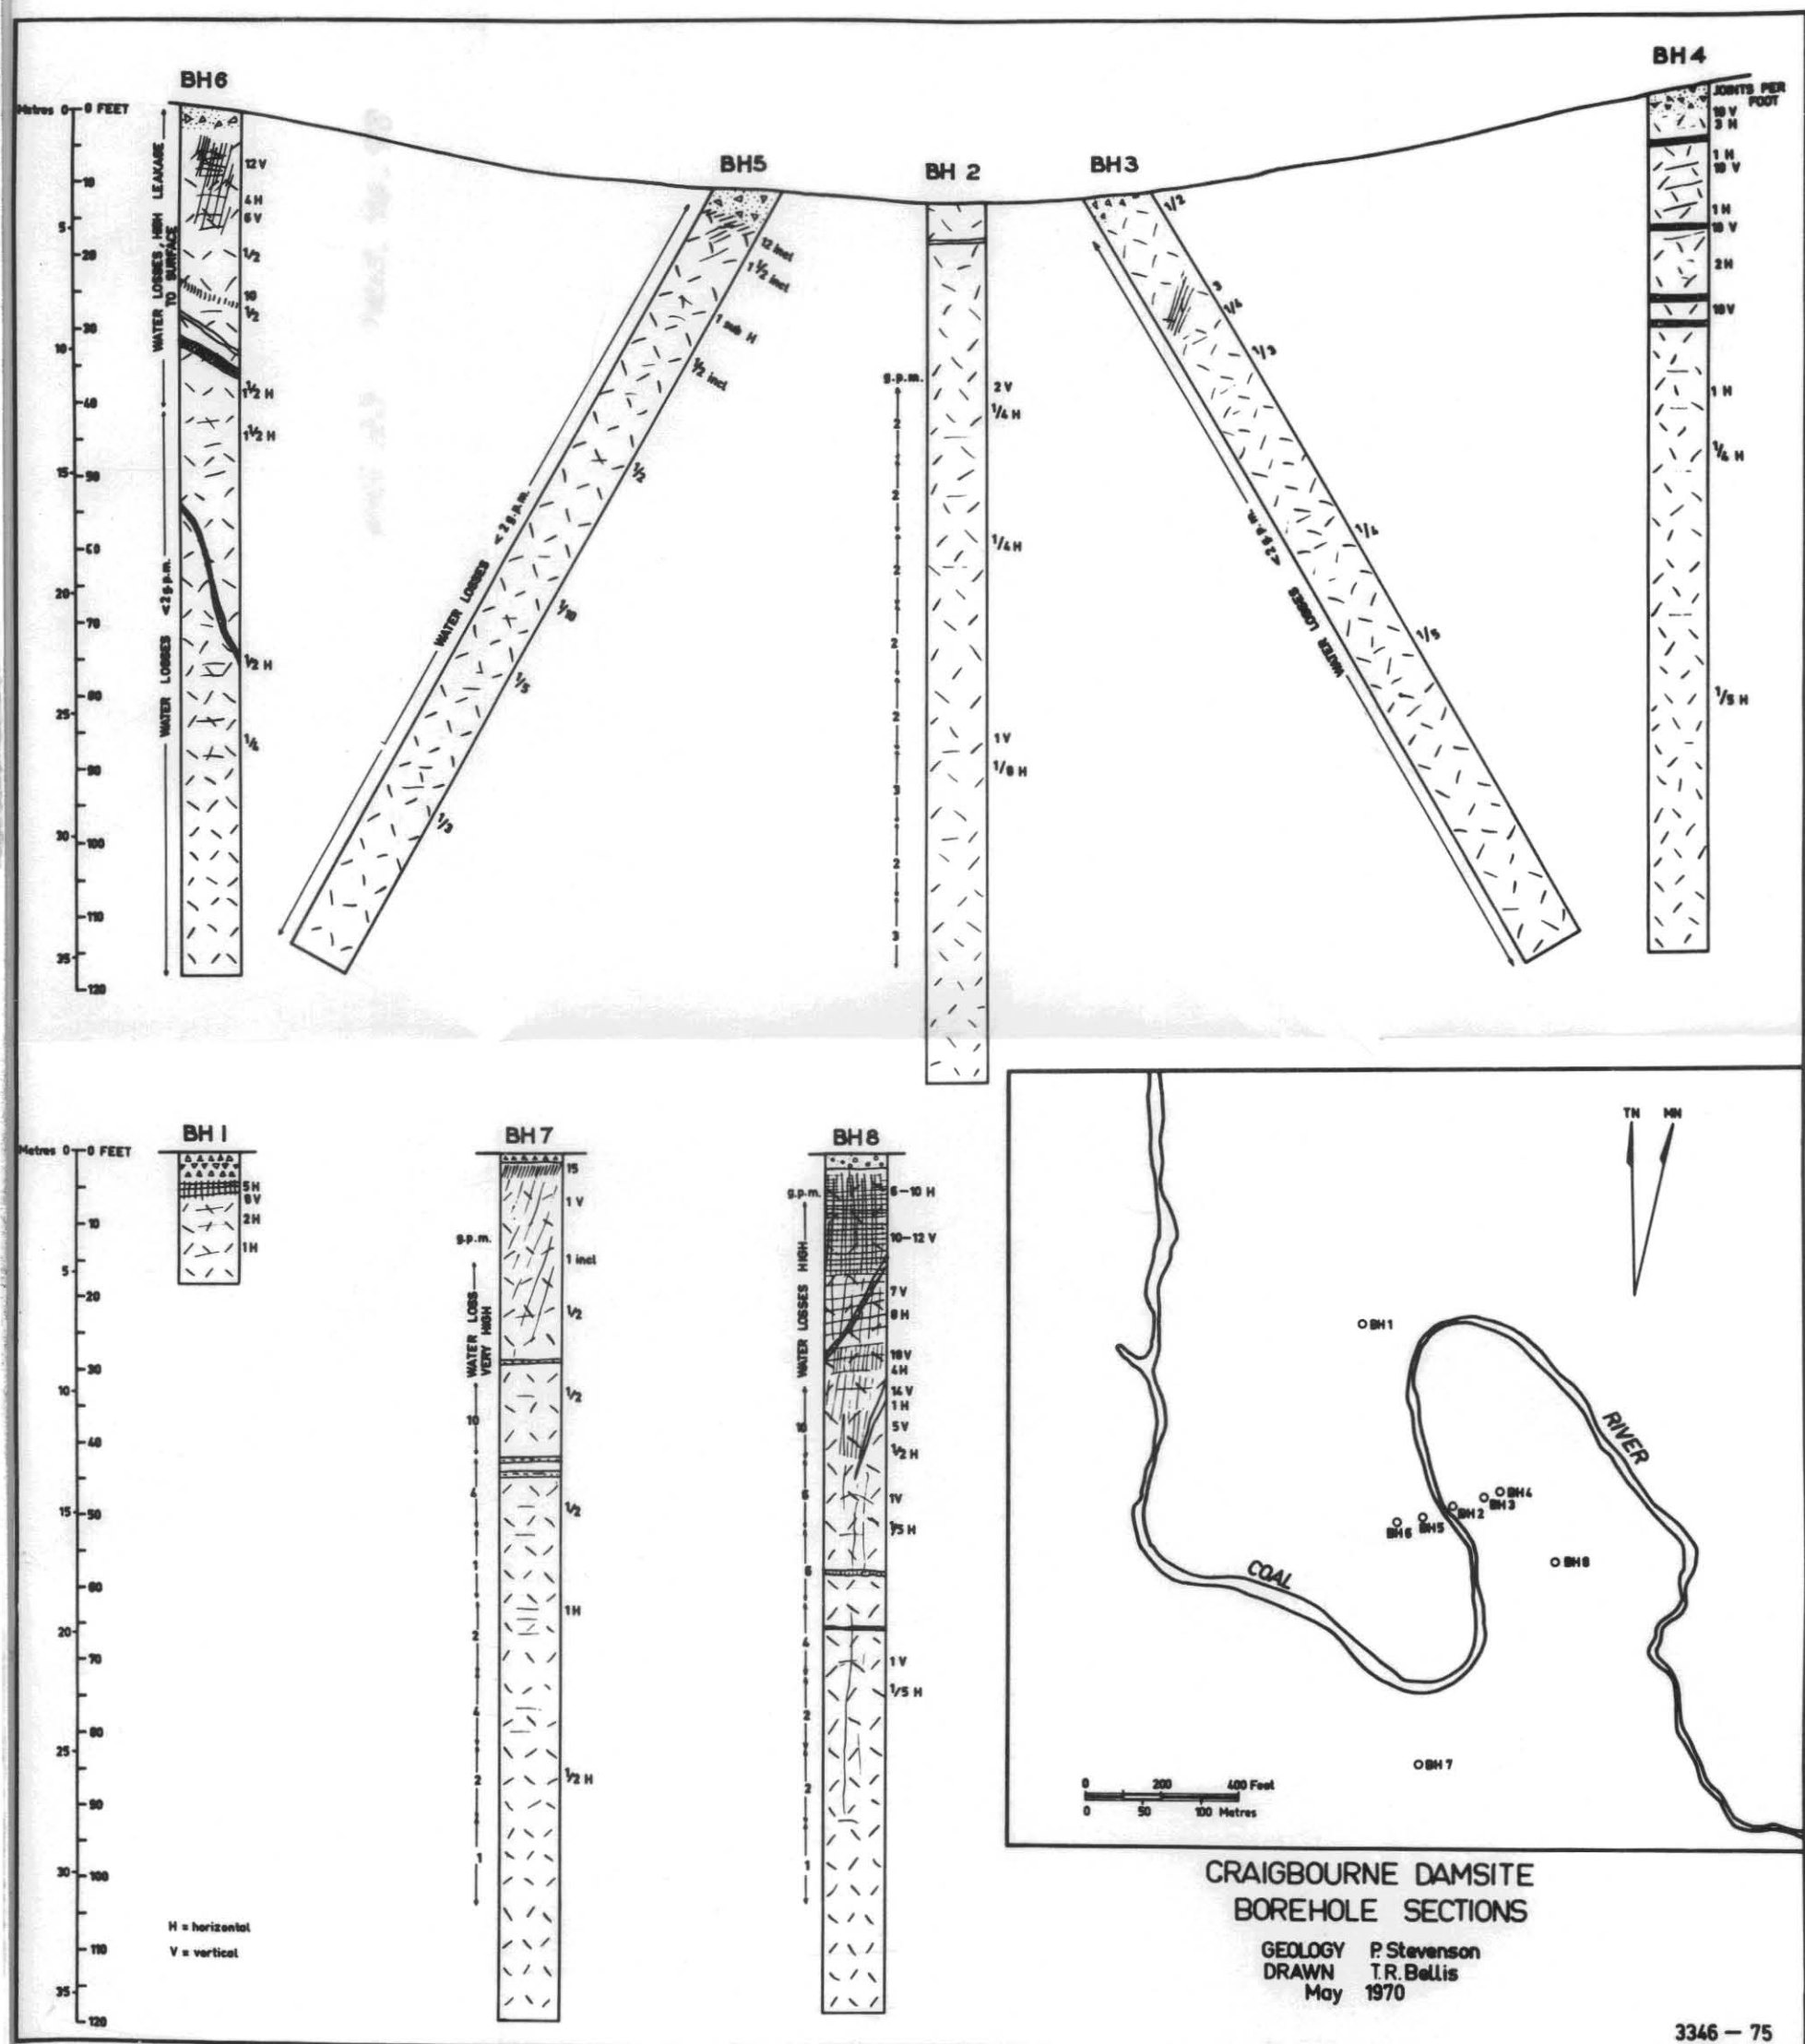
Figure 23.

The joint frequencies and descriptions as summarised in the table correlate well with the seismic and pressure test results.

Unjointed dolerite has an apparent seismic velocity of 6,700-7,600 m/s and water losses are less than 14 l/min (3 gal/min).

Where rock is fractured but unweathered, velocities of 3,700-4,600 m/s are observed and water losses are also low. Well jointed and weathered rock gives a velocity 1,700-1,800 m/s and high water losses.

A trial grouting cell in the areas of high water loss would be advisable.
