# LANDSLIPS AT BEAUTY POINT

by F. Blake.

At the request of the Chief Engineer, Public Works Department, a geological investigation was made to determine the cause and prevention of landslips affecting the West Tamar Highway at Beauty Point.

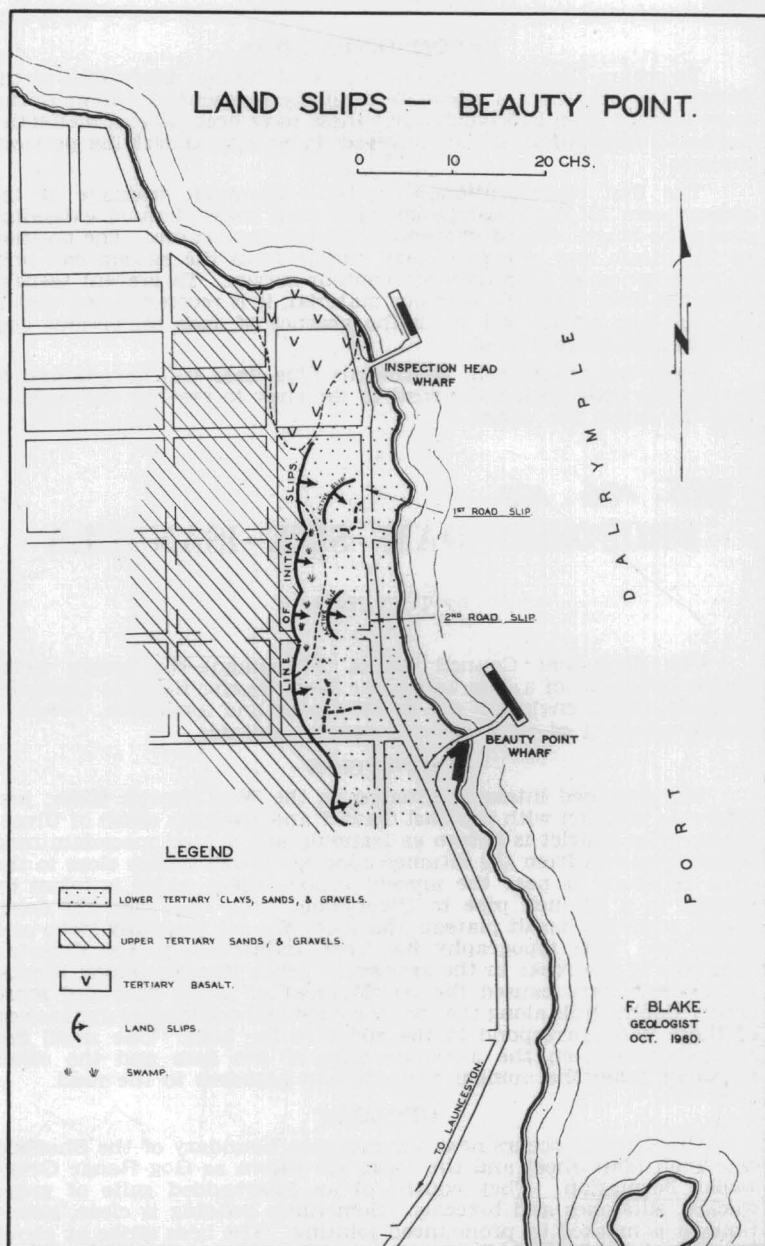
FIGURE 49.

The initial slips were caused by rain water percolating from the plateau surface down through the gravels, sands and weathered basalt to an underlying impervious clay bed at the foot of the steep upper slope of the hill. Water accumulating on and lubricating the clay, formed a greasy head on which the overlying material slipped down the hill.

The greatest accumulation of slip material occurs along the toe of the steep upper hill slope and this has formed a dam behind which a large quantity of water is held in the swamp area.

Two active slips, now in progress below the swamp and adjacent to the highway, have extensively damaged the road surface over lengths of 100 yards and 80 yards respectively.

To secure the active slips and prevent further movement in the future, the provision of adequate drainage is essential. Some drains have already been constructed but these have been largely ineffective owing to percolation of the conveyed water into underlying pervious material.

The first consideration must be a thorough drainage of the swamp area by the construction of a deep main channel extending along the length of and immediately below the swamp. The position of this drain and any subsidiary outlets from the swamp can only be determined by a preliminary contour survey. To prevent seepage from the drain through pervious material, it is recommended that it be sunk into a clay bed or, in the absence of such impervious bed, the channel be concreted.

From the main drain continuous pipe lines will be required to convey the water below the road to the river to prevent any leakage into the active slip areas.
