TR6-61-63

PROPOSED DAM SITE—ALLENS RIVULET, MUNICIPALITY OF KINGBOROUGH

by W. N. MacLeod.

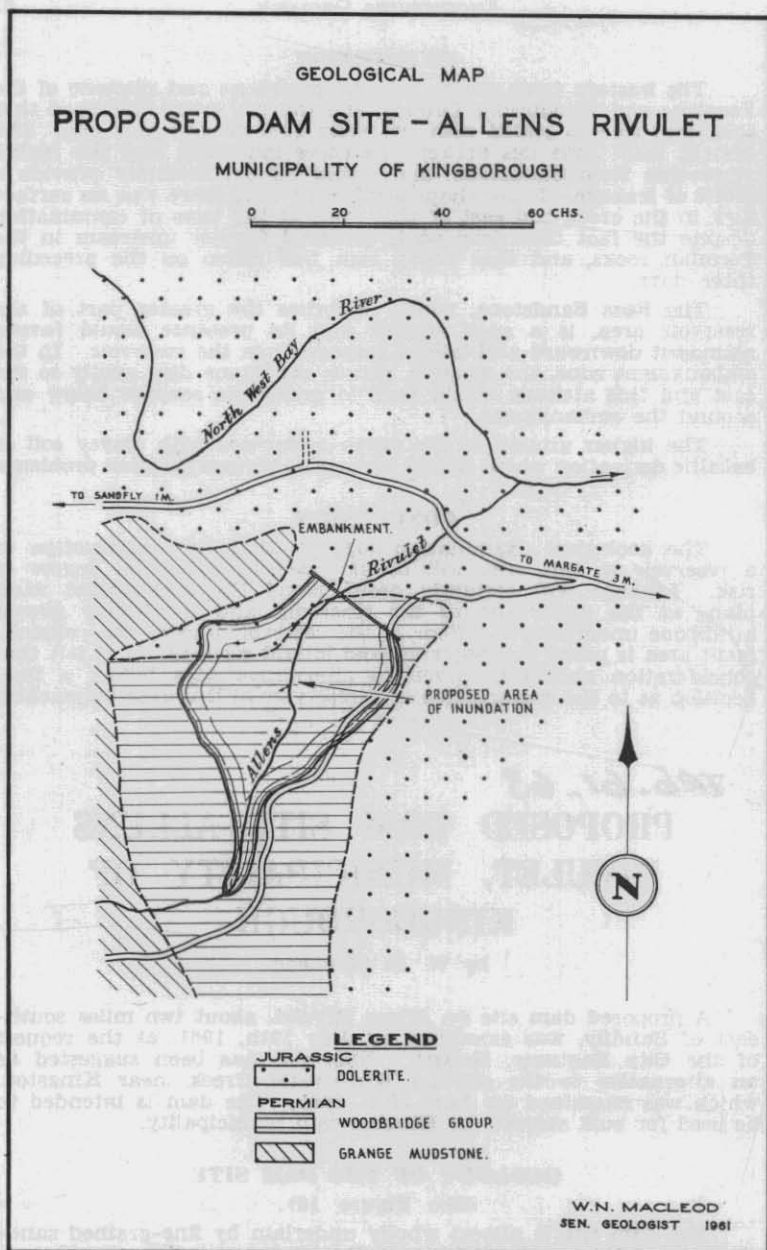
FIGURE 16.

The dam site is almost wholly underlain by fine-grained sandstone, mudstone and siltstone of Permian age. These sediments are intruded by and almost completely surrounded by dolerite

which forms much of the higher ground in the environs of the site, including Hickmans Hill (1070 feet) on the eastern side. The Permian sediments in the dam site area have been assigned to the Woodbridge Group. To the west these are conformably underlain by the older Grange Mudstone which includes a similar assemblage of rock types. Both groups are richly fossiliferous and well-bedded in units up to 18 inches thick with frequent intercalations of more fissile mudstone. Exposures of the sediments are rare, but the typical assemblage can be clearly observed in the small quarry on the branch road crossing Allens Rivulet, near the southern extremity of the area to be inundated. The sediments show a general dip to the south of less than 3° . There are two close and persistent vertical joint systems.

In the area north-west of the dam-site, and in the vicinity of the embankment, the proximity of the dolerite has caused induration of the sediments and some measure of recrystallization to produce dense hornstone and quartzite.
