TR7-81-82

### DAM SITE, FLAGSTAFF GULLY

by R. Jack.

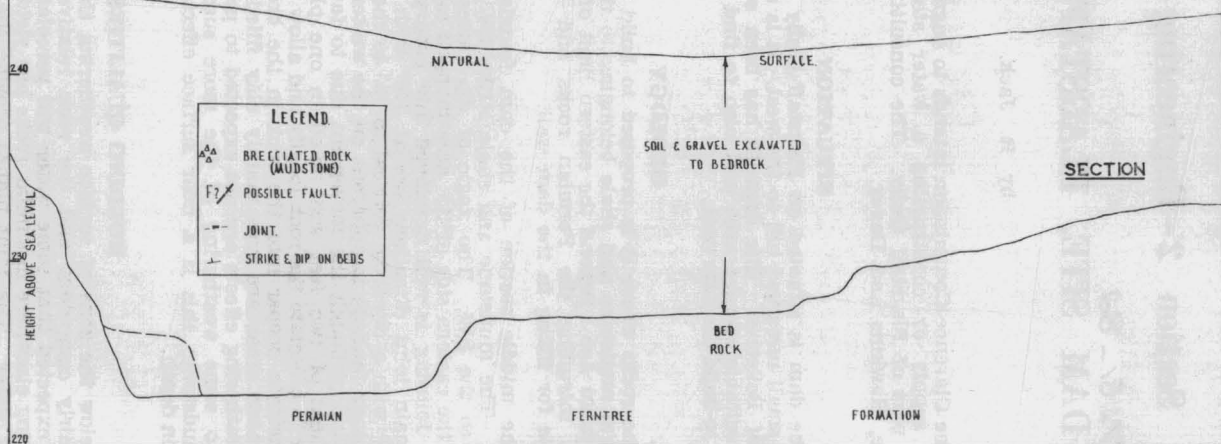
FIGURE 25.

The middle section of the dam foundations was mapped in detail. The mudstone and shale strike NW and dip at a shallow angle to the SW. The angle of dip varies slightly but is about  $6^\circ$  on the eastern side of the area mapped to  $8^\circ$ - $10^\circ$  on the western side. Jointing is well developed and occurs throughout the area. The main joint directions are at  $300^\circ$  with near vertical dip and at  $260^\circ$  with a dip from vertical to  $75^\circ$  to the SE. Some fracturing and minor faulting is apparent on the western part of the mapped area, and although the movement due to faulting is small—a displacement of two feet was noted in one place—it has been sufficient to brecciate the rock locally and allow the surface weathering to penetrate deeper into the rock in the brecciated areas. These brecciated areas are now mainly clay filled near the surface but the weathering effects are not expected to penetrate deeply. There is also some weathering of the more susceptible shaly beds in the mudstone; this is a near surface effect only and should not occur in depth.

Below the zone of surface weathering the mudstone and shale are fairly competent and the rock relatively impervious. It is to be expected that some water will percolate down through them as boring elsewhere in similar rocks has yielded appreciable quantities of water. The joint planes provide the channels down which most of the water will percolate, but this loss should not be too large and grouting is not considered necessary or practicable.
