TR8-115-118

18. FOUNDATION CONDITIONS AT FLAGSTAFF GULLY DAM

by I. Jennings

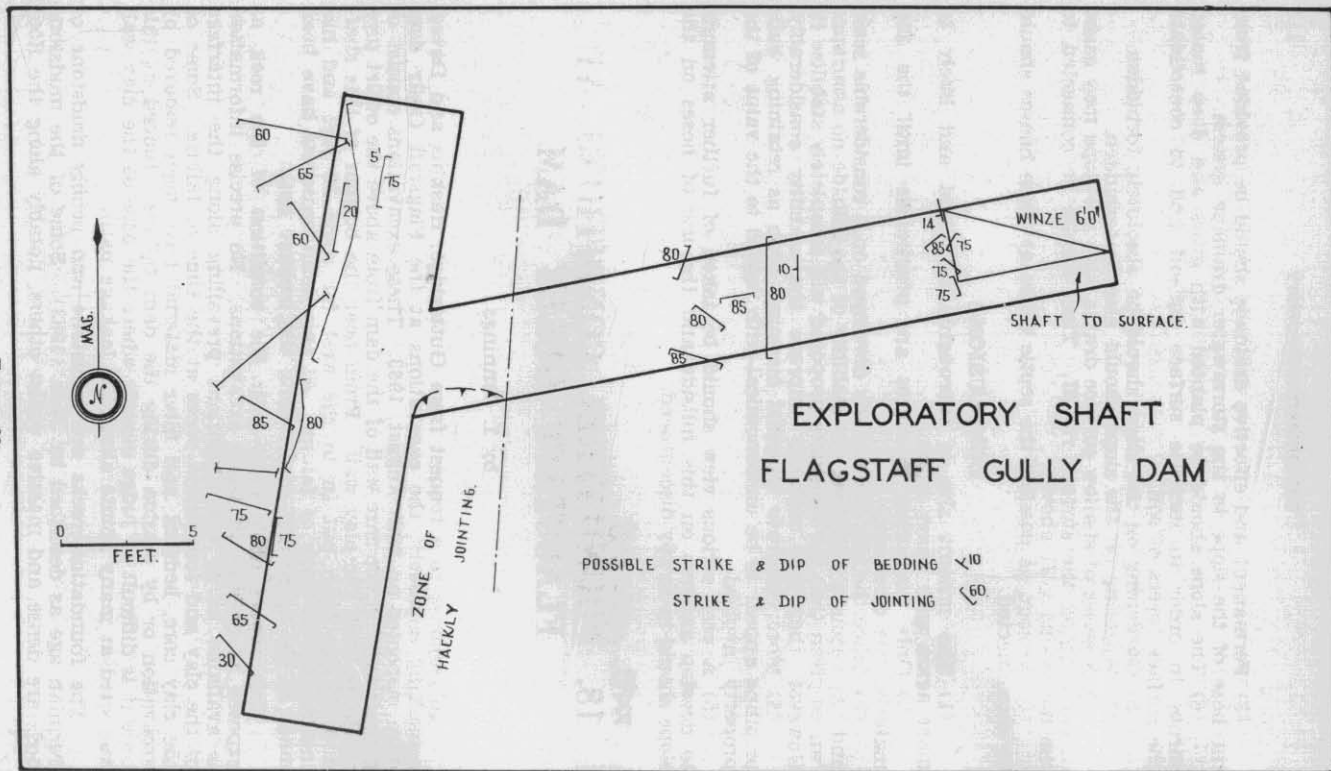
FIGURE 33.

The mudstone beds are broken into a series of irregular blocks by several sets of joints most of which are steeply dipping. Bedding if present is difficult to identify in the available exposures. The main joint systems present are indicated on Figure 33. The systems identified are:—

- (1) A strong set striking slightly east of north and dipping very steeply to the east.
- (2) A set striking roughly parallel to (1) but dipping flatly to the east and west. These may be incipient partings sub-parallel to the bedding.
- (3) A set striking at about 320° and steeply dipping.
- (4) A near vertical set striking about 230° .
- (5) An irregular, steeply dipping set roughly bisecting the acute angle between (3) and (4).

Sets (3) (4) and (5) are tightly closed and strike toward the dam abutment so that they do not appear to be important from an engineering viewpoint. Set (2) are poorly developed and frequently conform roughly to the surface of excavation. Little information is available concerning them.

A strong joint conforming to set (1) above is well exposed in the crosscut and appears to follow the zone of failure. In plan this joint is curved and cut by a number of cross fractures. In the northern end of the crosscut the joint appears to be slightly open but some clay filling can be observed a few inches below the present surface. Since the joint has been carefully cleaned out with a high pressure air hose several times it is not possible to indicate whether or not this joint was open at the time the clay wall was placed upon it.

(2) Several sets of joints are present which may affect the permeability of the rocks in mass. Most of these are tightly closed but a member of the strongest joint set exposed in the crosscut striking roughly at right angles to the dam axis is slightly open at its northern end at present.

Since most of the joint planes are nearly vertical it would be unsatisfactory to attempt to seal them by grouting from vertical drill holes. However, grouting and water pressure testing from such holes would give an indication of any permeable zones parallel to the bedding.

It should be noted that the spacing and direction of many of the joints in rocks of this kind are functions of the physical properties of the rocks. Thus the joint system may vary in direction from bed to bed and joints may not penetrate more than a single bed in some instances. To effectively grout the near vertical joints it will therefore be necessary to drill sub-horizontal holes parallel to the bedding along any beds which may contain suspicious joints.

(4) Consideration might be given to cleaning off the present excavations carefully and sealing all joints off carefully with gunnite or perhaps a bituminous compound before replacing the clay. Such a programme could possibly obviate the necessity for an expensive grouting programme.
