Examination of land at Ambleside, East Devonport

by W. L. Matthews

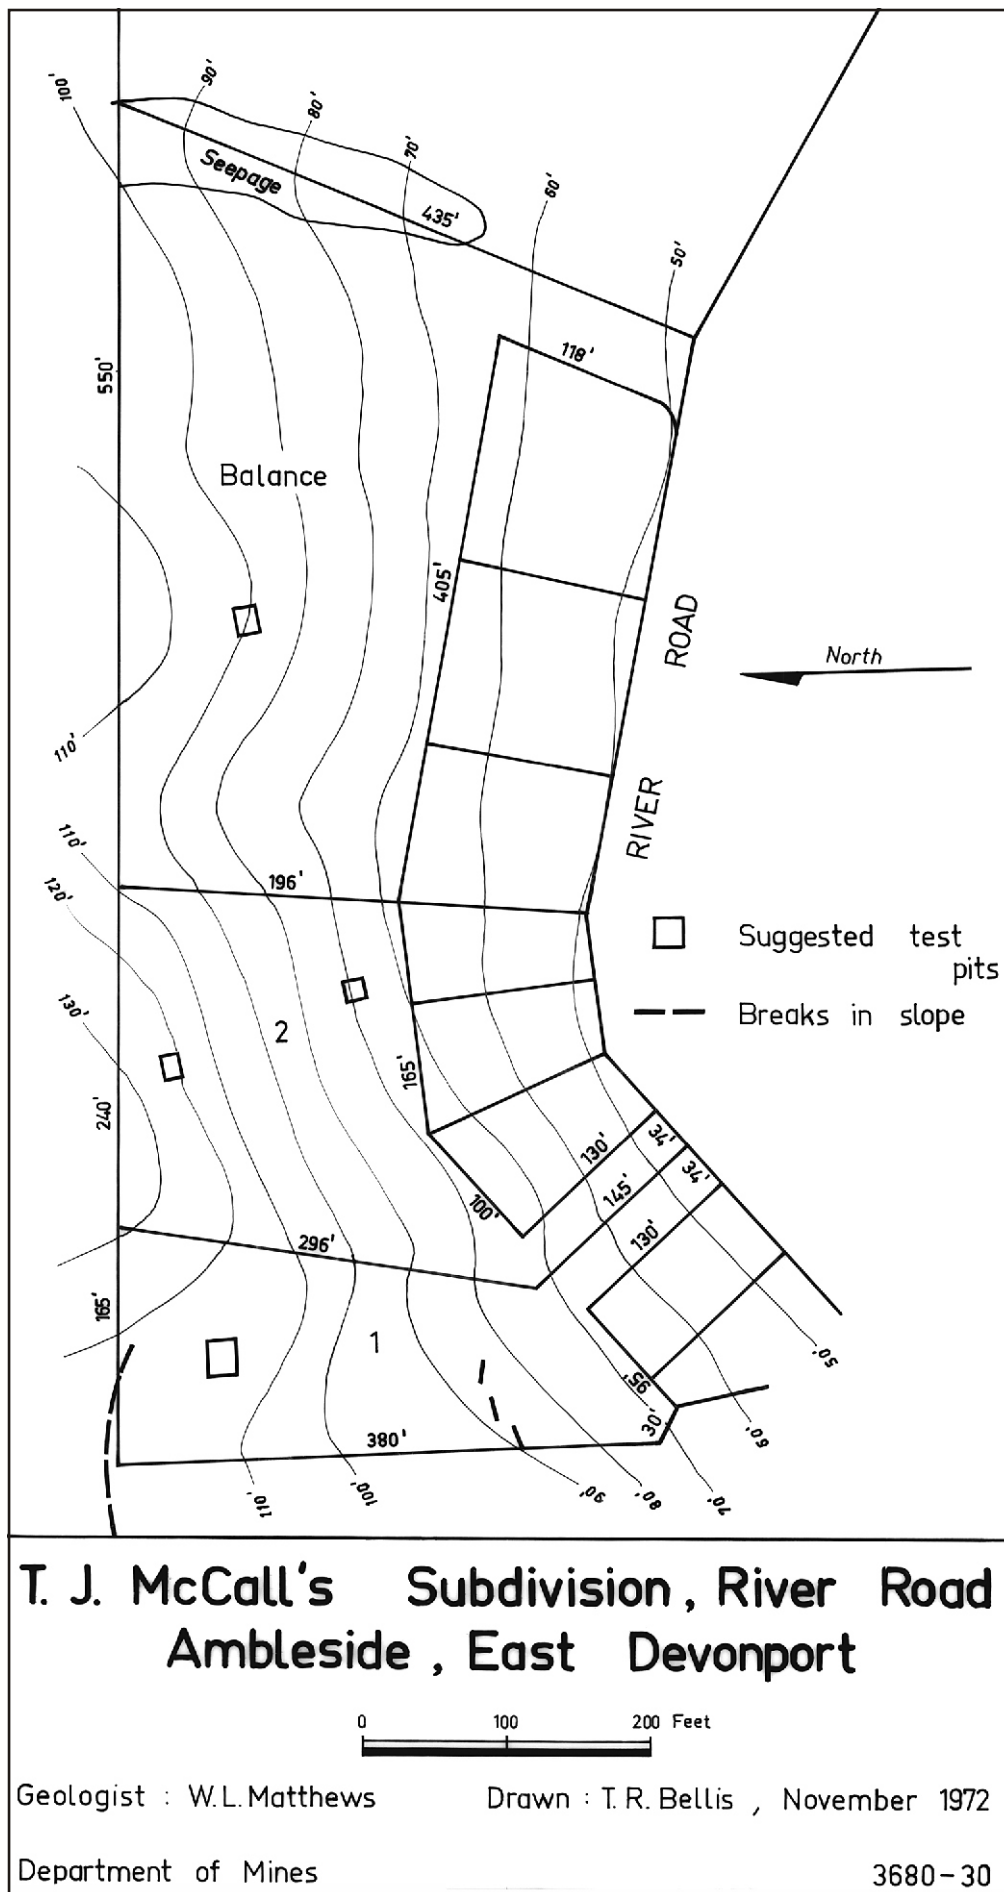
Figure 1

No definite slips, either active or old, occur on the land examined. One or two areas where there are changes in slope on Lot 1 could represent very old slips but they could also be due to differential weathering and erosion of the dolerite. Apart from a large seepage on the southern boundary the area appears to be dry.

The property has particularly steep areas in some locations, with parts of Lot 2 reaching angles of about 25°. In view of the steep nature of the area and the apparent deep weathering of the dolerite, more information on the subsurface material should be obtained before any assessment of the likely stability of the area could be given. It would be useful to obtain information on how deep the weathering of the dolerite has extended, the degree of weathering, and also to determine the presence or absence of subsurface water or moisture in the weathered material. Four test pits dug with a backhoe to about 12-14 feet, in positions marked on Figure 1, would allow this information to be obtained.
