UR1973-88

Further report on land stability at the J.T. Fieldwick Estate, Kayena, West Tamar.

C.J. Knights

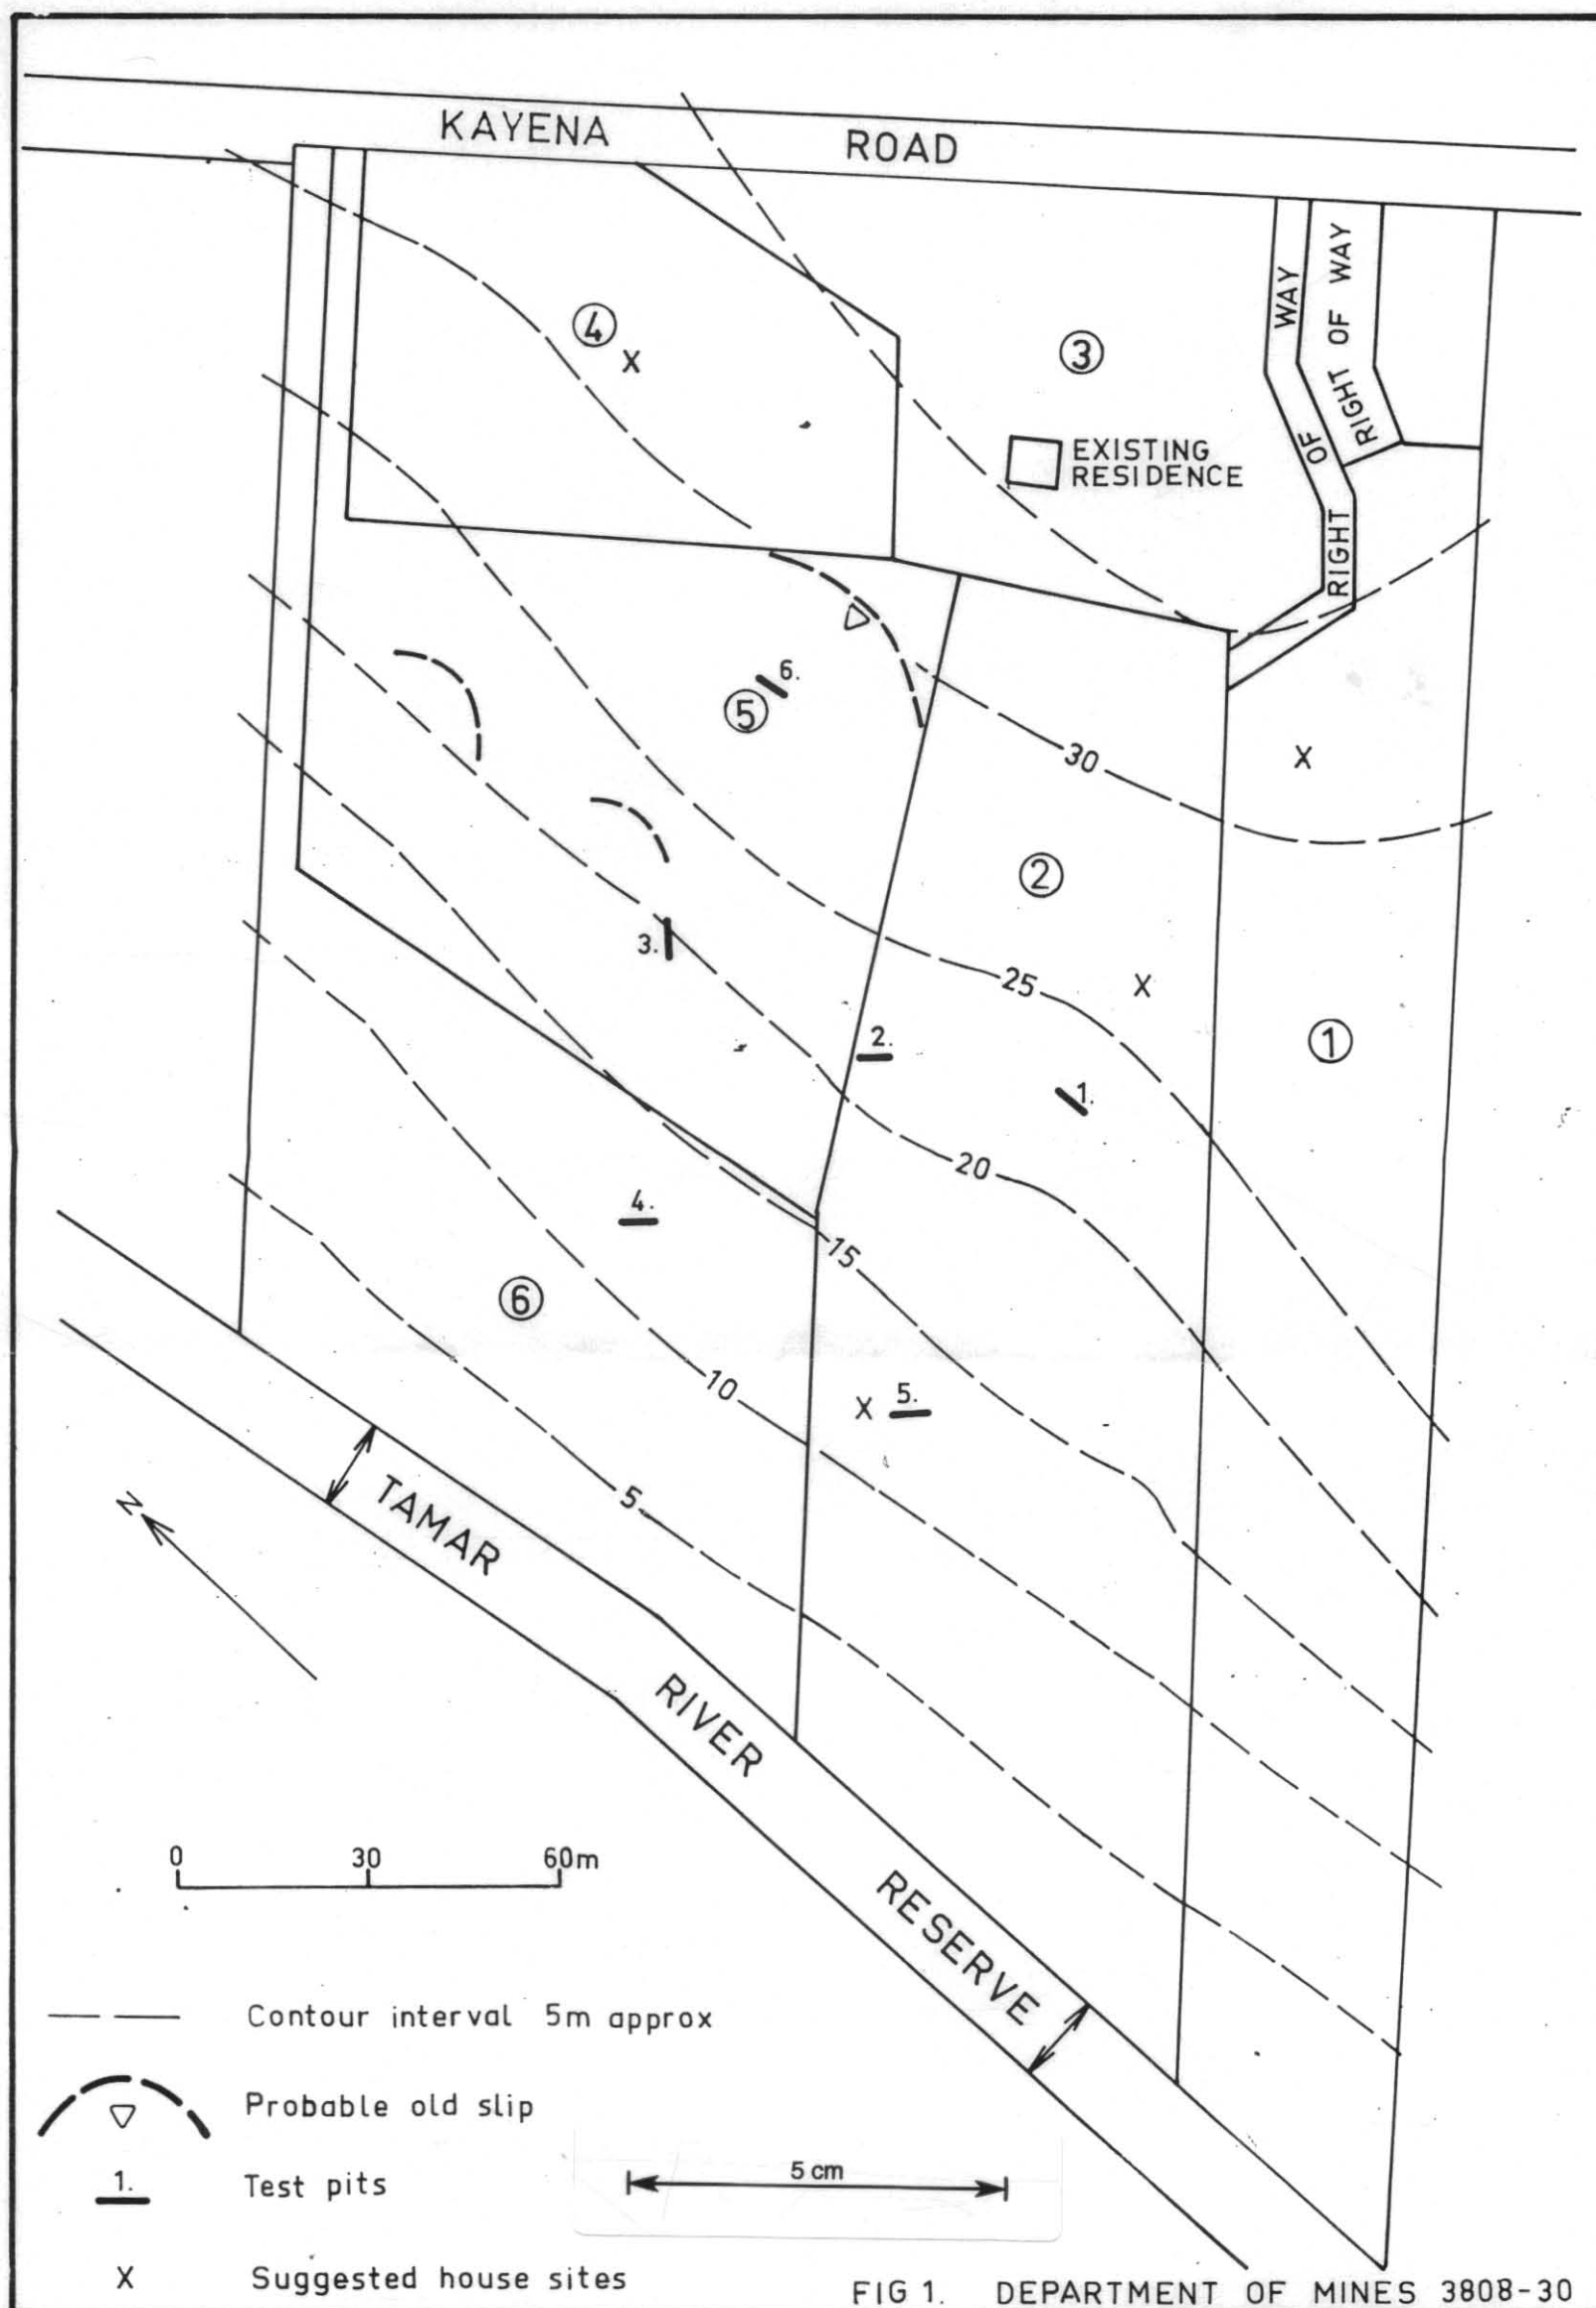
On Lots 5 and 6 the surface relief and test pit information indicate that there is an old landslip, with a deep slip plane. Such a slip could be reactivated by household drainage or by disturbance from construction works. There is also the danger that surface material in this area is weaker, so that even if the main slip remains stable, small parasitic slips are likely to develop on the previously disturbed material.

Lot 2. A house may be situated as planned. It should be safe to allow another house in the lower part of this block as shown in Figure 1.

Lots 5 and 6. These lots are unsuitable for building. A number of deep rooting trees should be left, or should be planted in this area. Deep rooting trees are known to help dry the clay and also to bind loose material.
