UR1973-90

Investigation of a site for Masonic Home flatlets, McKellar Road, Launceston.

C.J. Knights

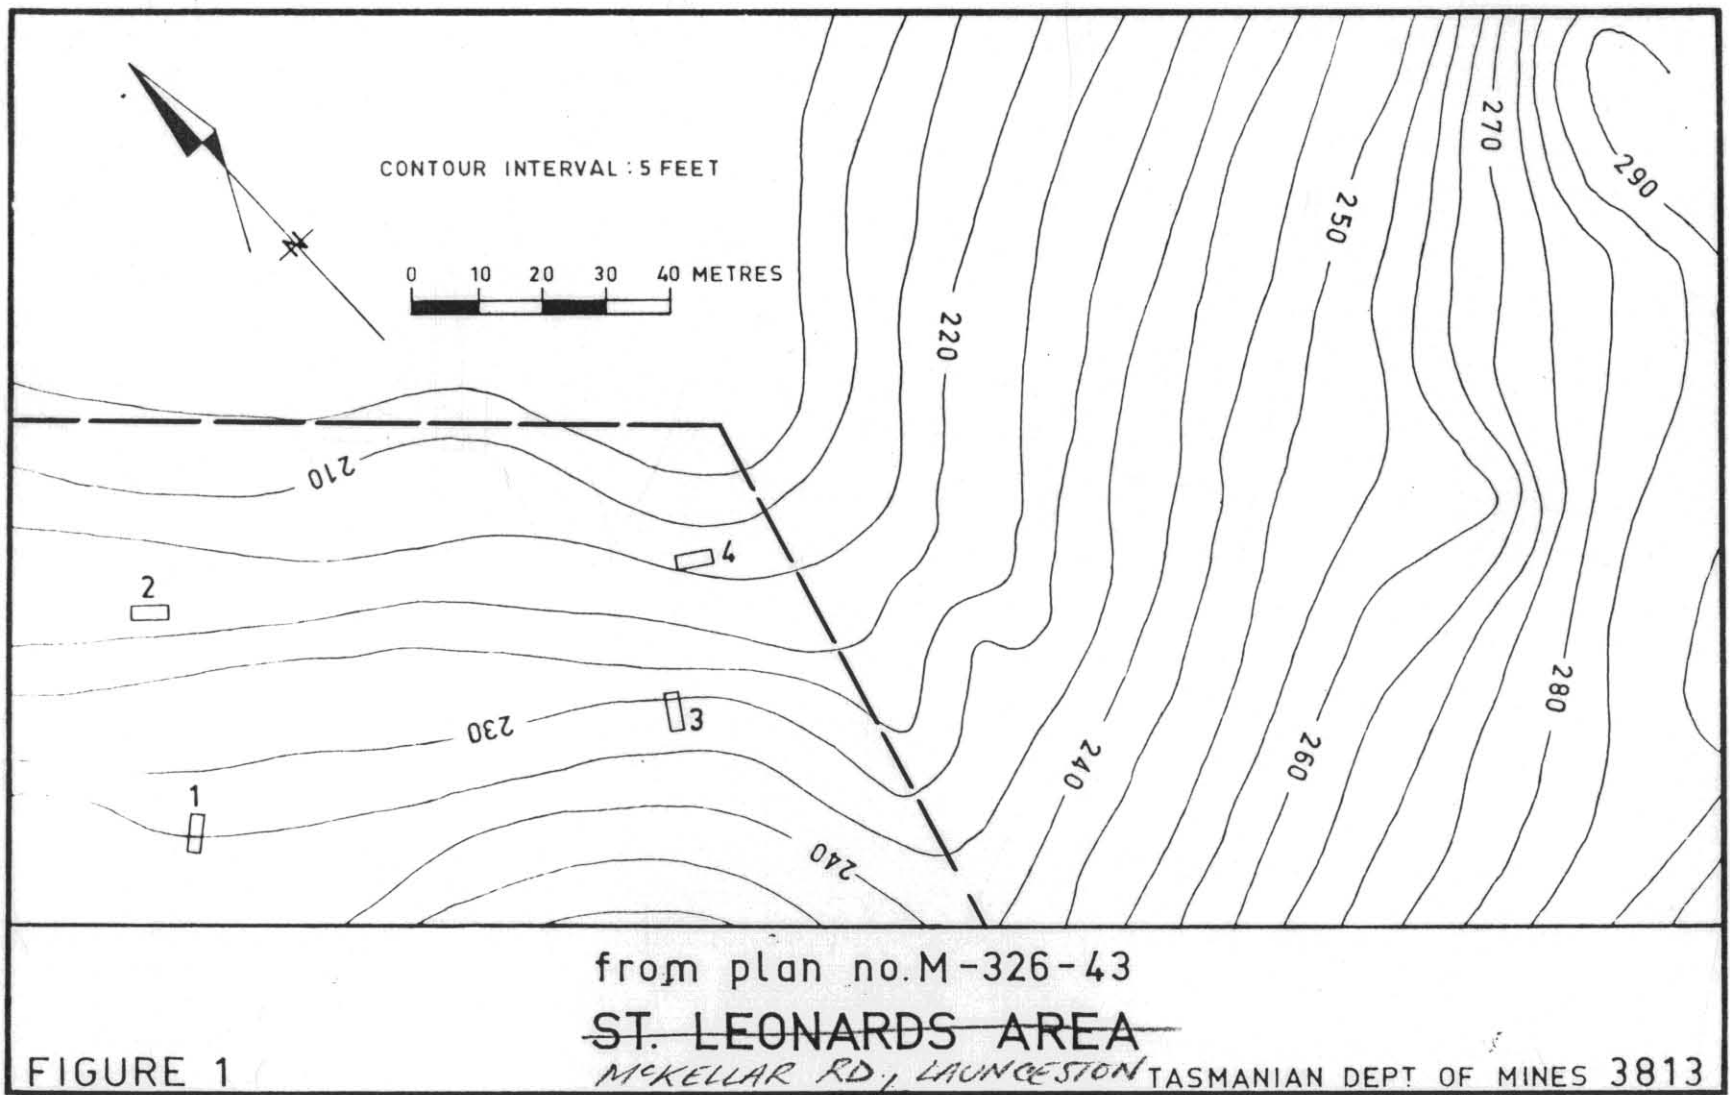
The area proposed for flatlets is outlined in Figure 1. Parts of this land are steep and old slip-like features occur on neighbouring blocks.
