UR1973_42

Stability of land at Dilston, East Tamar.

C.J. Knights

An investigation was made of the stability of a block of land at Dilston owned by C. Salmon.

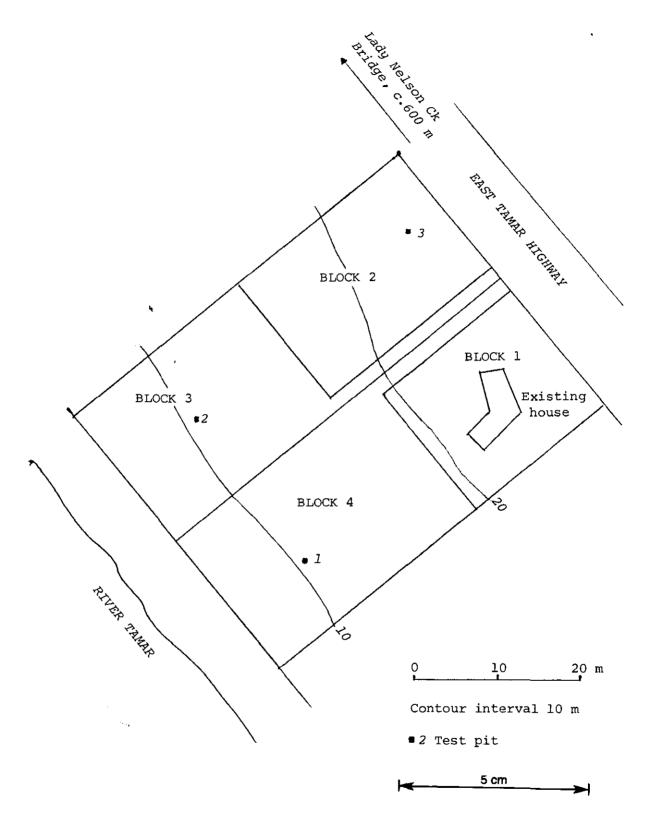
Figure 1. Position of test pits, Dilston.

Test pits (fig. 1) were dug to enable the investigation of subsurface conditions.

HOLE 1. (Block 4) Depth 3 m; elevation c.10.5 m. Dry hole.

- 0-0.6 Topsoil and ironstone boulders.
- O.6-1.4 Crumbly clay, yellow-brown in colour with blue and grey patches.

Grades into paler grey clay. Digging stopped by ironstone boulder.
- HOLE 2. (Block 3) Depth 3 m; elevation c.10.5 m. Dry hole.

- 0-0.9 Dry brown topsoil.
- 0.9-1.5 Crumbly clay. Mostly red to brown in colour.
- 1.5-2.0 Gradation into yellow clay.
- 2.0-3.0 Damp, grey-yellow clay.
- HOLE 3. (Block 2) Depth 2-8 m; elevation c.21 m. Dry hole.

- 0-0.5 Topsoil and ironstone pebbles.
- 0.5-2.0 Orange, brown damp clay, ironstone boulders.
- 2.0-2.8 White-grey clay.
