## Stability of land at Windermere, East Tamar.

P.C. Stevenson

[1 April 1974]

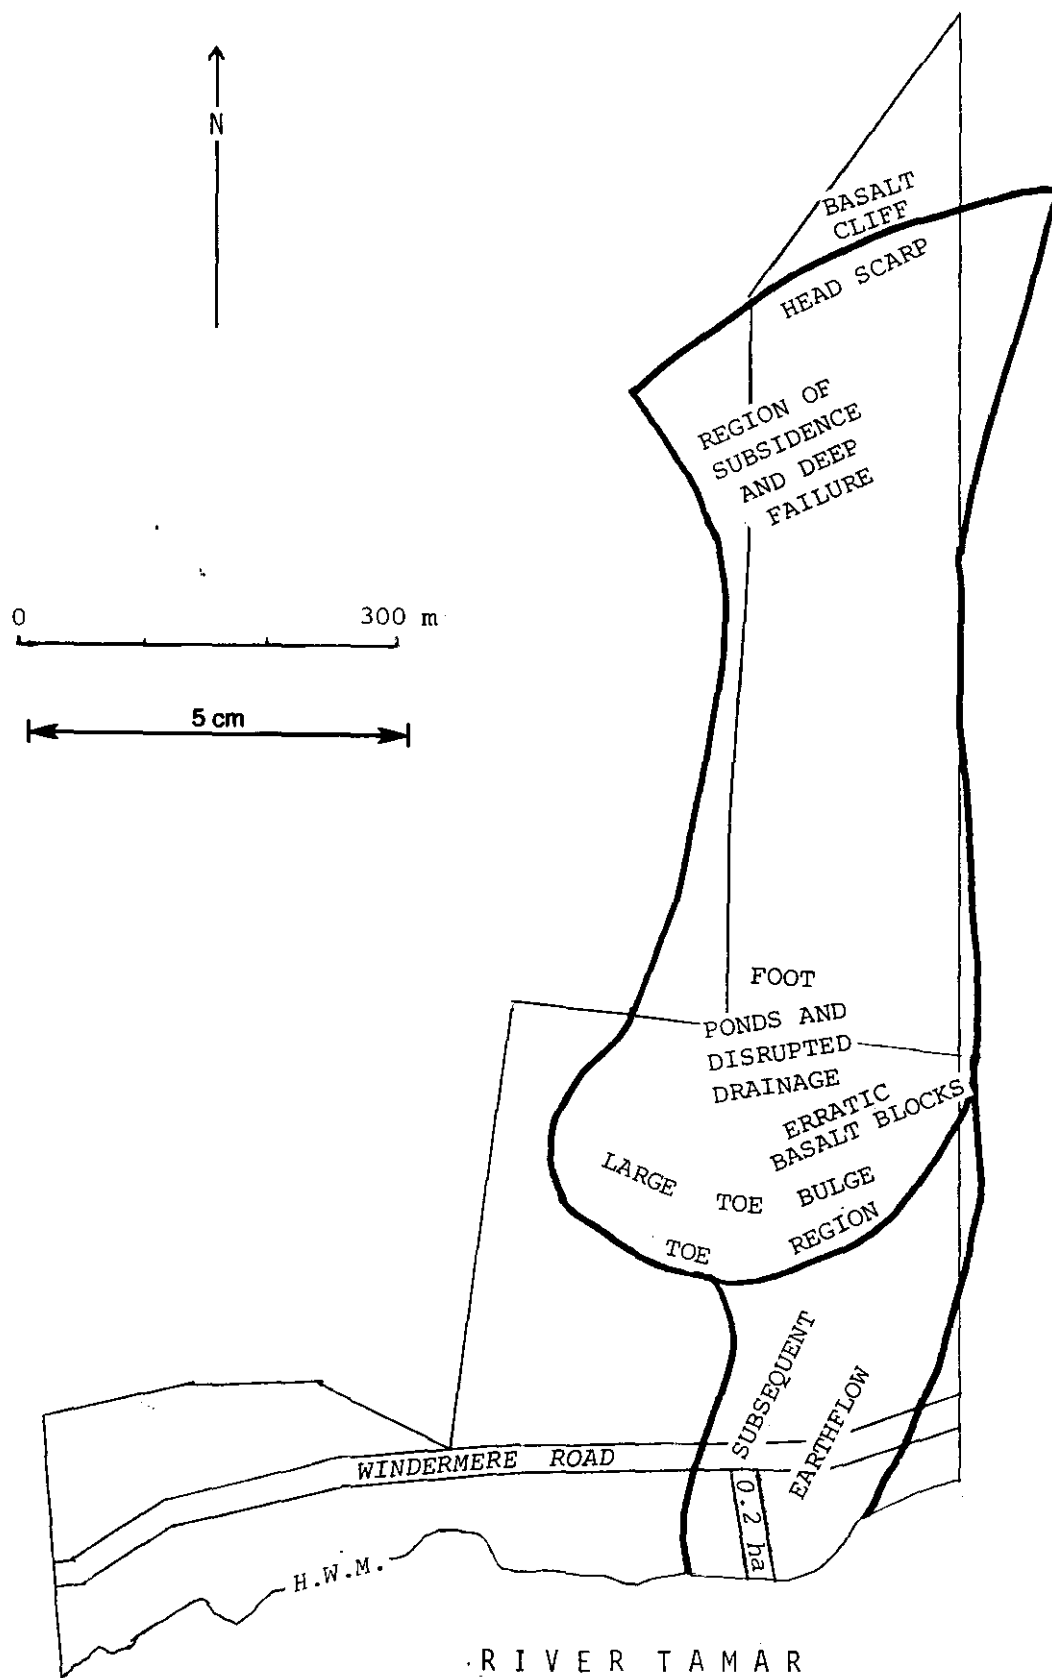
The irregular contours, hummocky ground, the ponds and generally disturbed nature of the watercourses, the large transported basalt blocks and the high basalt scarp above all point to a major disturbance in the recent geological past. This may readily be sketched from aerial photographs as has been done in Figure 1.

Large landslips of this kind are active for periods of many decades and often develop earthflows from the toe region as has been suggested in the sketch. The activity of this earthflow may continue long after the main slip has been stabilised and this very late minor activity may account for some of the features seen in the house block.

Figure 1. Land at Windermere, showing evidence of landslip.
