1976/62. Investigation of a proposed subdivision at Upper Scamander.

D.J. Sloane

# PROPOSED SUBDIVISION - J. WIGRAM - UPPER SCAMANDER

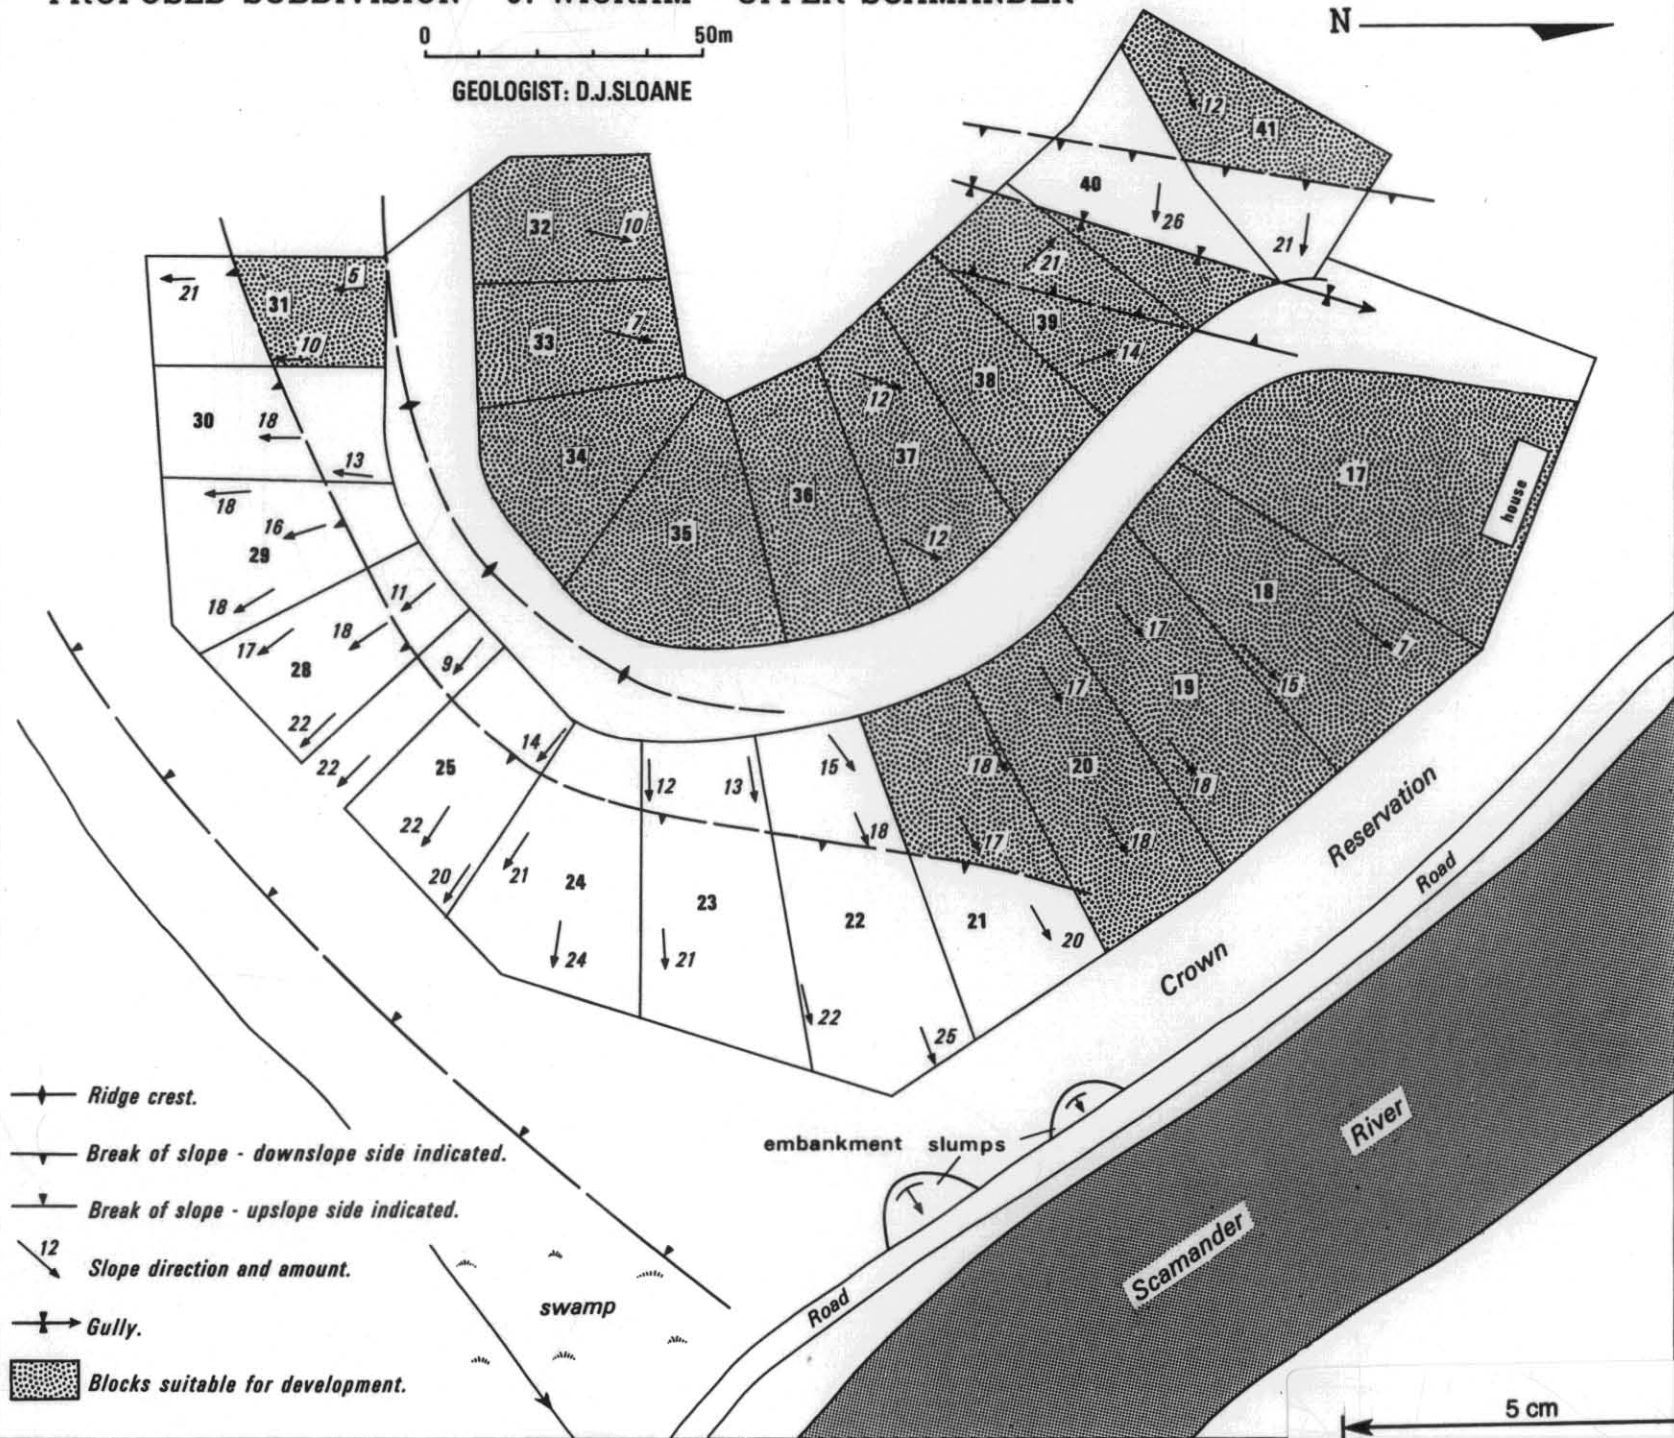
Figure 1.

The accompanying map (fig. 1) shows the general topography of the subdivision site. To the south and east slopes are moderate to steep (18-24°) from a ridge crest along the proposed subdivision road towards the Upper Scamander road to the east and a low-lying swampy area to the south. Slopes in the northern and western section of the subdivision are moderate to gentle (7-17°). A large gully crosses blocks 39, 40 and 41; slopes here are about 20-25°.

Two embankment failures have occurred adjacent to the Upper Scamander road. These are a direct result of artificial oversteepening of the regolith material. Although no failures have been observed on natural slopes in the area, some caution must be exercised where subdivision development is associated with steeply sloping areas to ensure that stability is not impaired by building development. Undue disturbance through cut and fill techniques, the infiltration of water from sewerage systems and storm water runoff, and the removal of vegetation all contribute to potential instability of land formerly stable under natural conditions. Owing to the increased thickness of the regolith along the south-eastern boundary of the subdivision and the steep slopes, this area is potentially unstable as are the steep slopes adjacent to the gully on block 40.

The factors described above indicate potential instability of the south-eastern area of the subdivision and the sides of a gully to the north-west. The threshold of stability for development is considered to be a slope of 18°. Therefore blocks 22, 23, 24, 25, 28, 29, 30 and 40 are considered unsuitable for development. Blocks 21, 31, 39 and 41 are considered

suitable *only* if building is conducted in the shaded portion of the blocks on the accompanying map; except for block 41, buildings should be sited as close as possible to the subdivision road.

If the subdivision road were to be re-located 15 m further west blocks 22-30 could be considered suitable for development. Although this would probably necessitate fewer building blocks on the western side of the road, all seven blocks on the eastern side could then be developed. If the layout of the subdivision is altered, a re-inspection by a geologist from this department would be necessary.
