1976/65. Investigations of a landslip at Alexander Terrace, Stanley.

W.L. Matthews

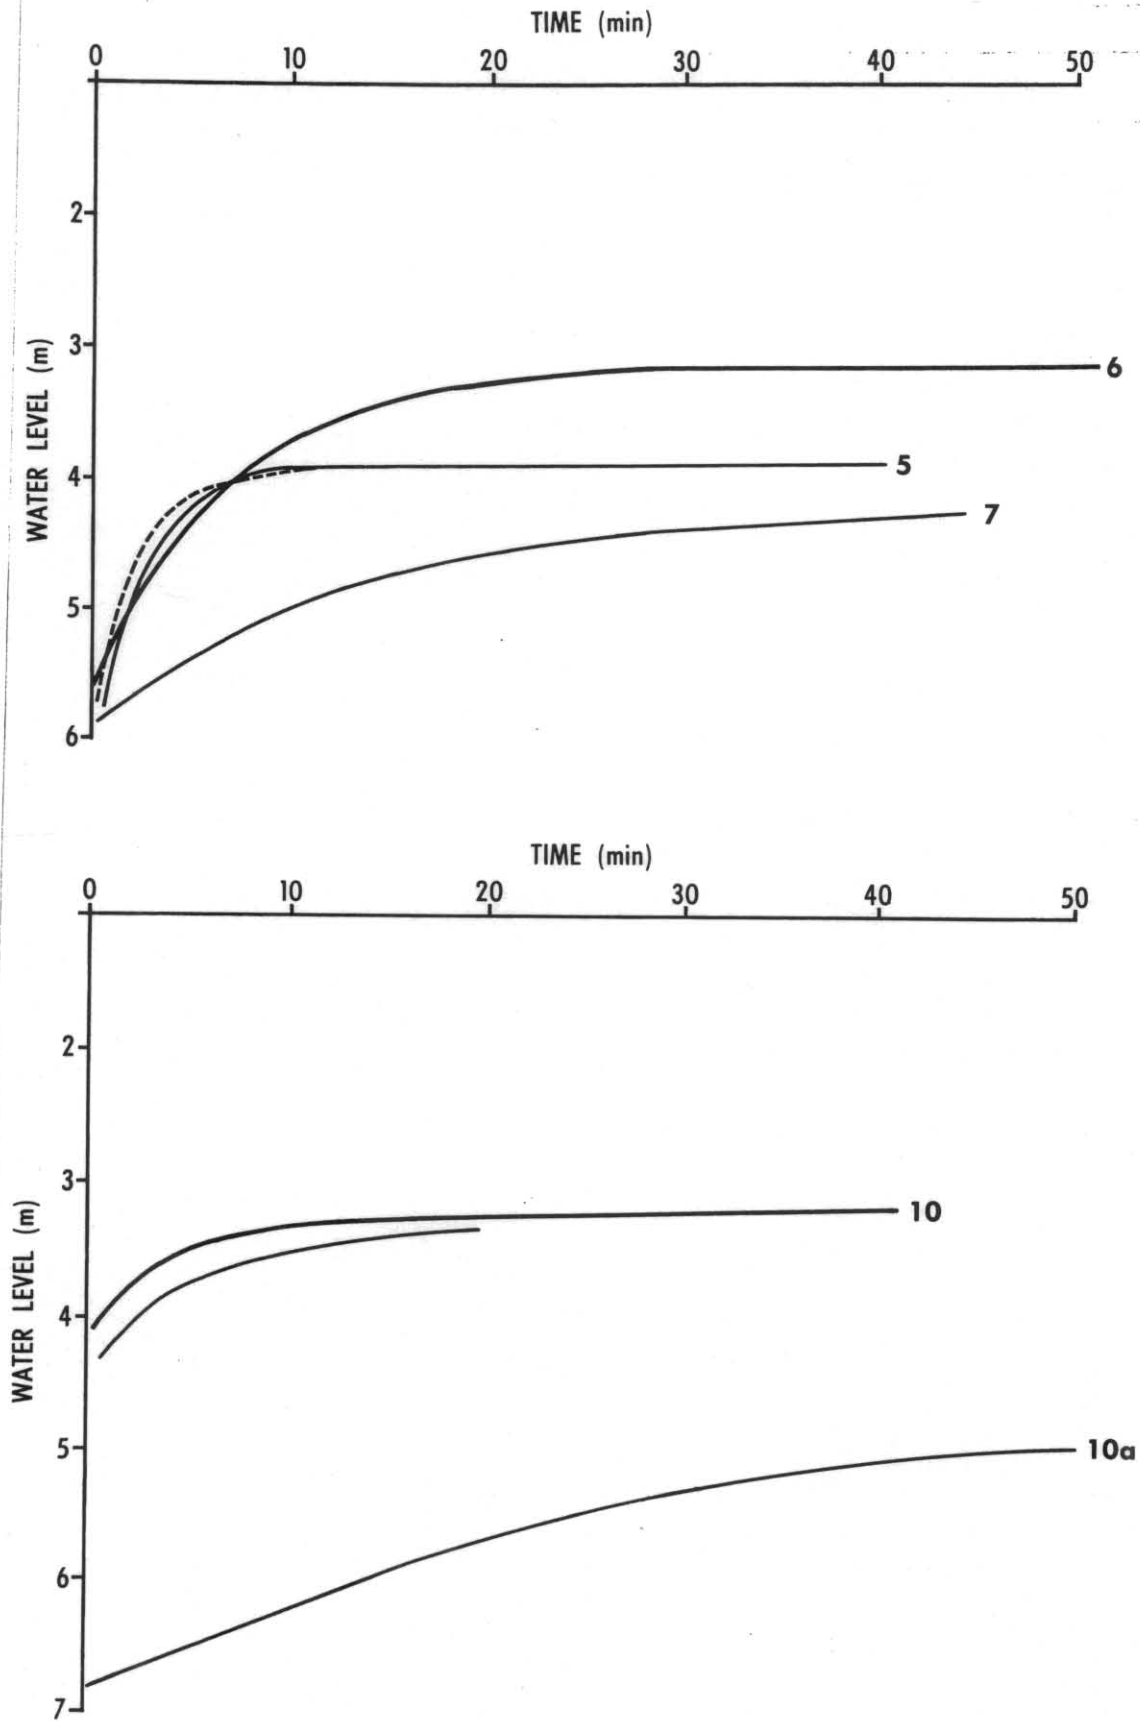
Figure 1.

A test pit was dug to 3.7 m (fig. 1) and a hole was augered in the base of this to 6.7 m. Basalt talus was penetrated to 3 m with the remainder

The standing water levels in the bores have been measured at various times but not at regular intervals (Appendix 2). Measurements prior to 28 September 1976 were taken by the consulting groups and later ones were measured during the present survey. The range of fluctuations is shown on Figure 1; the lowest level in each hole except for Hole 4 was recorded on 20 October 1976. The amount of fluctuation after the first measurement is not very great. The winter of 1975 was very wet and water levels were probably still high at the time of drilling in December. Rainfall has been below average since then. The depressed zone in the water table indicated by Holes 2 and 9 is probably due to the presence of a permeable zone in the tuff and this has resulted in the formation of a strong seepage in the embankment below these holes.
