1976/71. Engineering geology investigation of a proposed cutting on the Murchison Highway at Somerset.

W.R. Moore

The Public Works Department (P.W.D.) requested the Department of Mines to undertake a rock stability analysis of a 200 m cliff section of the Murchison Highway at Cam River, Somerset [DQ019553] (fig. 1; plate 1).

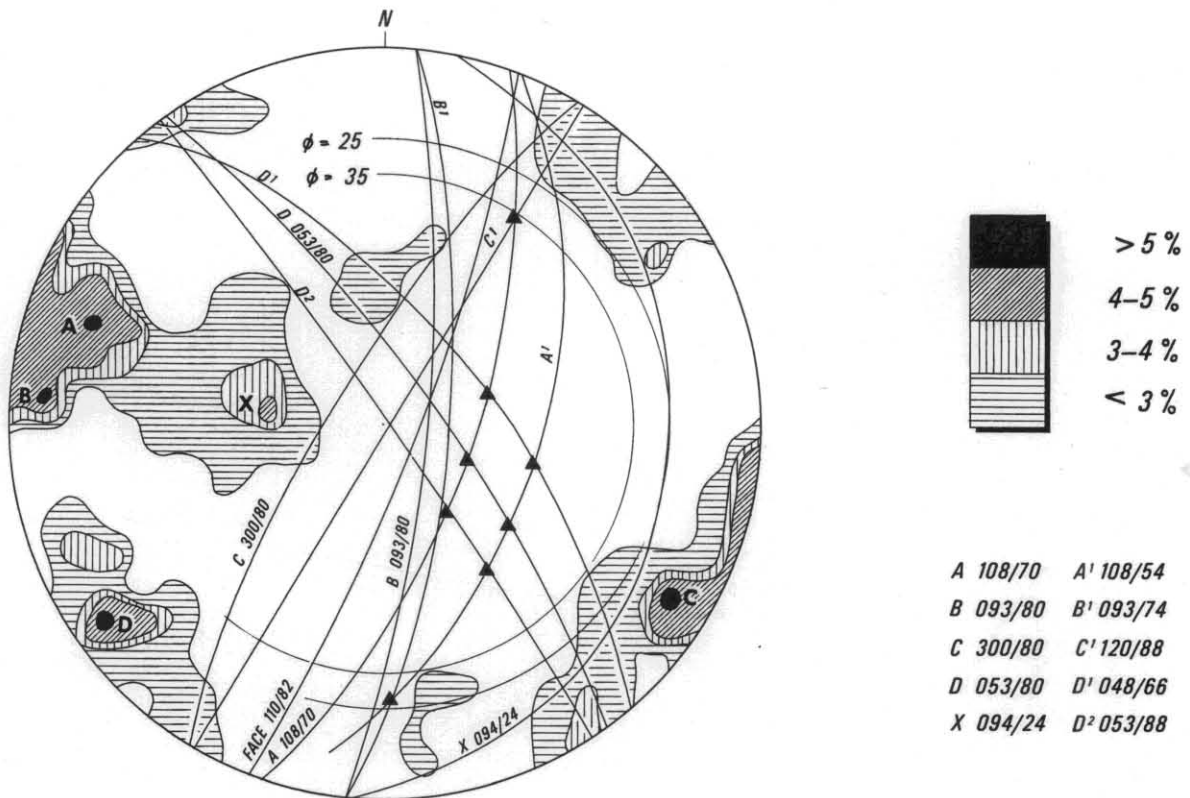
Figure 3. Stability analysis, Section 1

This section was measured on the southern end of the cliff line where the sediments are softer and very thinly bedded. These rocks are more weathered and are better described as a cleaved mudstone rather than an argillite. There are four sets of joints (A, B, C, D) all very closely spaced. The poles of the bedding (X) are not well marked. Wedge failures are made possible by the intersection of two sets of joints (A and D) and toppling failure on set C which has a plot scatter range from  $80^\circ$  through to the vertical.

With jointing so closely spaced and the joint scatter so wide the only failure likely to occur on this section of the cliff line is fretting. This type of failure is present on the cliff face in this area and has already occurred on the new face south of this section (plate 1). No back analysis plot is given as no other types of failure were seen in section 1.

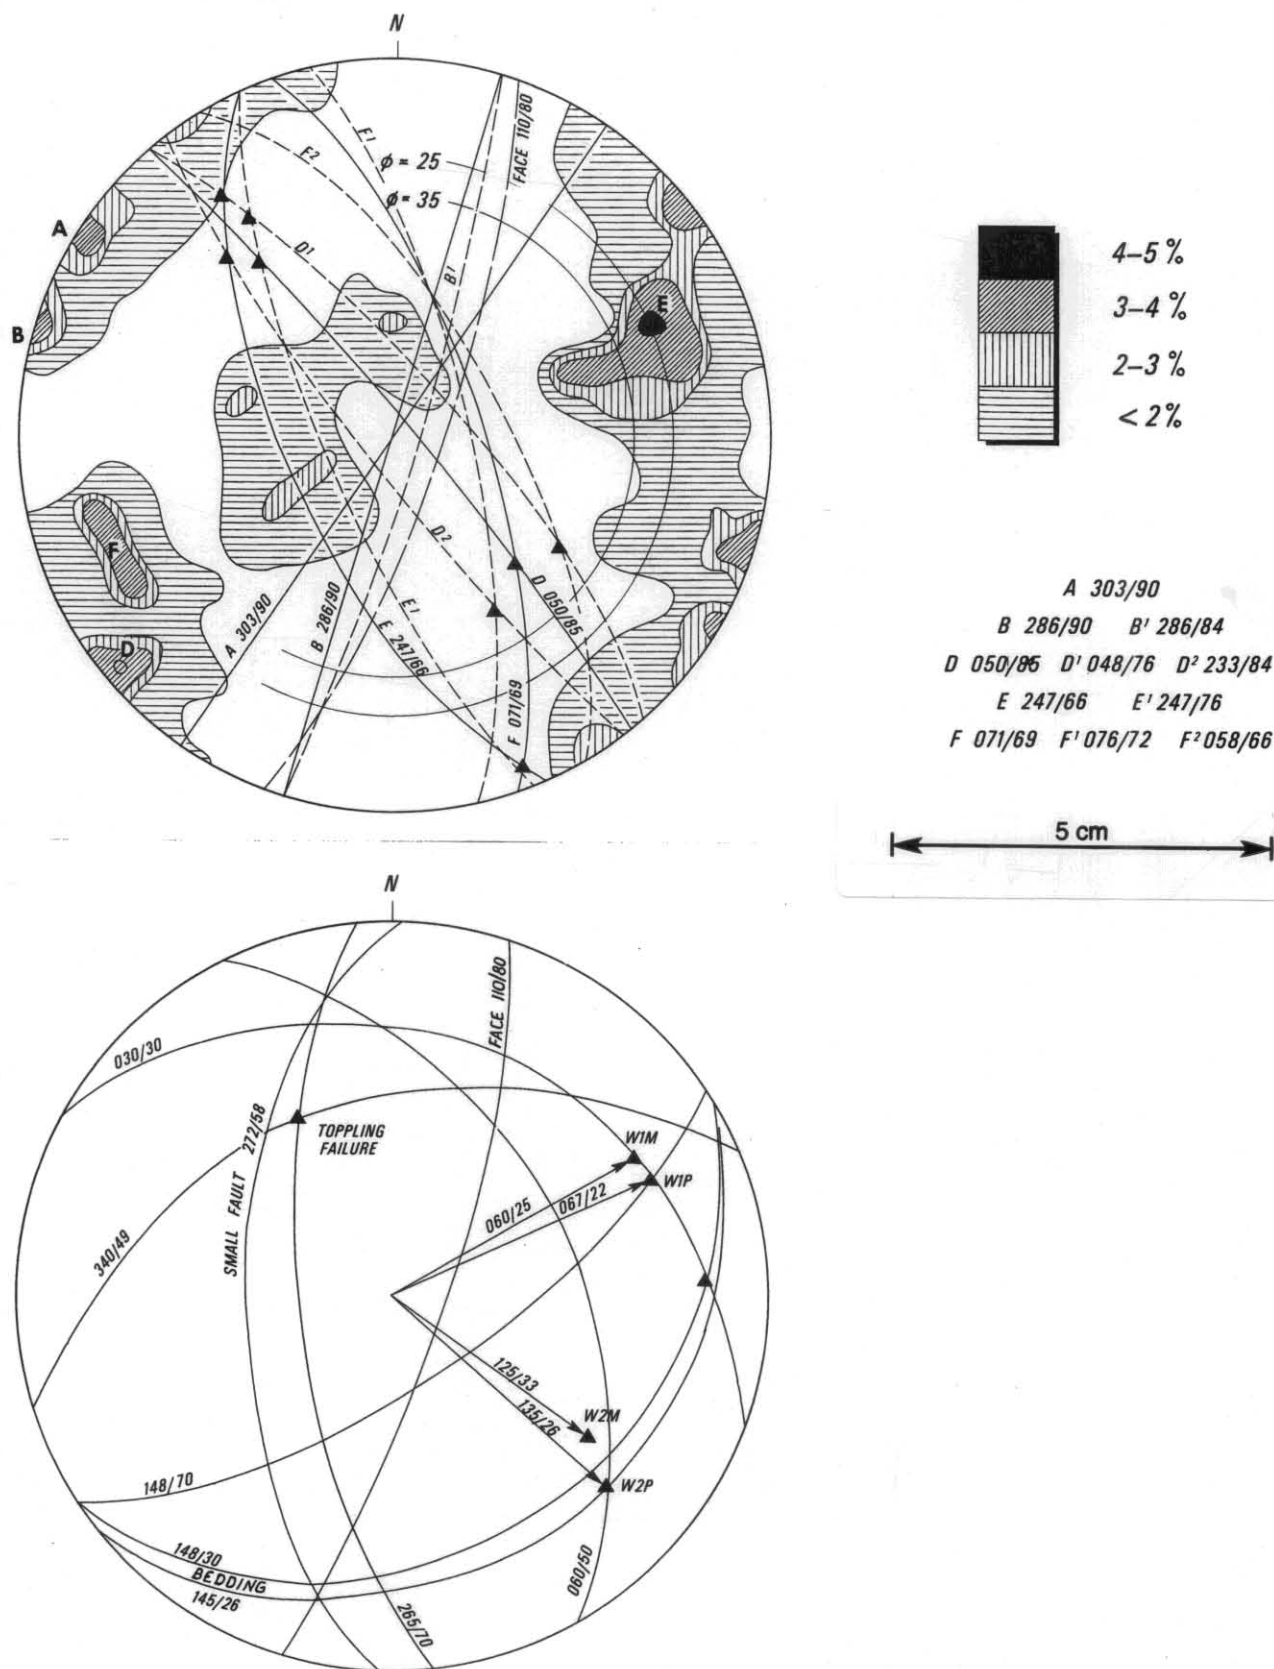
Figure 4. Stability analysis, Section 2 (226 plots)

From the measured section plots potential wedge failures are likely to occur at the intersection of the two sets of joints D and F. These wedges are narrow and small, sliding in a south-easterly direction ( $150^\circ$ ) with a dip on the line of intersection of  $50^\circ$ .

The poles of the bedding are scattered along a belt in the low dip area in the south-west and north-west quadrants of the plot. Any planar failure will occur on the bedding and not on the concentrations of the joint sets A, B and D because the majority of dips on these joints are too steep for these joints to daylight, even on a steep face with an  $80^\circ$  dip. Toppling is likely to occur on set E joints, but only because the existing face is so steep.

In the measured back analyses failures above section 2 there is a close approximation in the direction of sliding of wedge W2 to the direction of sliding of the potential wedge, although the measured dip on the line of intersection (which is the angle of sliding of the actual wedge) is much lower,  $26-30^\circ$  compared with the  $40-45^\circ$  dip of the potential wedge.

The geometry of the two measured wedges, W1 and W2 is different to the potential wedge of section 2. These measured wedges both include the bedding as a plane of discontinuity, with joint set F forming the other limb of wedge W2, and joint set D in W1. These wedges are wide and open, with low dips on the lines of intersection of their two planes ( $W1 = 26-33^\circ$ ;  $W2 = 22-25^\circ$ ) indicating that the angle of friction for this argillite is low. Because of these three properties, such wedges are potentially more dangerous than the narrow and deep type of wedge with a steeply dipping line of intersection (see measured plot, fig. 4). To prevent this large type of wedge failure the slope angle needs to be less than  $30^\circ$ .

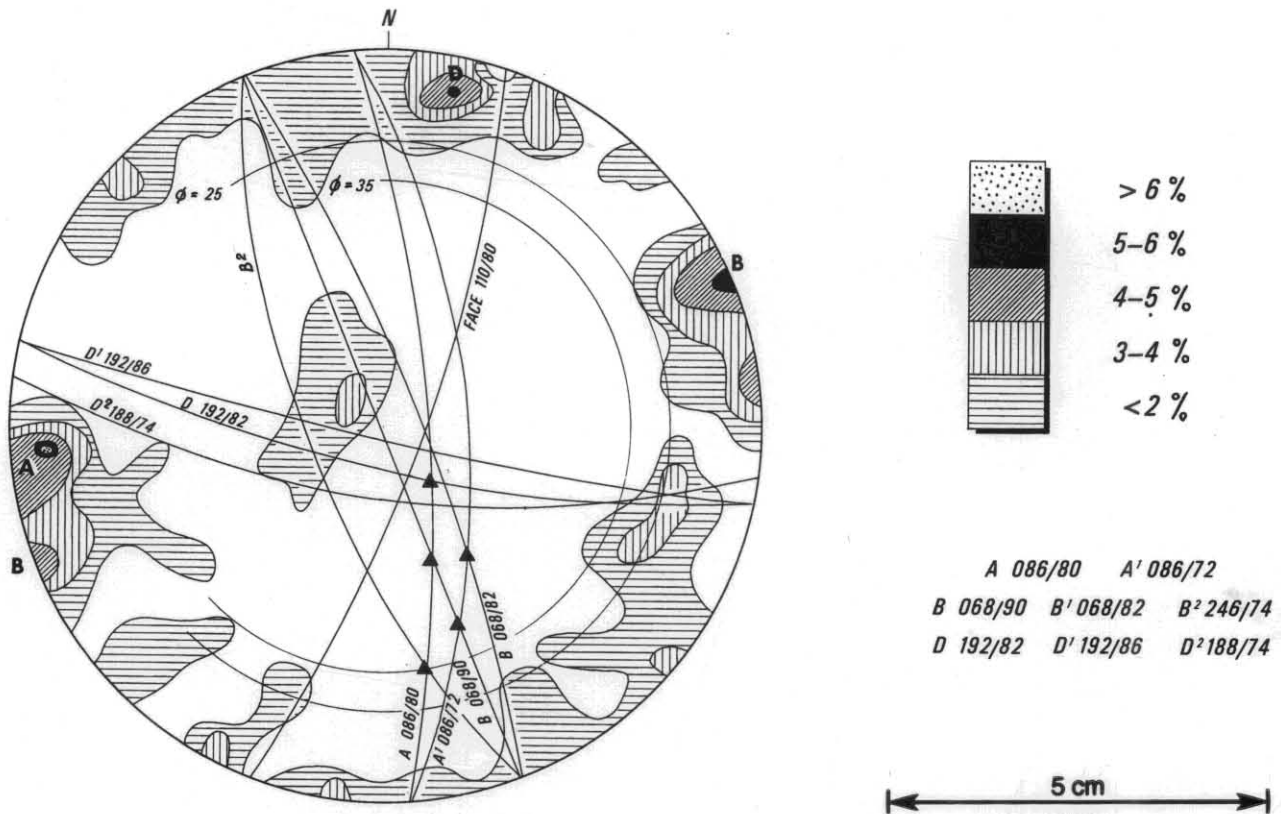
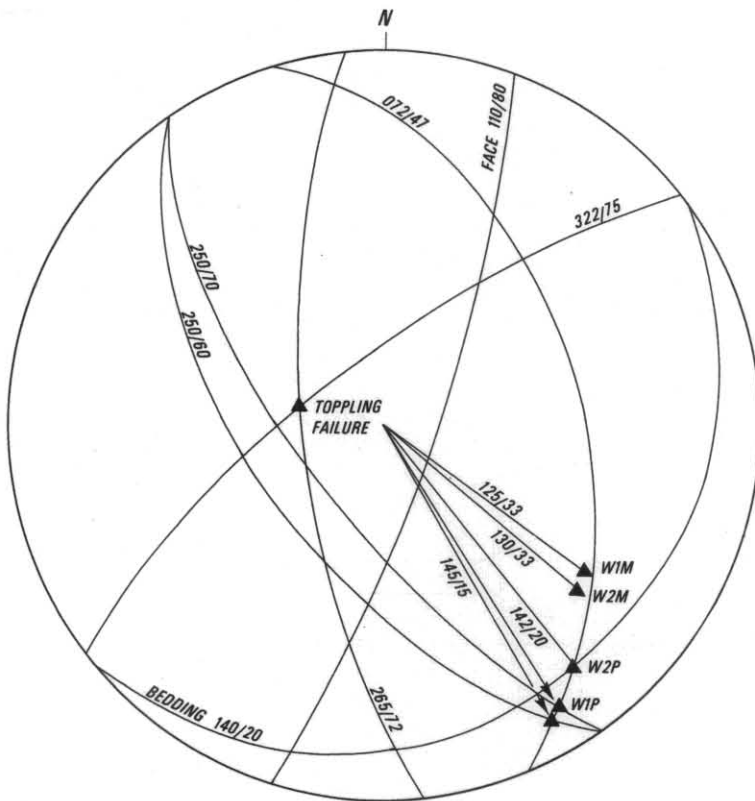
Figure 5. Stability analysis, Section 3 (183 plots)

From the statistical contouring of the discontinuities on measured section 3 there are three sets of joints A, B and D. Potential wedge failures are possible from the intersection of sets A and B with the line of intersection dipping SSE ( $158^{\circ}/40^{\circ}$ ). These wedges are narrow and small, and even if the scatter of the joints to next lowest percentage subdivision on the plot is included, the bearing of the direction of sliding only ranges from  $140-170^{\circ}$  and the angle of dip of the potential movement ranges from  $35-62^{\circ}$ .

Two wedges W1 and W2 were measured above this section on the cliff face. The direction of sliding and the dip of the line of intersection was measured at  $125-130^{\circ}/33^{\circ}$ . The two sets of joints in these wedges coincide with joint sets A and B of the measured section, although in the actual wedge failures these joints do not intercept each other to form the wedges but intersect with the bedding. The poles of the bedding in the measured section plots form a scatter belt in the low angle area of the north-west quadrant.

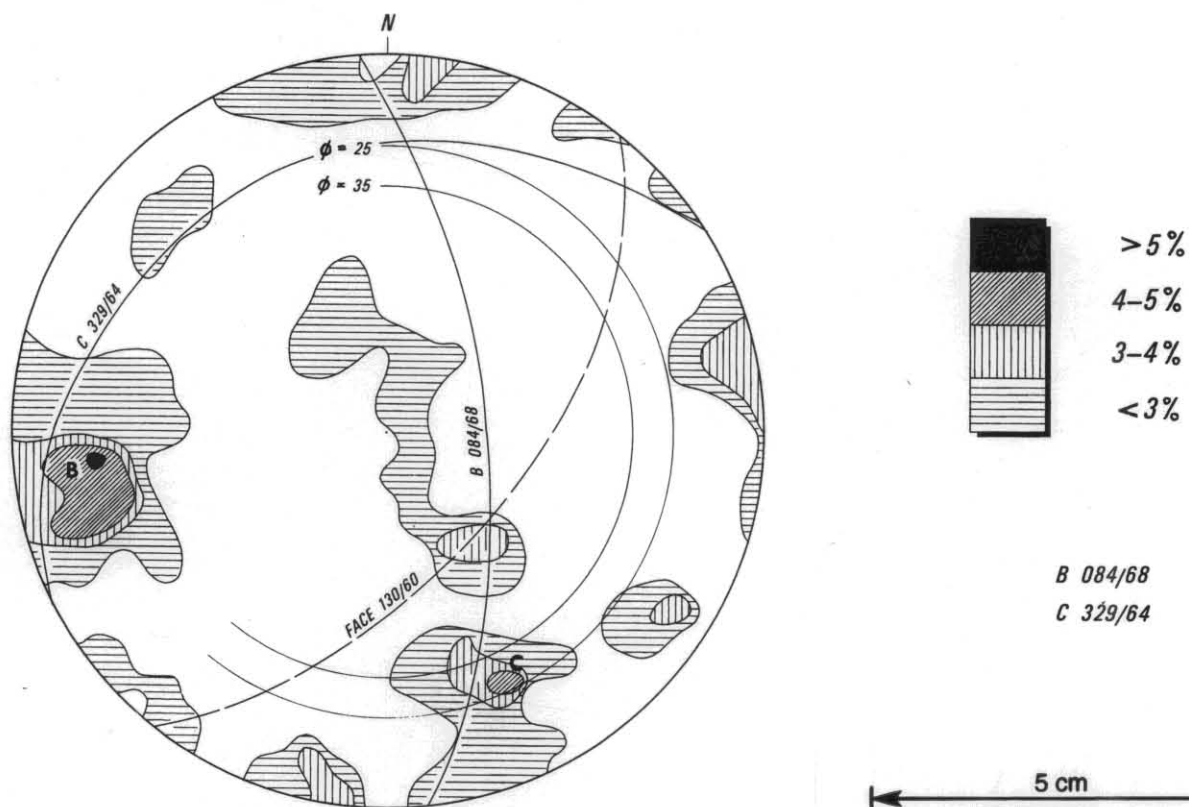
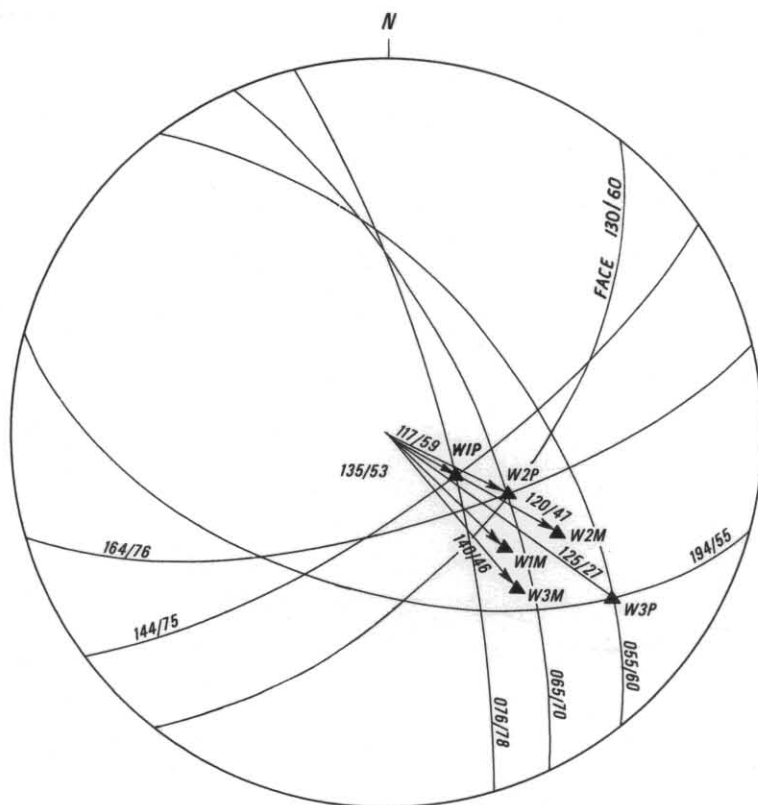
Figure 6. Stability analysis, Section 4 (168 plots)

This section is most interesting because of the potential stability as shown from the plot of the measured section at road level, whereas on the cliff above the section several wedge failures are present (plate 7 and 8) as well as the beginning of a large planar failure (plate 5).

In the stability analysis plots no obvious potential wedge failures can be seen and the dips on joint set B, even allowing for their wide scatter, are too steep to daylight even on such a steep face, for planar failure to be likely. The concentration and position of joint set C makes toppling failure a possibility. Many of these joints are discontinuous and the toppling would be on a small scale and probably of the complex inverted wedge type.

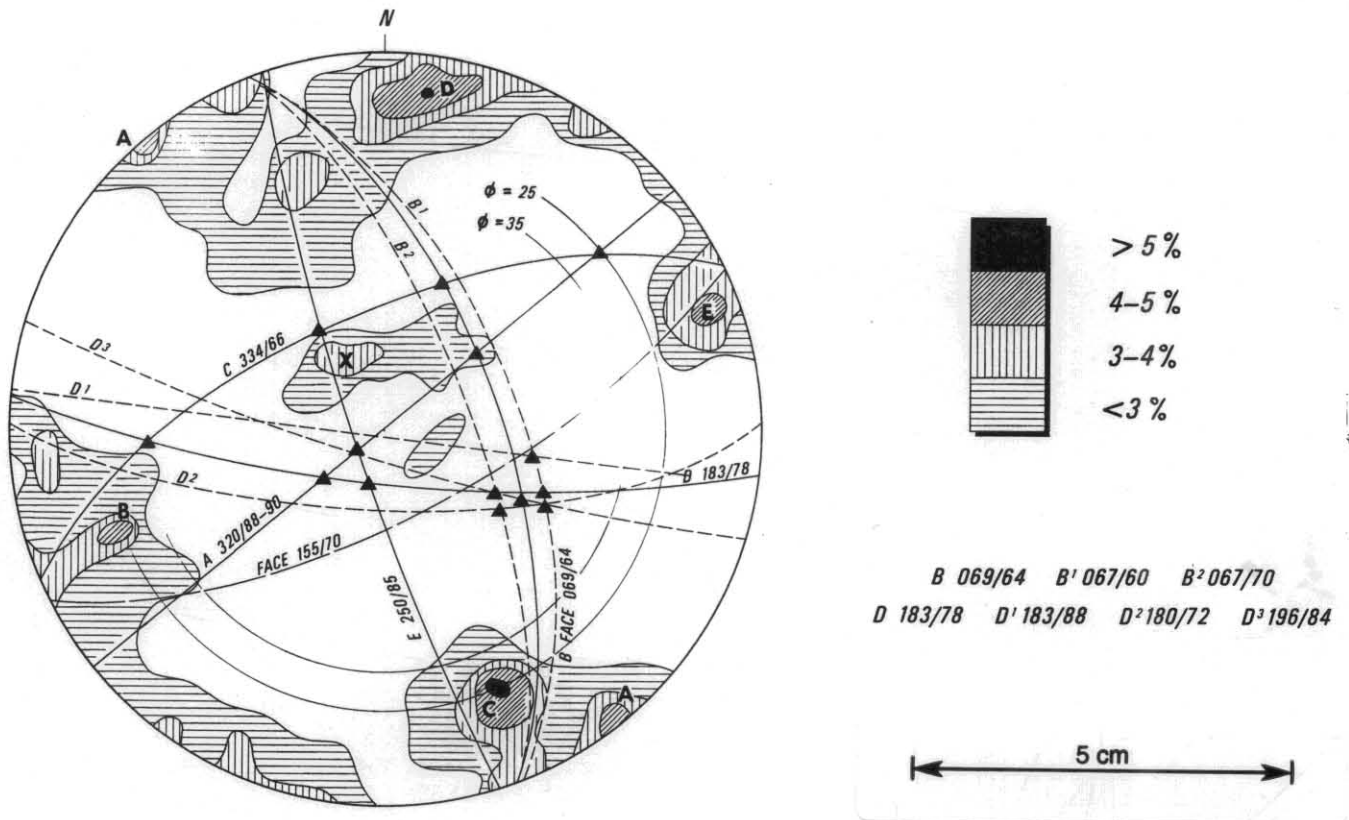
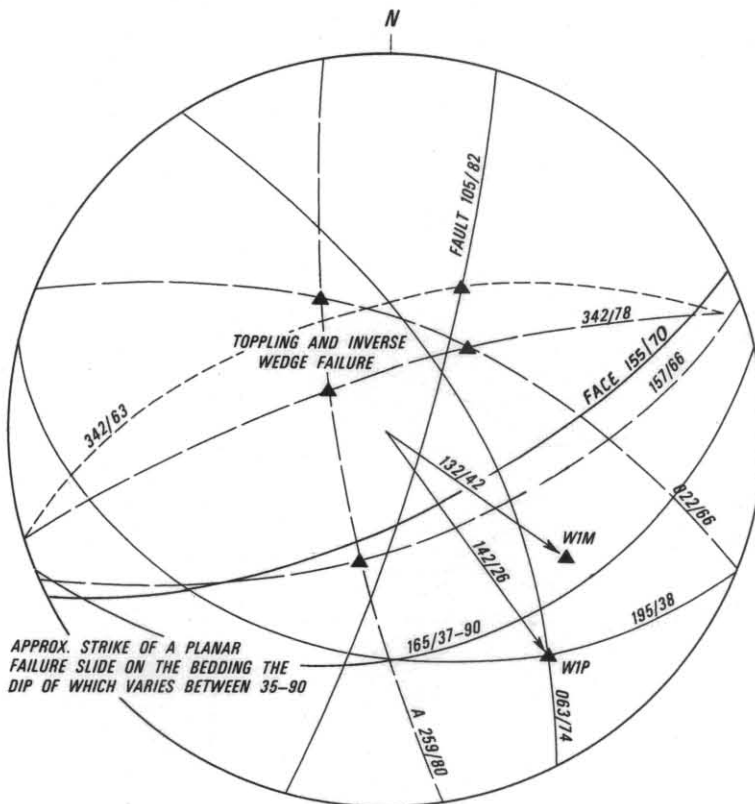
Figure 7. Stability analysis, Section 5 (162 plots)

In the measured section, wedge failures can be predicted as occurring on the intersection of joint sets B and D with the direction of movement to the south-east ( $122^{\circ}$ ) with a dip of  $55^{\circ}$ . Scatter to a 4% concentration can lower the dip of this movement to  $50^{\circ}$ . Therefore on the proposed cutting with a better angle of  $55^{\circ}$  many of these wedges will daylight on the face.

Toppling failures are likely on joint set C particularly when the scatter is considered as the range of dip extends beyond the vertical. Planar failure is not obvious from the statistical contouring until it is realised that the low dipping concentration of 3-4% is the bedding. In the type of folding present at the Cam River the dips of this bedding range from 35-90° in directions into the face as well as away from the face.

In the back analysis of rock falls seen above section 5 a wedge failure with a measured line of movement of 132°/42° coincides approximately with the above potential wedge position on joint sets B and D. In reality the wedge failure occurred on the intersection of joint set B (063°/74°) and bedding (195°/38°).

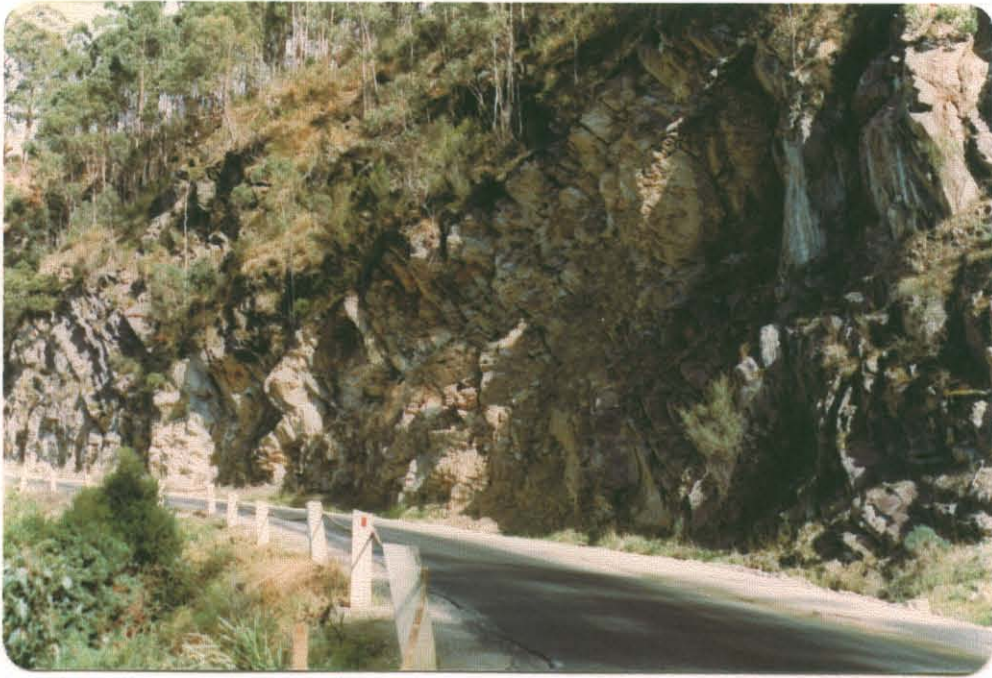
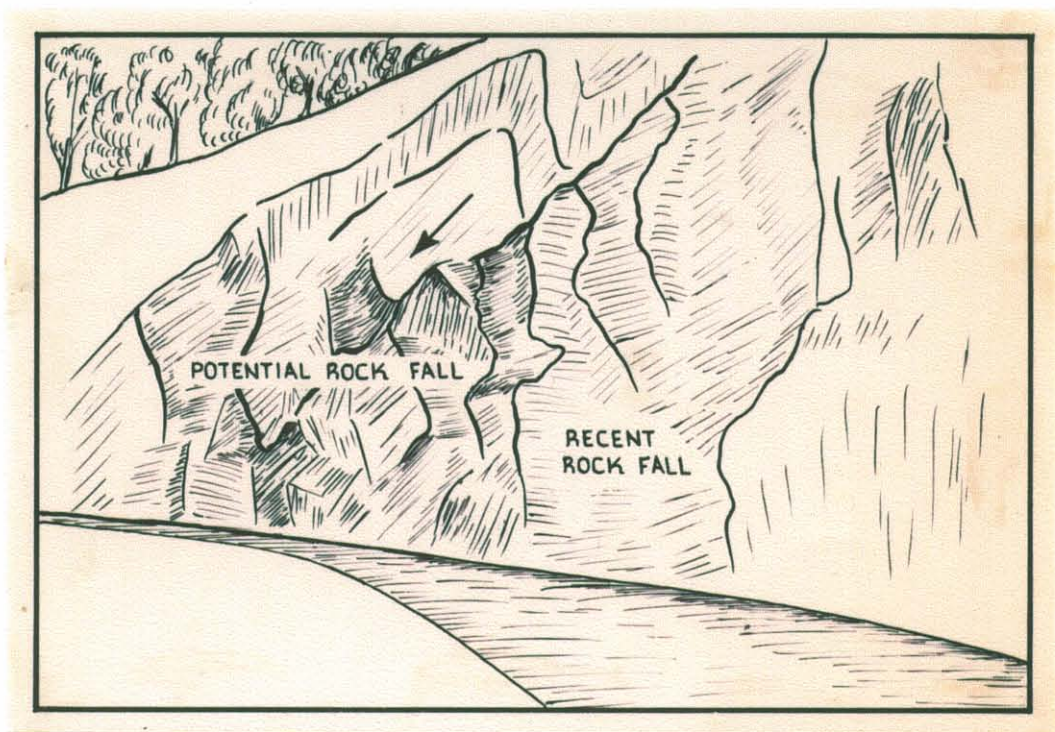
Plate 3. *Potential large wedge failure with tension cracks visible on upper and side face.*

##### Area 1 (plates 3 and 4)

A tension crack about 1-1.5 m long and about 4 cm wide was found on the upper surface in the area of an old wedge failure above measured section 3 (fig. 1). This upper surface tension crack connects with a series of cracks which run from road level to the top of the cliff. These cracks are clearly visible from the road (plate 4). The tension crack on the upper surface of the wedge could not be traced continuously because of the cover of vegetation but isolated cracks were found over the area of upper surface in the position and in the anticipated direction where a large wedge failure will occur. Little imagination is required to visualise the continuous ledges present as having been formed by intersecting tension cracks on which movement has already taken place.

The existence of this tension crack indicates that some movement has already occurred but the time of movement is not known. In time, this wedge will fail and fall. An attempt is now being made to monitor at weekly intervals any movement on this potential wedge in the hope that some warning may be possible before it falls.

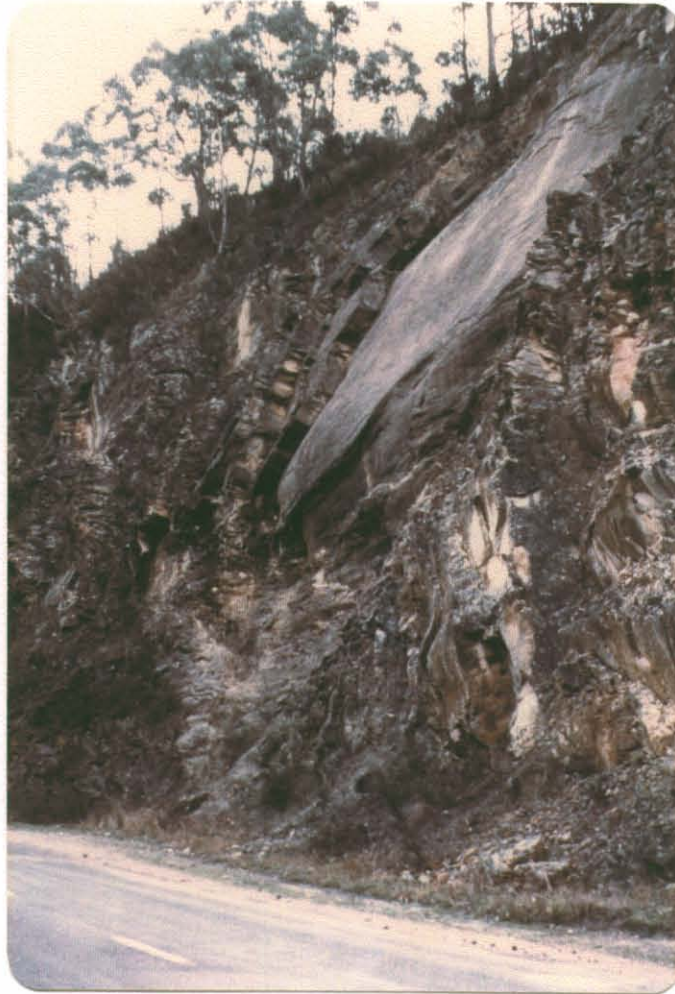
Plate 5. *Planar failure along the bedding plane on an upper limb of a fold.*

##### Area 2 (plate 5)

The second potentially dangerous area is at the northern end of the cliff, above measured section 5 (fig. 1). A planar failure has already occurred along a bedding plane of a thick silty argillite bed when most of the upper limb of a fold fell. The P.W.D. then removed some further material considered dangerous after this initial rock fall. On what appears to be the initial southern release surface of this planar slide are a series

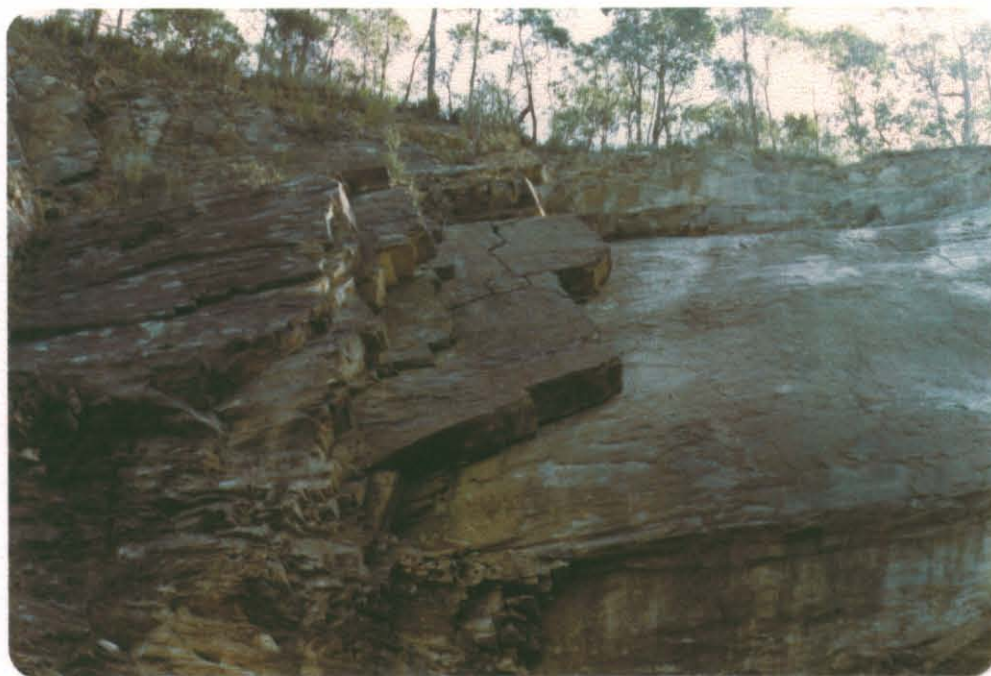
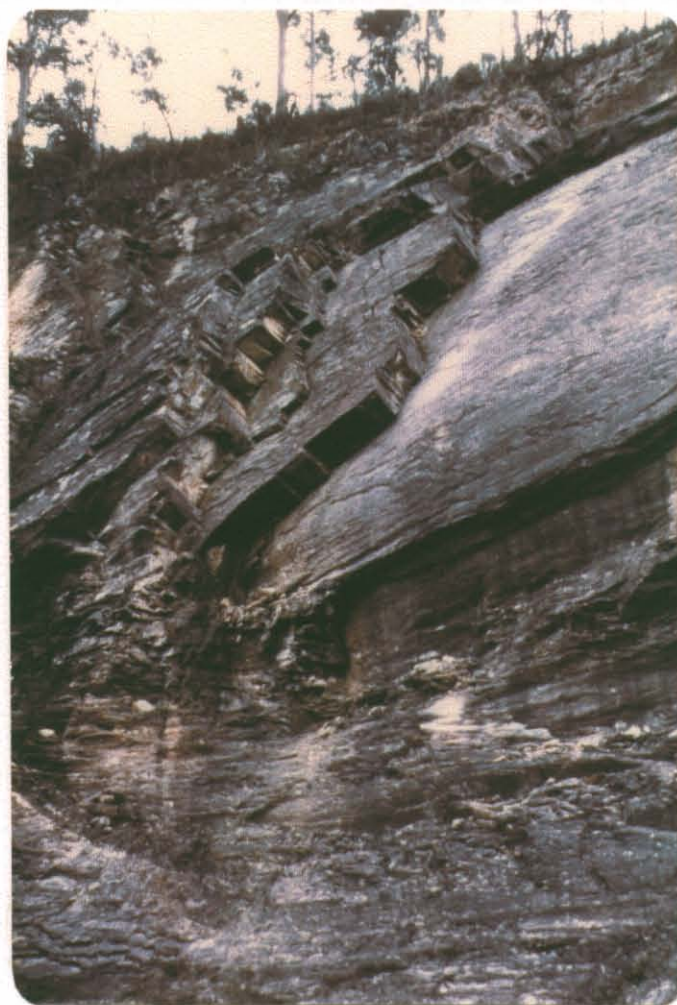
Plate 6. *Series of perched slabs held by bottom cracked slab.*

of perched slabs or argillite, all badly cracked, and supported on a small slab on the concave section of the fold at the base of the old planar slide. This bottom slab is badly cracked with some cracks opening, showing the rotating movement of the slabs above it (plate 6). A large tension crack is visible along the top of this area immediately below the drainage trench and path at the top of the face. A monitor has been placed on this lower slab, but there is a danger that most of the initial rock movement has already occurred and the next movement will be the final rock fall.

The larger planar failure (plate 6) could only be measured approximately from the road and some of the blocks had been removed by the P.W.D. after the initial rock fall. As a result neither the position of the initial failure (the dip of the bedding), nor the position of the release surfaces are known with certainty; this restricts the usefulness of the back analysis, although the angle of friction must be lower than the lowest dip of the bedding which is approximately 35° below the present tension crack on the potential slide. Toppling failures are present above this section on the cliffs where some large blocks have fallen. These are not simple toppling failures but a complex inverted type of wedge failure. One of these failures is associated with a small fault that passes through this section. The other is the intersection of three joints where a large block of rock has recently dropped just above road level. Large fallen blocks are a major traffic hazard, particularly on the narrowest section of the road.

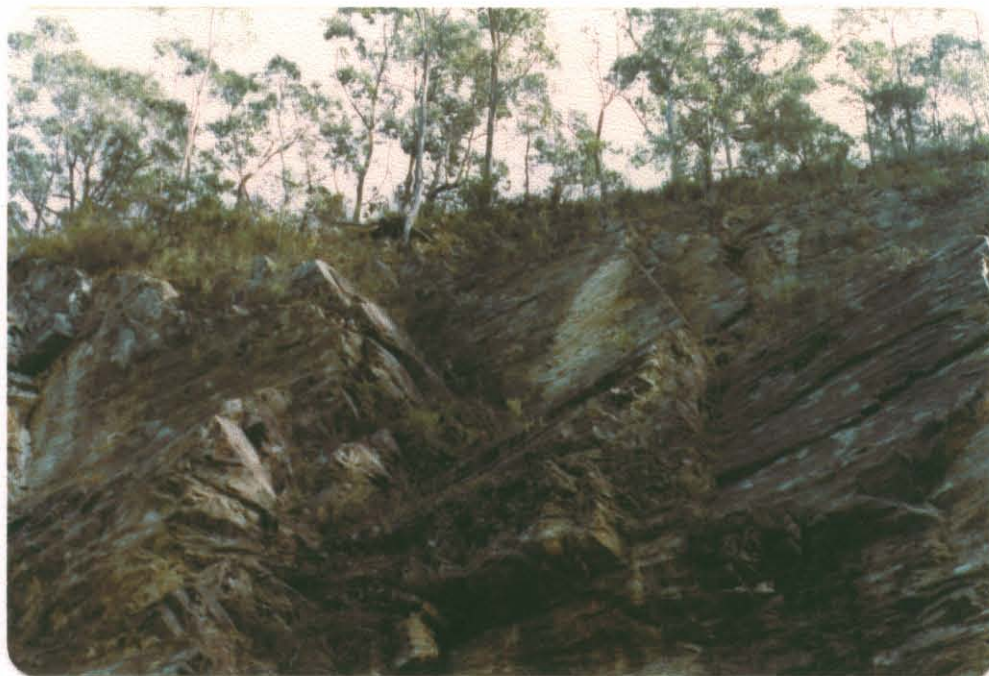
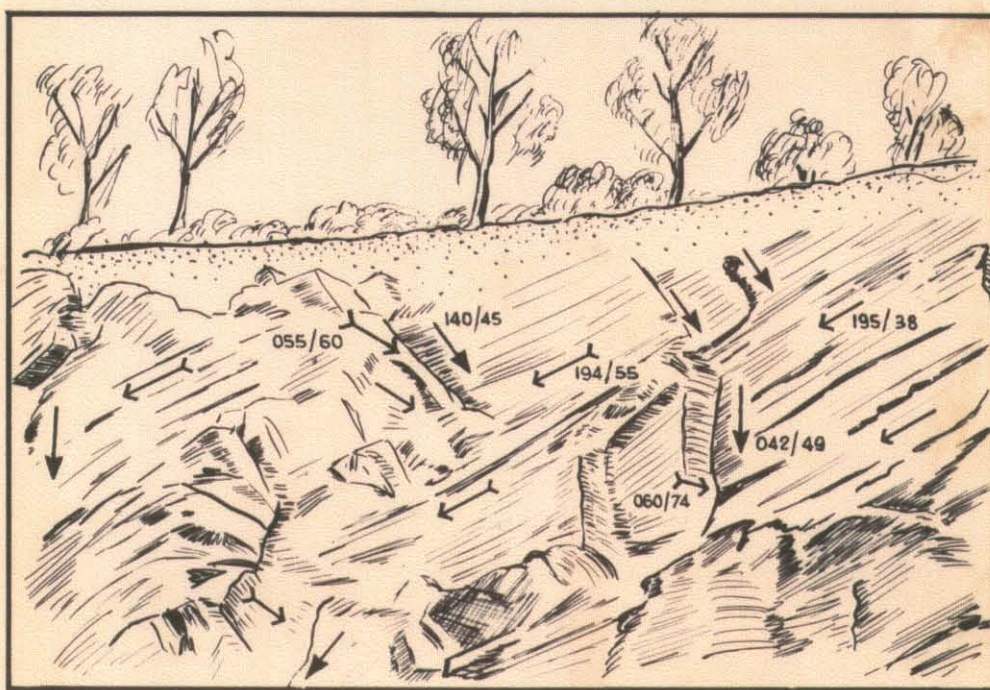
Plate 7. *Small wedge failures  
above section 4.*

There are a series of small wedge failures along the top of the cliff face, above measured sections 3 and 4 (fig. 1; plate 7).

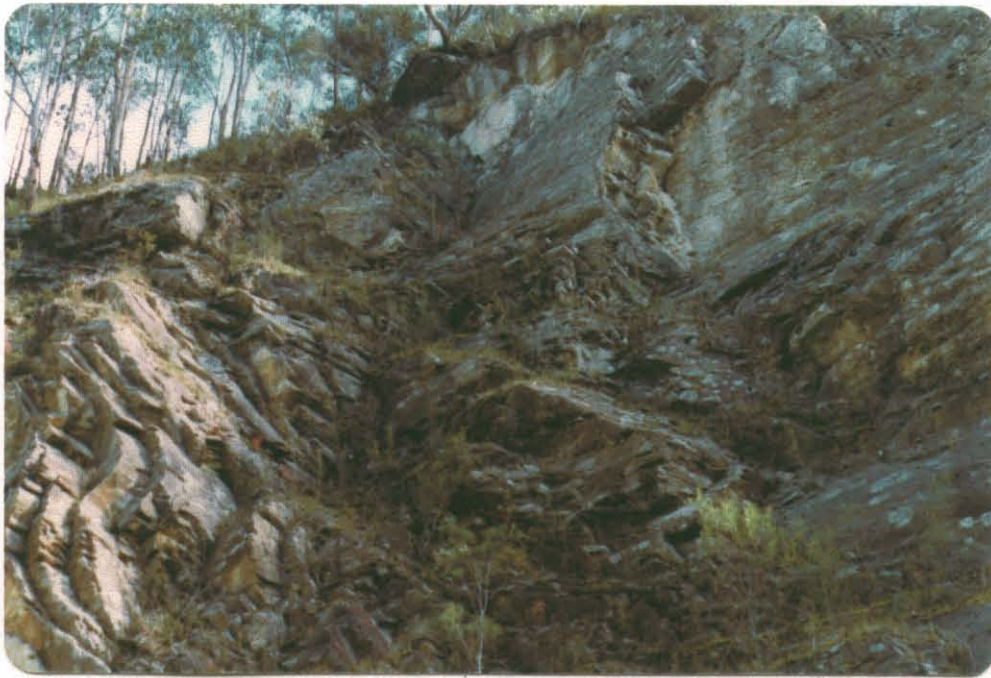
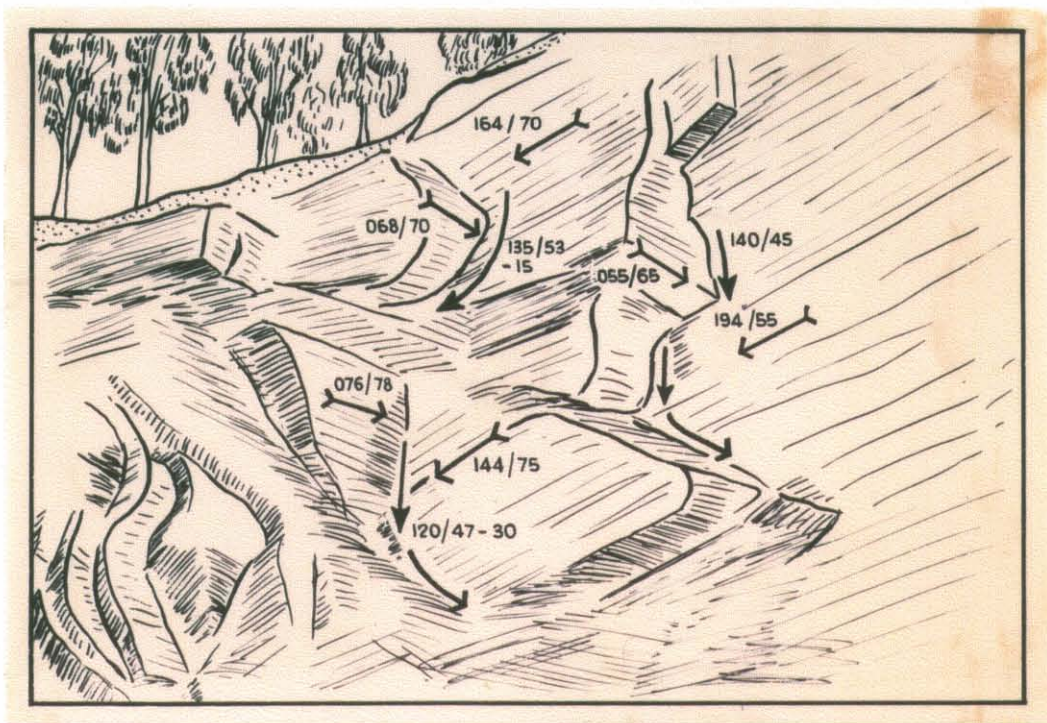
Plate 8. Small wedge failures with curved line of intersection and low angle of inclination for the direction of movement of the wedge. This curved line of intersection is the result of folding of the bedding (one of the discontinuities of the wedge). Above sections 3-4.

In some of these wedges the line of intersection between the faces of the wedge is curved. This is because one face (the bedding) is folded. The wedge is asymmetrical and therefore its geometry is variable, giving this type of wedge a ski-jump type of slope at its base (plate 8).

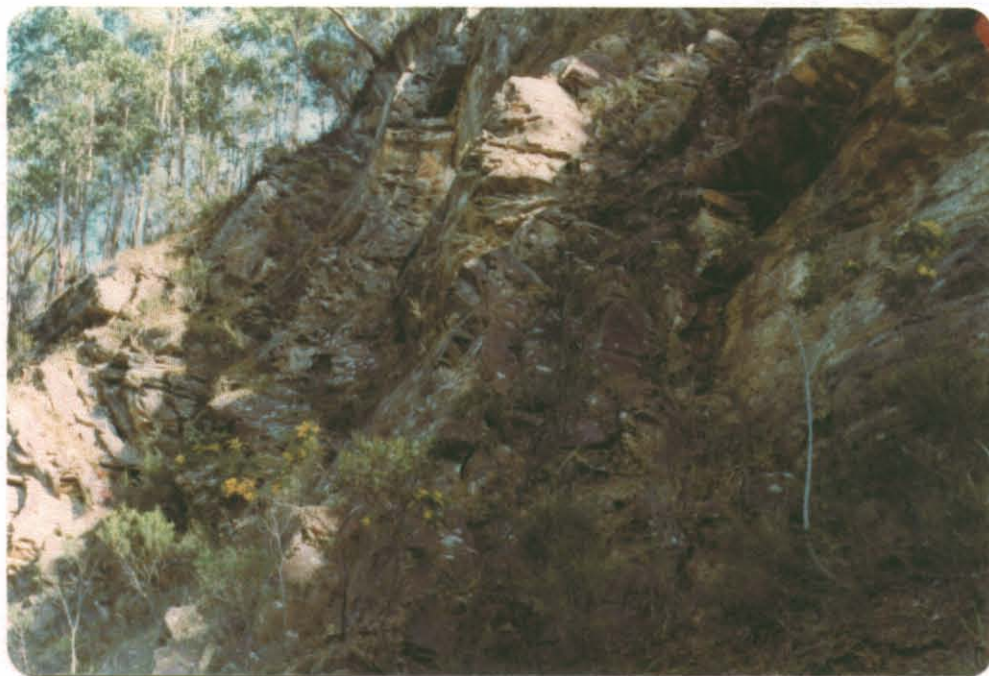
Plate 9. *Wedges which have failed on a major joint dipping NE, and three bedding planes forming a large wedge failure unit.*

Another series of wedge failures is seen where a major joint intersects a series of thick beds in the argillite (plate 9). These wedges appear to have fallen as a unit, the upper wedge bringing with it the underlying wedges as it fell.

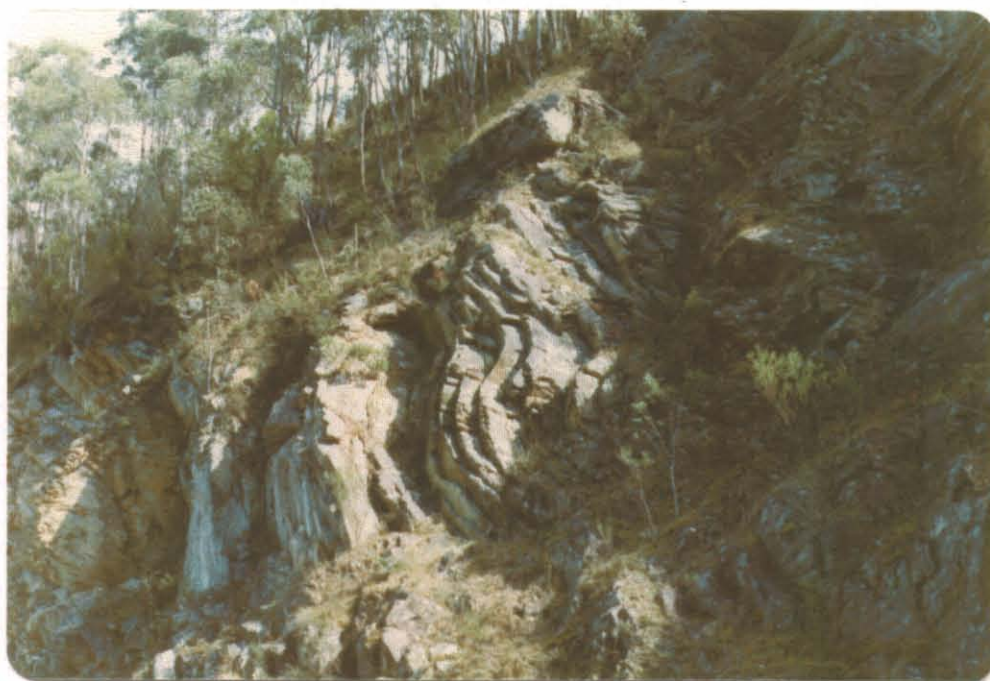
Plate 10. *A large wedge failure scar built up by a sequence of failures along NE-dipping jointing and bedding.*

In the case of some of the larger old wedge failure scars visible along the cliff face it is unlikely that the failure occurred as one fall but as a series of falls. This process will continue until a more stable face configuration is achieved, with a lower slope angle and the face direction determined by the structural geology at that particular location (plate 10).

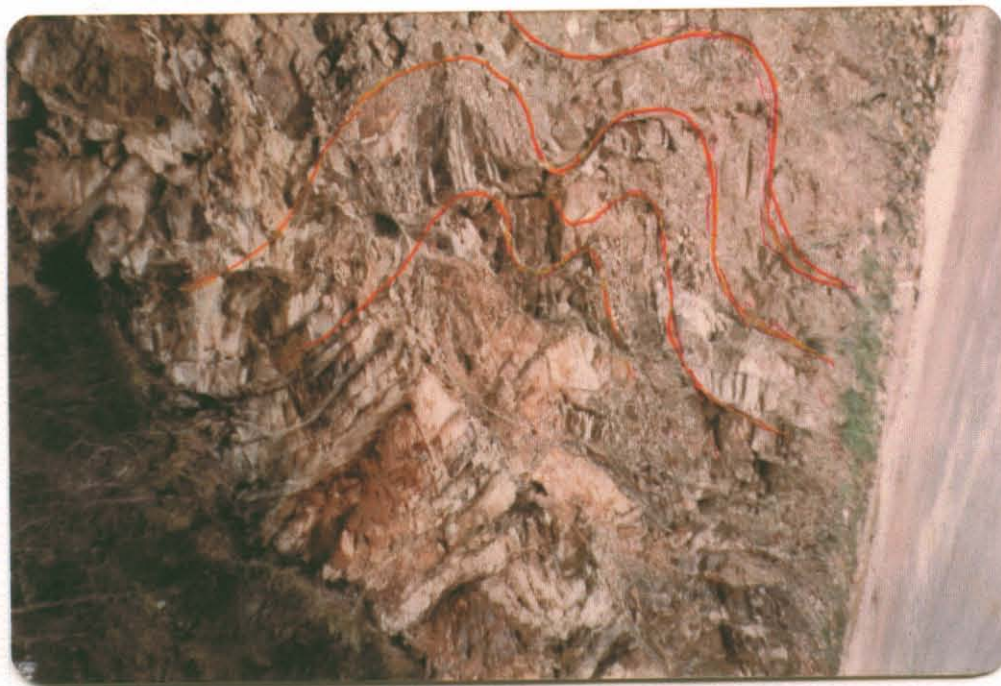
Plate 11. Style of folding in the argillite showing complex wedge failure in the contorted and crushed zone in the nose of a fold.

Although the style of folding exposed in the cliffs (plate 11) will not alter, the position of the folds and the intersecting of joints will change as the cliff face is cut back.

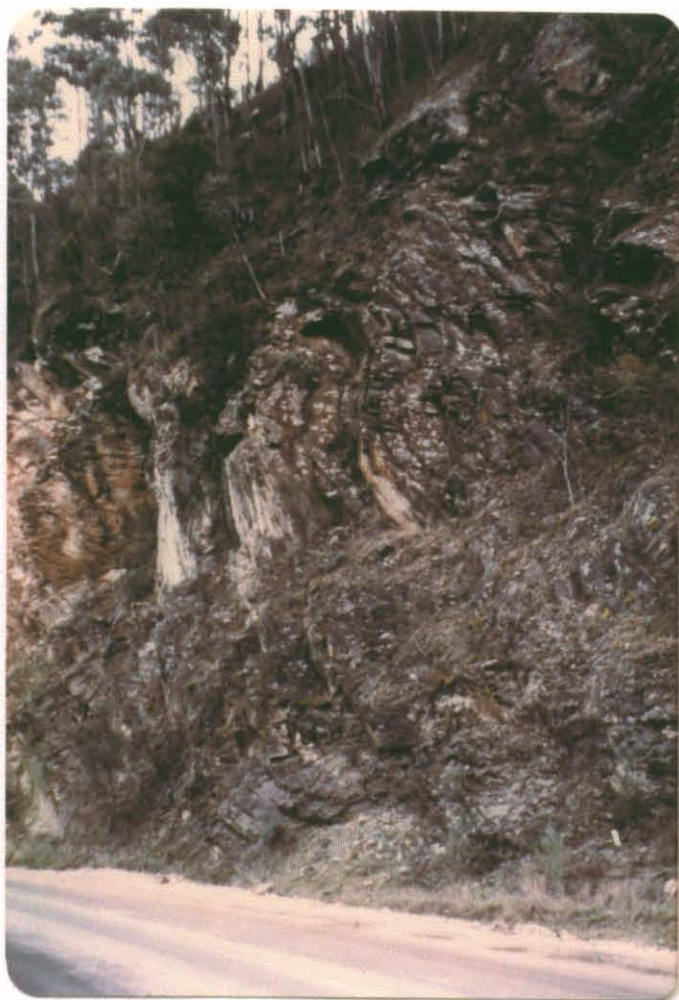
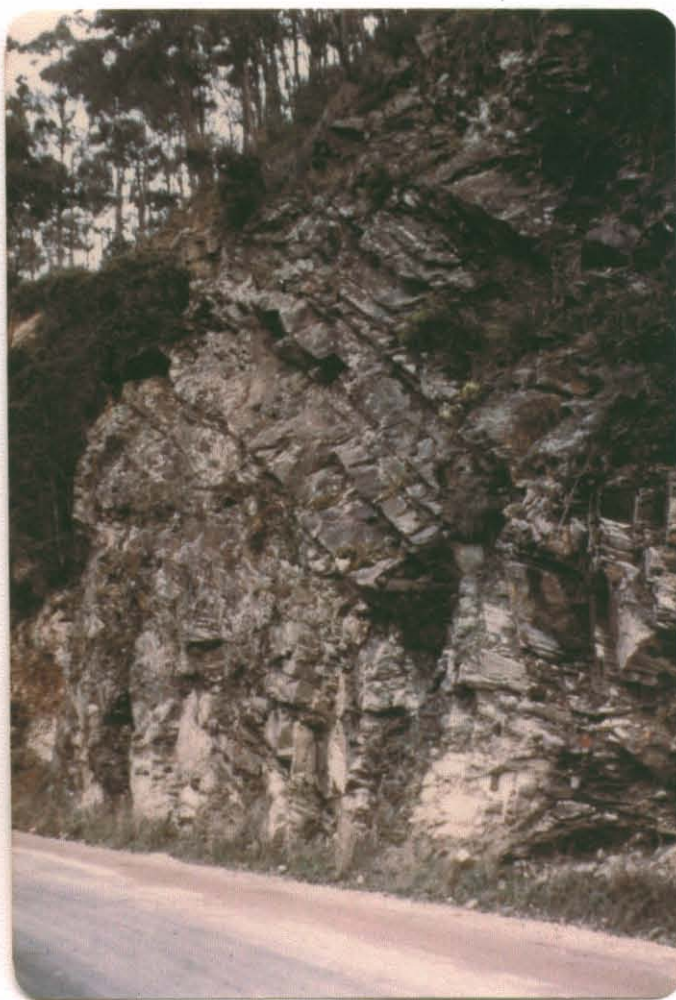
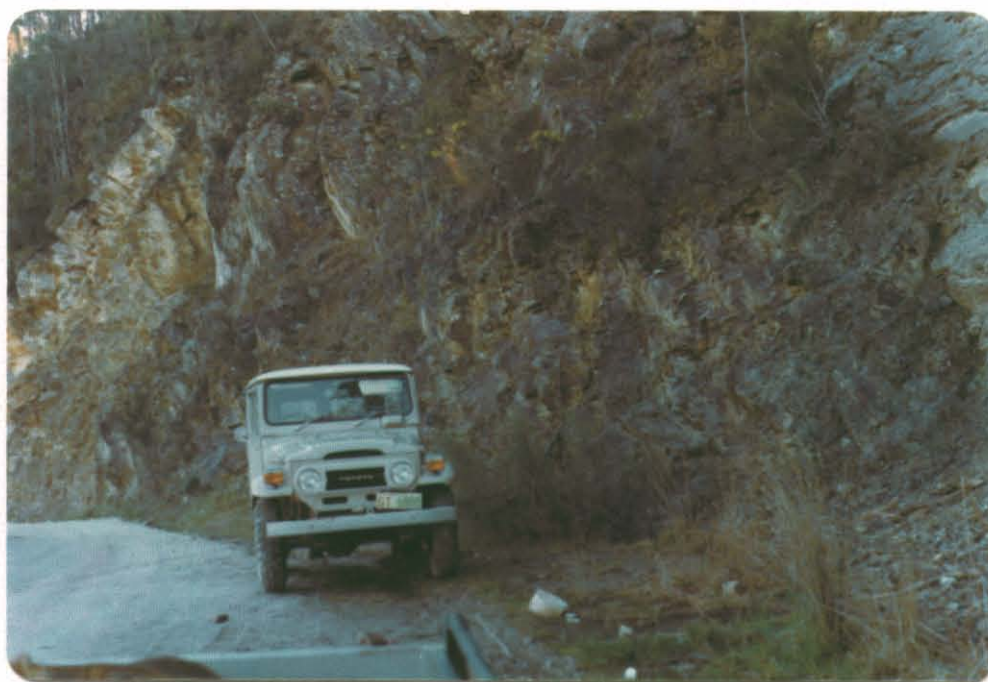
Plate 12. *High face angle and local stability due to the bedding having a dip component away from the cliff-face.*

By a selective process of previous rock falls and to a lesser degree by other natural erosional process such as creep and weathering, the existing face has assumed an irregular and stepped appearance with a variable direction of dip. In some areas a high slope angle has been achieved with considerable stability where, because of the folding, the bedding at this

location is dipping in towards the cliff (plate 12), but where the bedding has a component of dip out towards the face the area is still unstable even though a much lower face angle has been formed (plate 13).
