1976/71. Engineering geology investigation of a proposed cutting on the Murchison Highway at Somerset.

W.R. Moore

The Public Works Department (P.W.D.) requested the Department of Mines to undertake a rock stability analysis of a 200 m cliff section of the Murchison Highway at Cam River, Somerset [DQ019553] (fig. 1; plate 1).

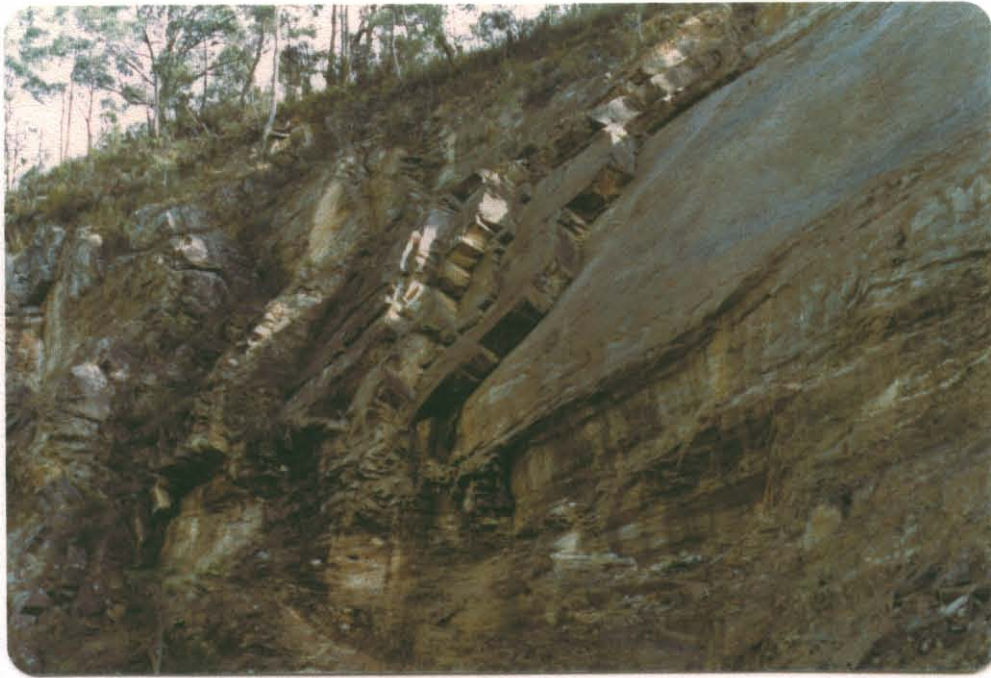
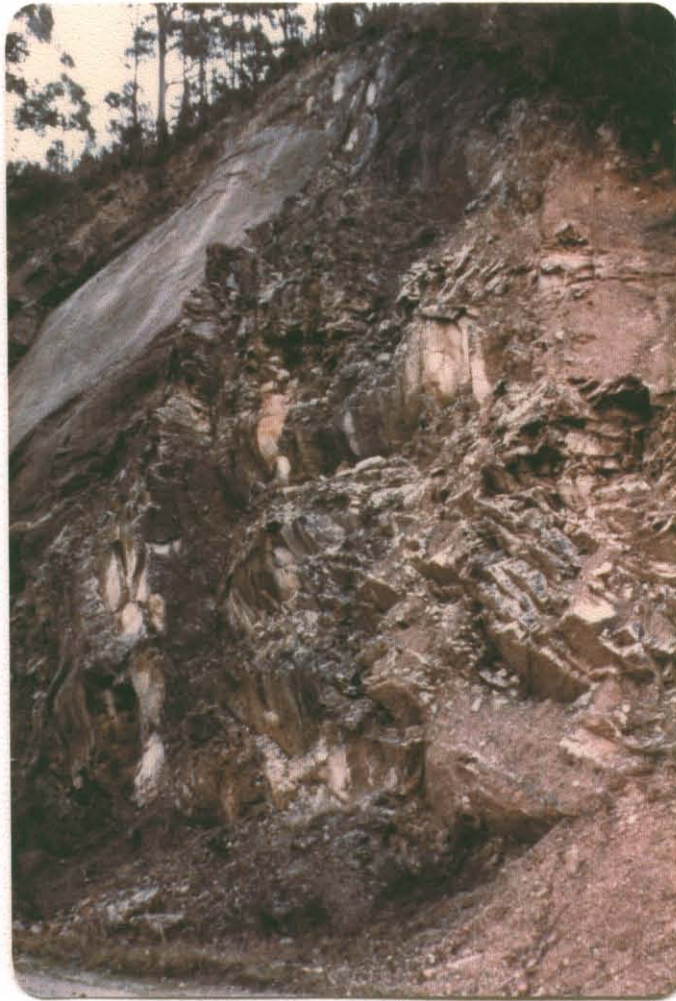
Plate 13. *Bedding with a component of dip towards face resulting in a lower face slope angle, and instability leading to wedge and planar failures.*

location is dipping in towards the cliff (plate 12), but where the bedding has a component of dip out towards the face the area is still unstable even though a much lower face angle has been formed (plate 13).
