**TASMANIA DEPARTMENT OF MINES  
UNPUBLISHED REPORT 1976/73**

**Examination of a property  
at Howick Street, Launceston**

A property at 28 Howick Street, Launceston, was examined. The property is located on steeply sloping ground rising from Howick Street. This land is located in Zone 3, or potential landslip, on the Tamar Valley Landslip Zone Map.

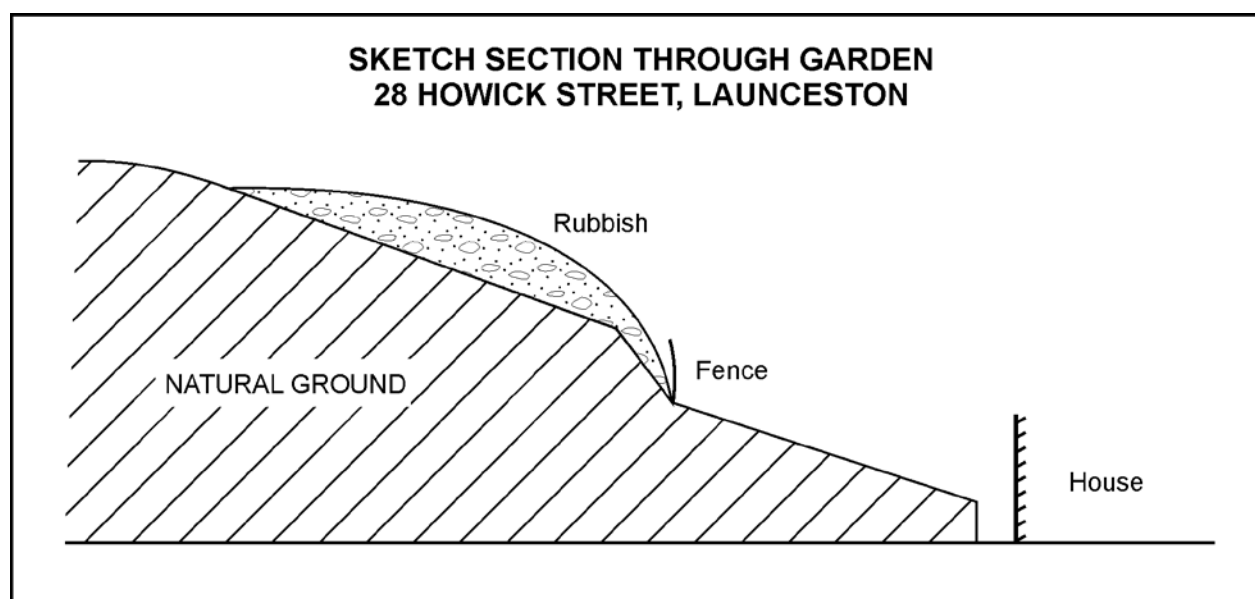
**Figure 1**

Immediately behind the back fence is a steep bank about 1.5 m high and behind that a slope of about 20°. Lying on this bank and slope is a pile of material, 1.5–2.0 m in depth, which is reported to consist of rubble and rubbish. This pile is loading the back fence which has been partially destroyed.

A sketch section which shows the relationship between the rubble, garden and house is shown in Figure 1. The slope itself is composed of clay and silty clay of the Launceston Beds. In this locality ironstone bands are also common, and these would account for the presence of the unusually steep slope.

The pile of rubble is largely stabilised by blackberries, but the slow down-hill creep will continue to damage the fence. A mudflow of rubble is unlikely, although without knowing the constituents of the pile the possibility cannot be ruled out.

The main danger is that the rubble is loading what is already an exceptionally steep bank. It could well induce instability in the bank itself and so start a process which would be difficult and expensive to halt.

It is considered prudent that the pile should be moved and spread thinly over the more shallow land behind. The procedure should not take place in late summer or winter, as there must be time to re-establish vegetation on the slope before the winter rains.
