1977/8. Cliff stability investigation of a property at Lindisfarne.

W.R. Moore

At the request of the Municipality of Clarence, an engineering geological investigation was undertaken of the cliffed section of the River Derwent foreshore that forms the western boundary of A.L. Pearce's property, 'Salamis' in Talune Street, Lindisfarne.

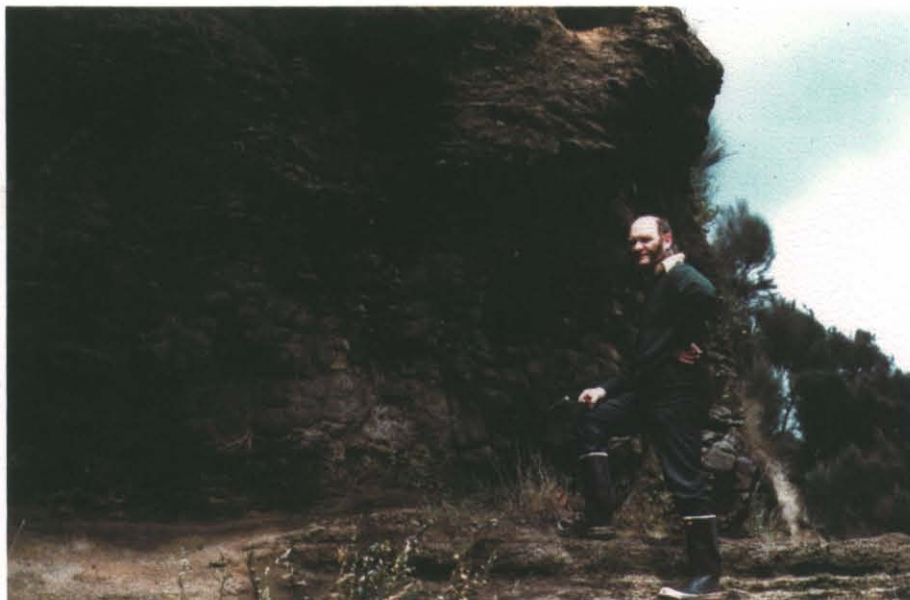
The weathered basalt is soft, has an earthy texture and appears to have been altered on extrusion. Only in the centre of some concentrically weathered zones does the rock become at all hard, forming small nodules, although no completely fresh unaltered or unweathered basalt was found on the cliff face. The basalt is soft but because it is massive, having only a few widely but regularly spaced vertical joints (plate 2) it is erosion resistant and forms near vertical cliffs.

Plate 1. *Typical cliff section in basalt.*

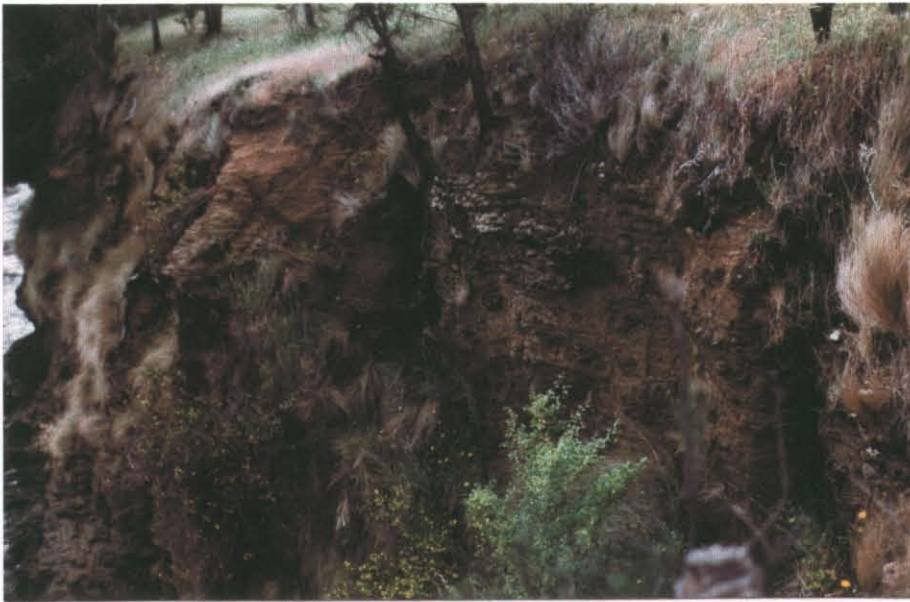
A series of small steps or terracettes forms a distinct change in slope towards the cliff edge. This zone ranges from 5-10 m in width. These steps are thought to be associated with the open vertical joints exposed along the cliff face (plates 2, 3).

Plate 2. *Cliff section showing widely spaced vertical joints.*

The units should not be built on the zone some 7-10 m wide that occurs immediately behind the cliff, because of its potential instability.

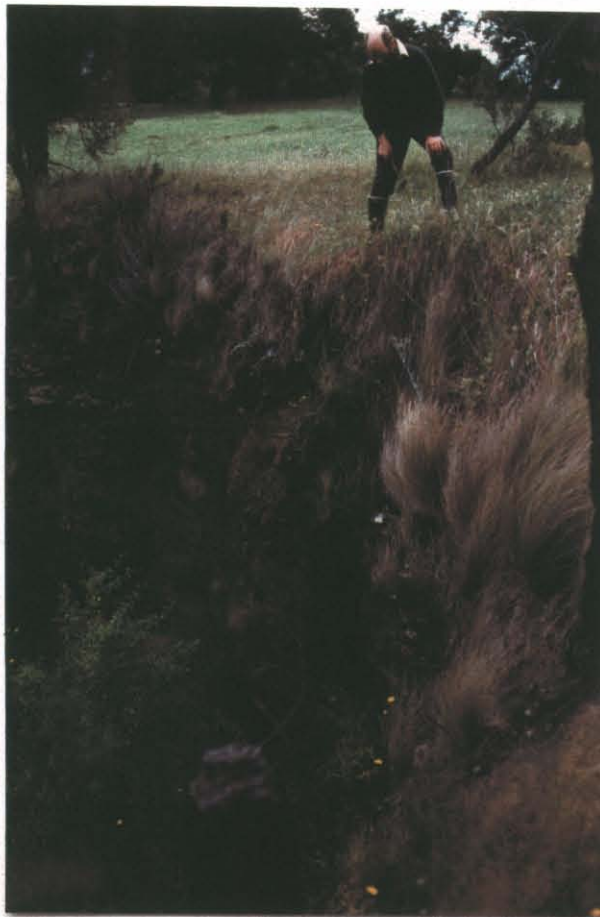
Joints occur at 1-1.5 m intervals and are often open, the joint walls separated by up to 50 mm (plate 3). The joints appear to be mostly cooling contraction joints but some veins containing weathered clay minerals are present. The horizontal banding of the basalt is the result of vesicle layering and vesicle density (vesicles frequently form 50-60% of the rock surface). Where these vesicles become particularly dense and closely spaced, the rock weathers differentially and rapidly to form a grey-white clay. Such layers or areas in the basalt are less resistant to erosion, as seen at the northern point on the northern boundary of the subdivision.

The open joints exposed on the cliff face are related and associated with the change in slope of the terrace profile where it falls by a series of small steps to the cliff edge. If these joints are as open as appears along the cliff face then increased surface drainage down these joints could form potential slip failure or movement. This unstable zone is narrow (about 7-10 m in width) and it is in this zone that existing failures have occurred. Increased surface water infiltration associated with the development of the area could possibly accelerate this slow natural process.

Plate 3. *Open joint in basalt.*

The sewerage, storm water and other service drains should not be dug along this zone, but should be sited behind the units.

Light structures such as concrete patios, carports, driveways etc. from which the surface water run off could be directed away from the vertical joints could, if essential, be built on this zone.
