UR1978-32

- . Further report on the stability of a proposed subdivision near Lilydale.

W.R. Moore

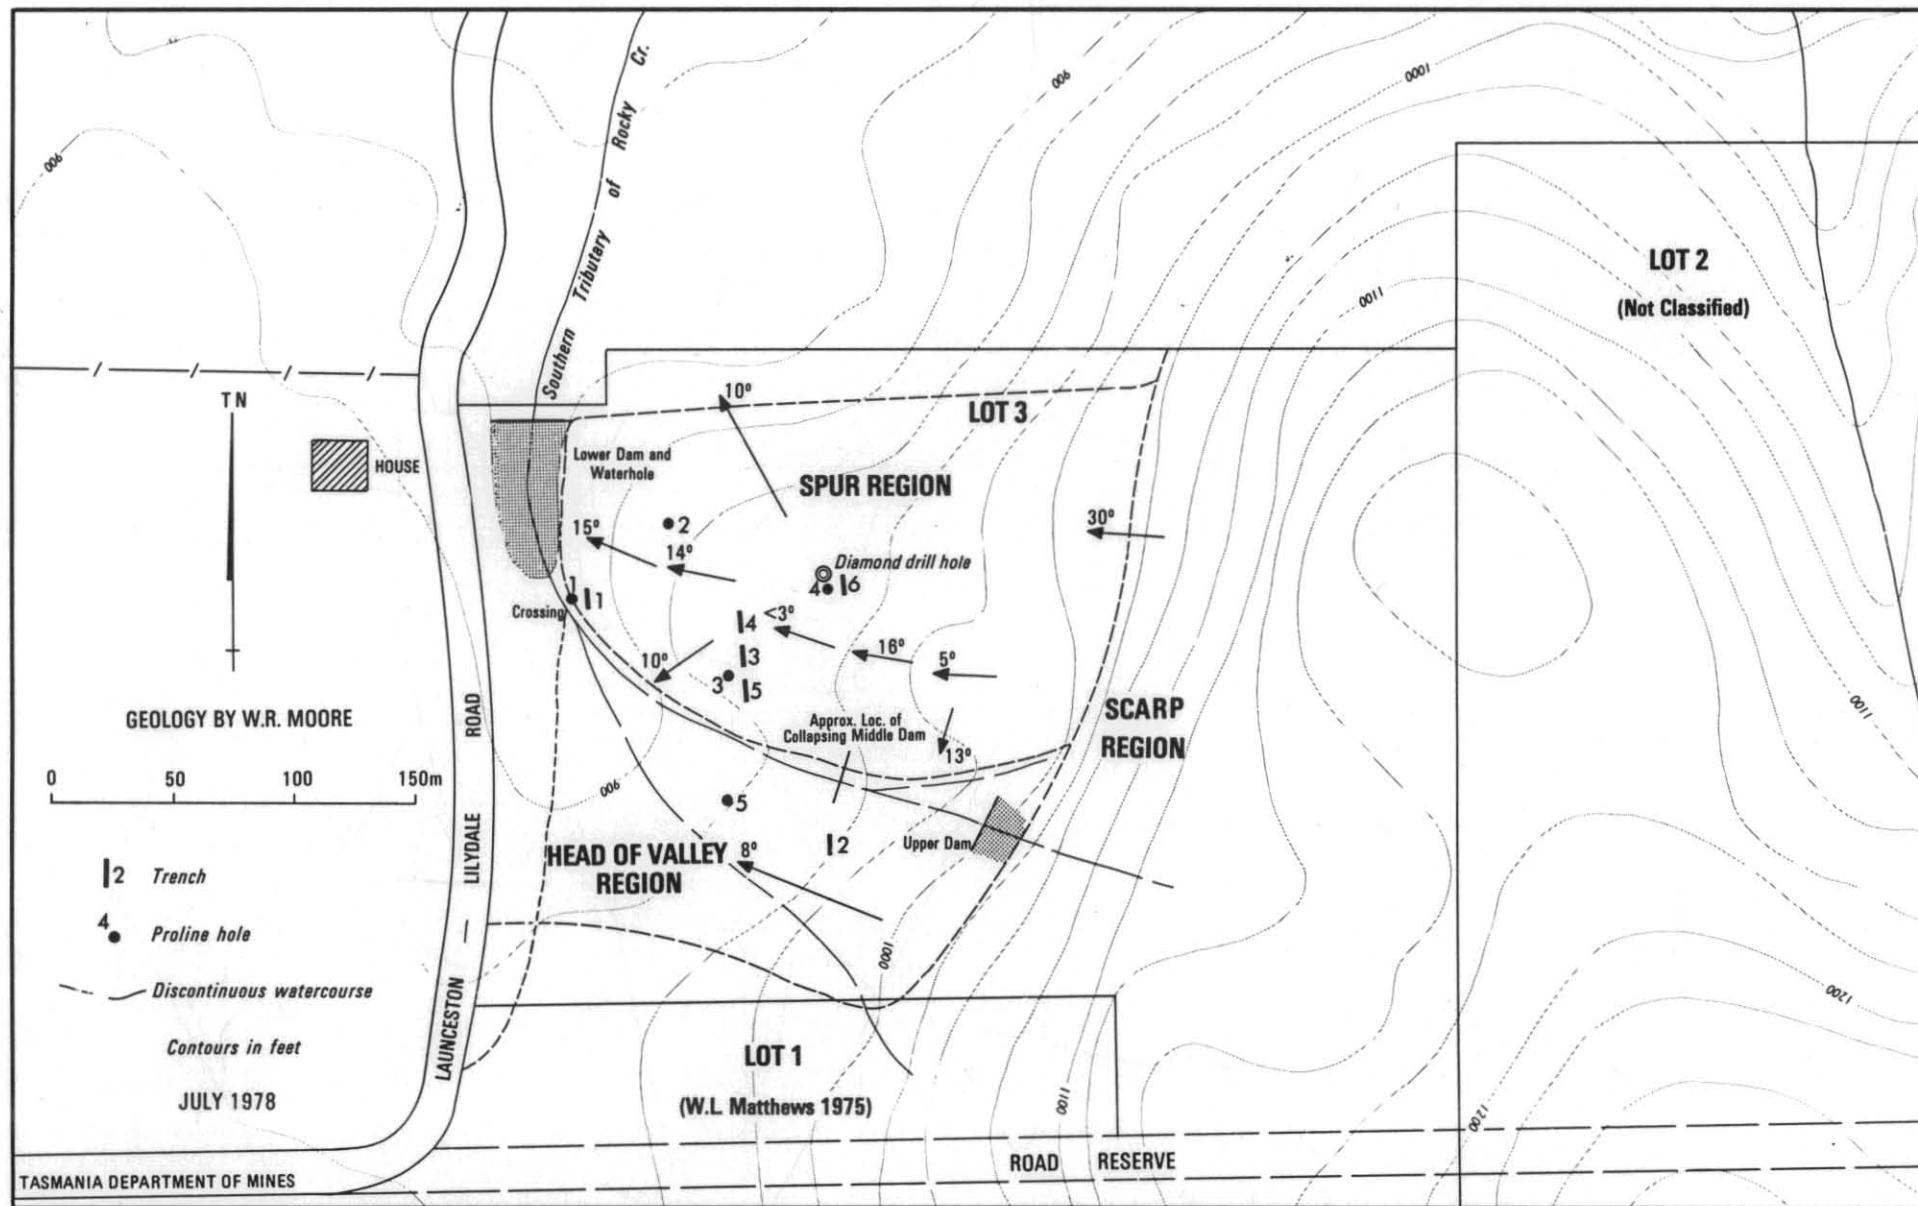
Figure 1. Location of diamond drill hole

One diamond drill hole was drilled on the most likely home site in the area. The hole was located in the middle of the lower bench, away from the steeply sloping edge (fig. 1). The upper bench may have been a more stable area, but its closeness to the high scarp region and lack of winter sun make it unattractive as a home site. It also lacks the commanding view of the lower bench area.
