UR 1978-36

. Test pits on R. Harris' property at Kelcey Tier, Spreyton.

W.L. Matthews

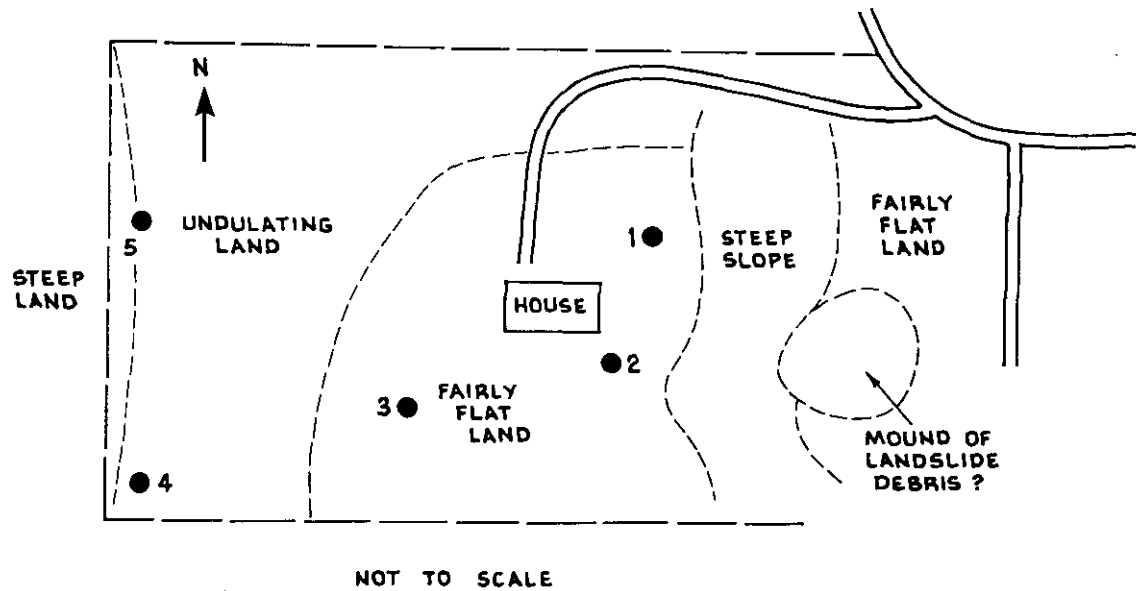
Figure 1. Location of test pits

Five test pits were dug in the approximate positions shown in Figure 1. Holes 1, 2 and 3 encountered a thin layer of material containing dolerite boulders, the lower parts of the pits being dug in mainly Permian derived material. It is not known whether this material has been involved in landslip movements or whether it is weathered *in situ*. Certainly in the upper sections of this material, flat pieces of relatively unweathered Permian rock have an irregular orientation suggesting movement. The lower parts, particularly in Holes 1 and 2, may have *in situ* weathered rock in them. Holes 4 and 5 are situated at slightly higher levels and have dolerite boulders from the top of the pit to the base, indicating that all the material has moved to these points from higher levels.
