1979/44. Foundation conditions at George Town Golf Club

P.C. Stevenson

Investigation of foundation conditions at the George Town Golf Club does not show any evidence of mass movement, although a minor risk of slow toppling of basalt columns exists. Examination of foundation rock by trenching is recommended.

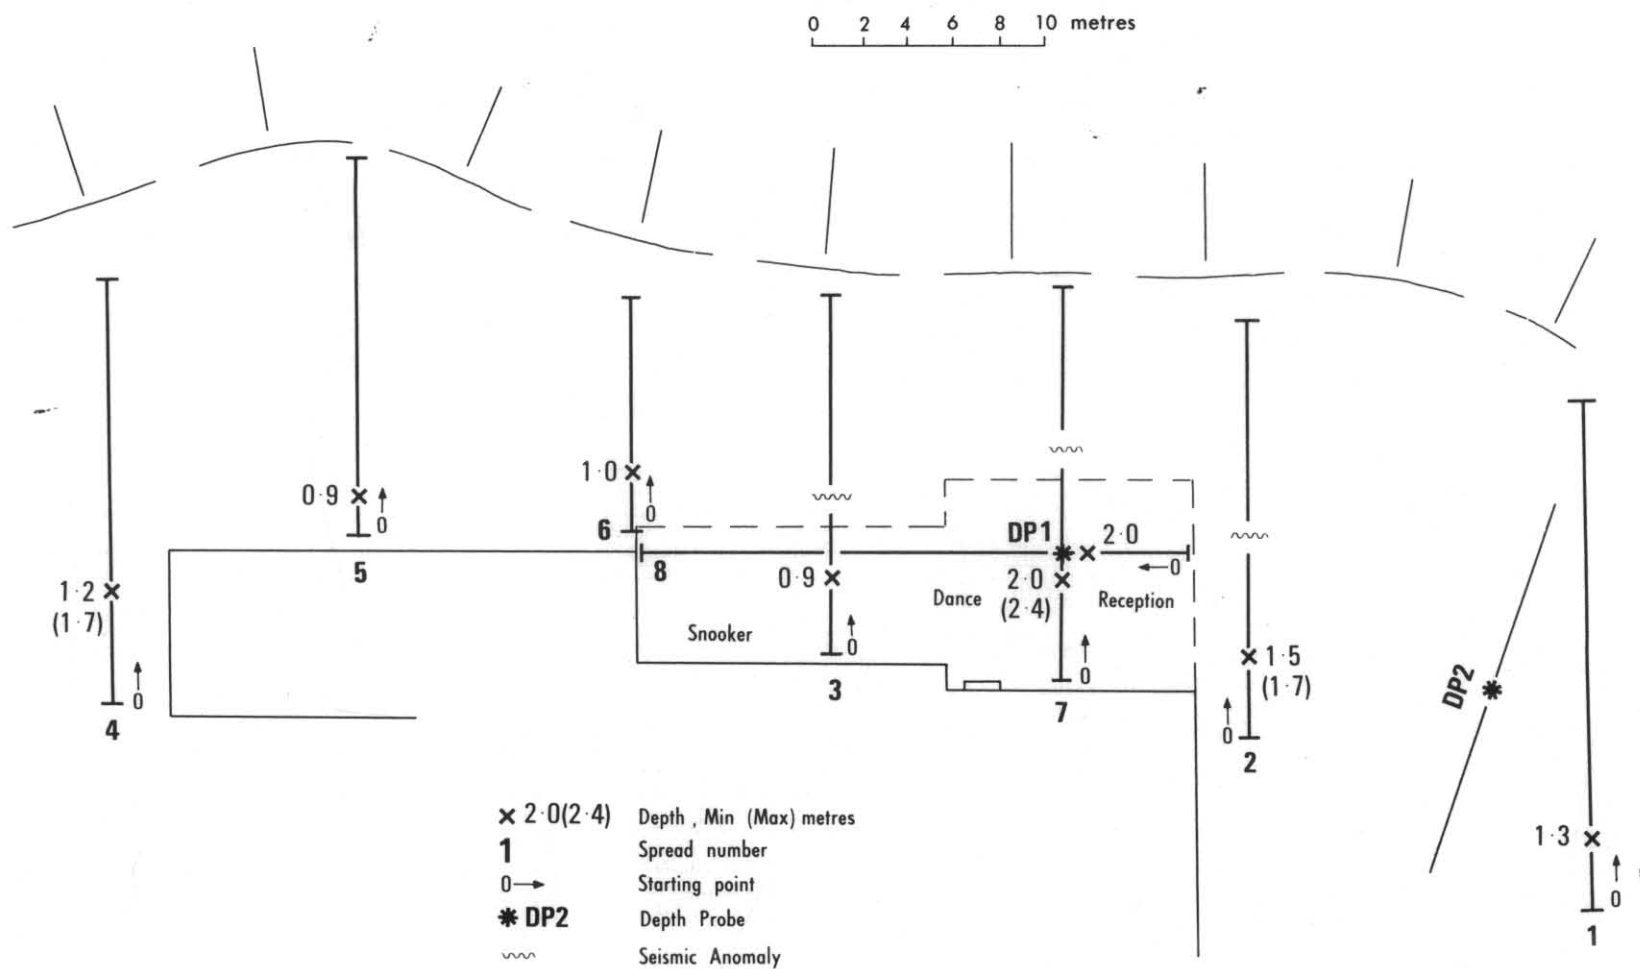
To examine this possibility, small scale detailed seismic velocity and electrical resistivity measurements were made in the positions shown in Figure 1. The measurements were made to discover if any open or clay-filled gaps could be found in the rock close to the surface. Gaps of this kind would be expected to show up as a local reduction in both the seismic velocity and in the resistivity of the rock close to the surface.

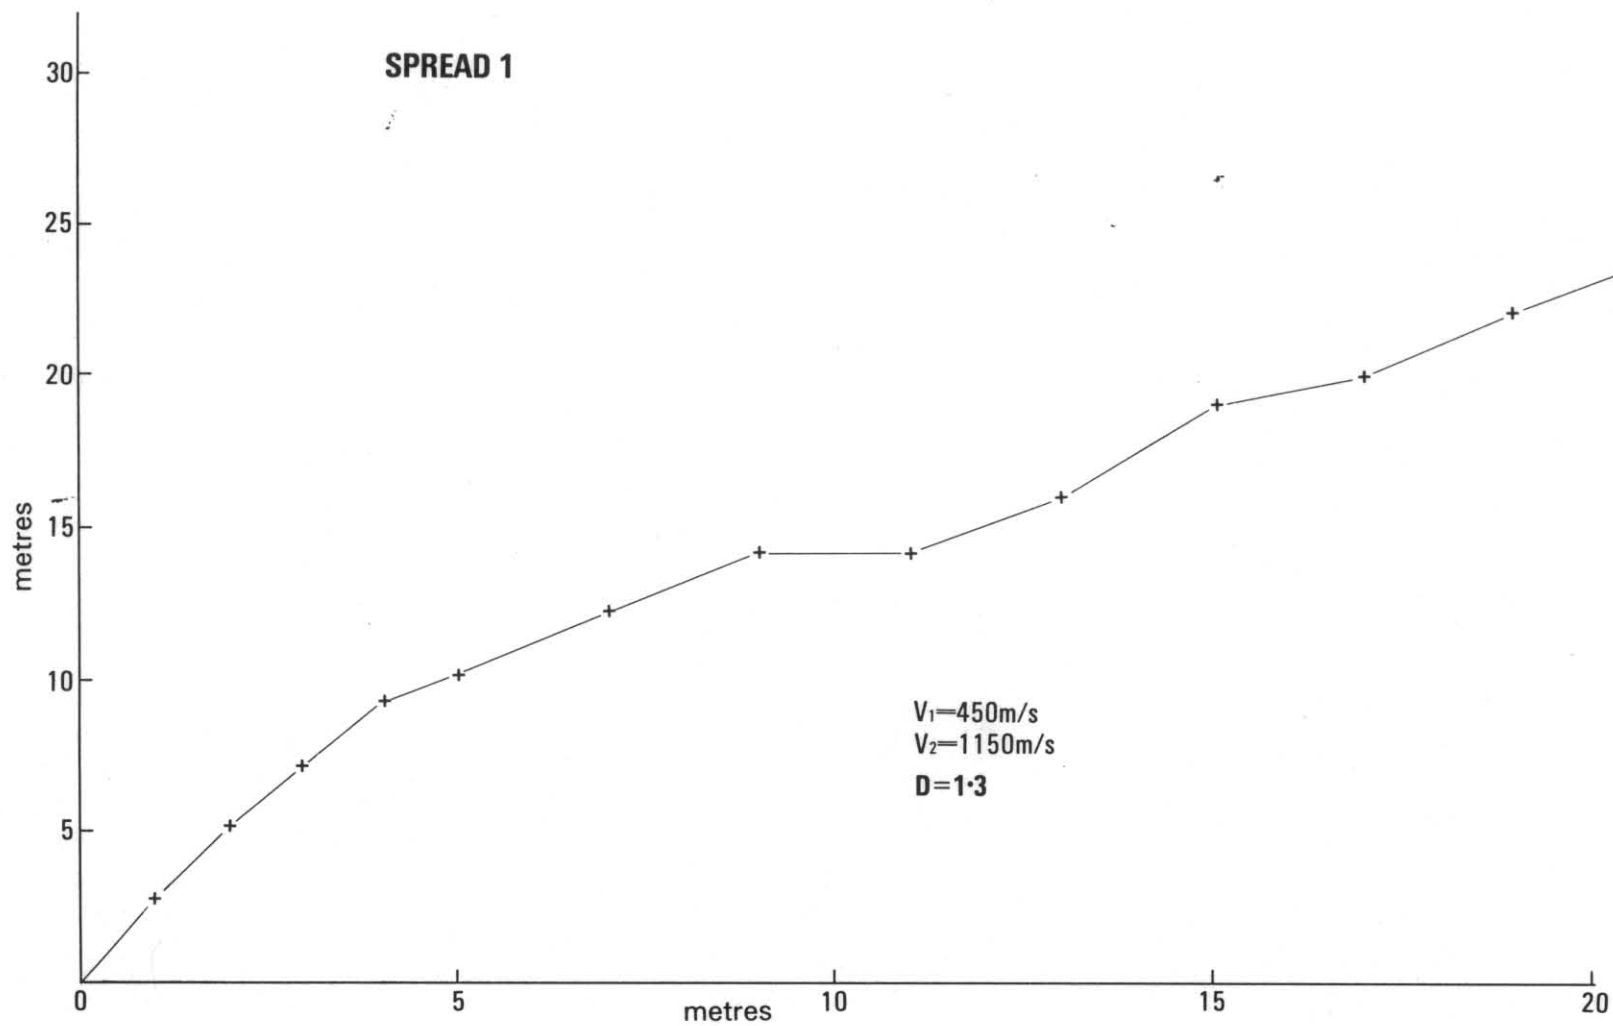
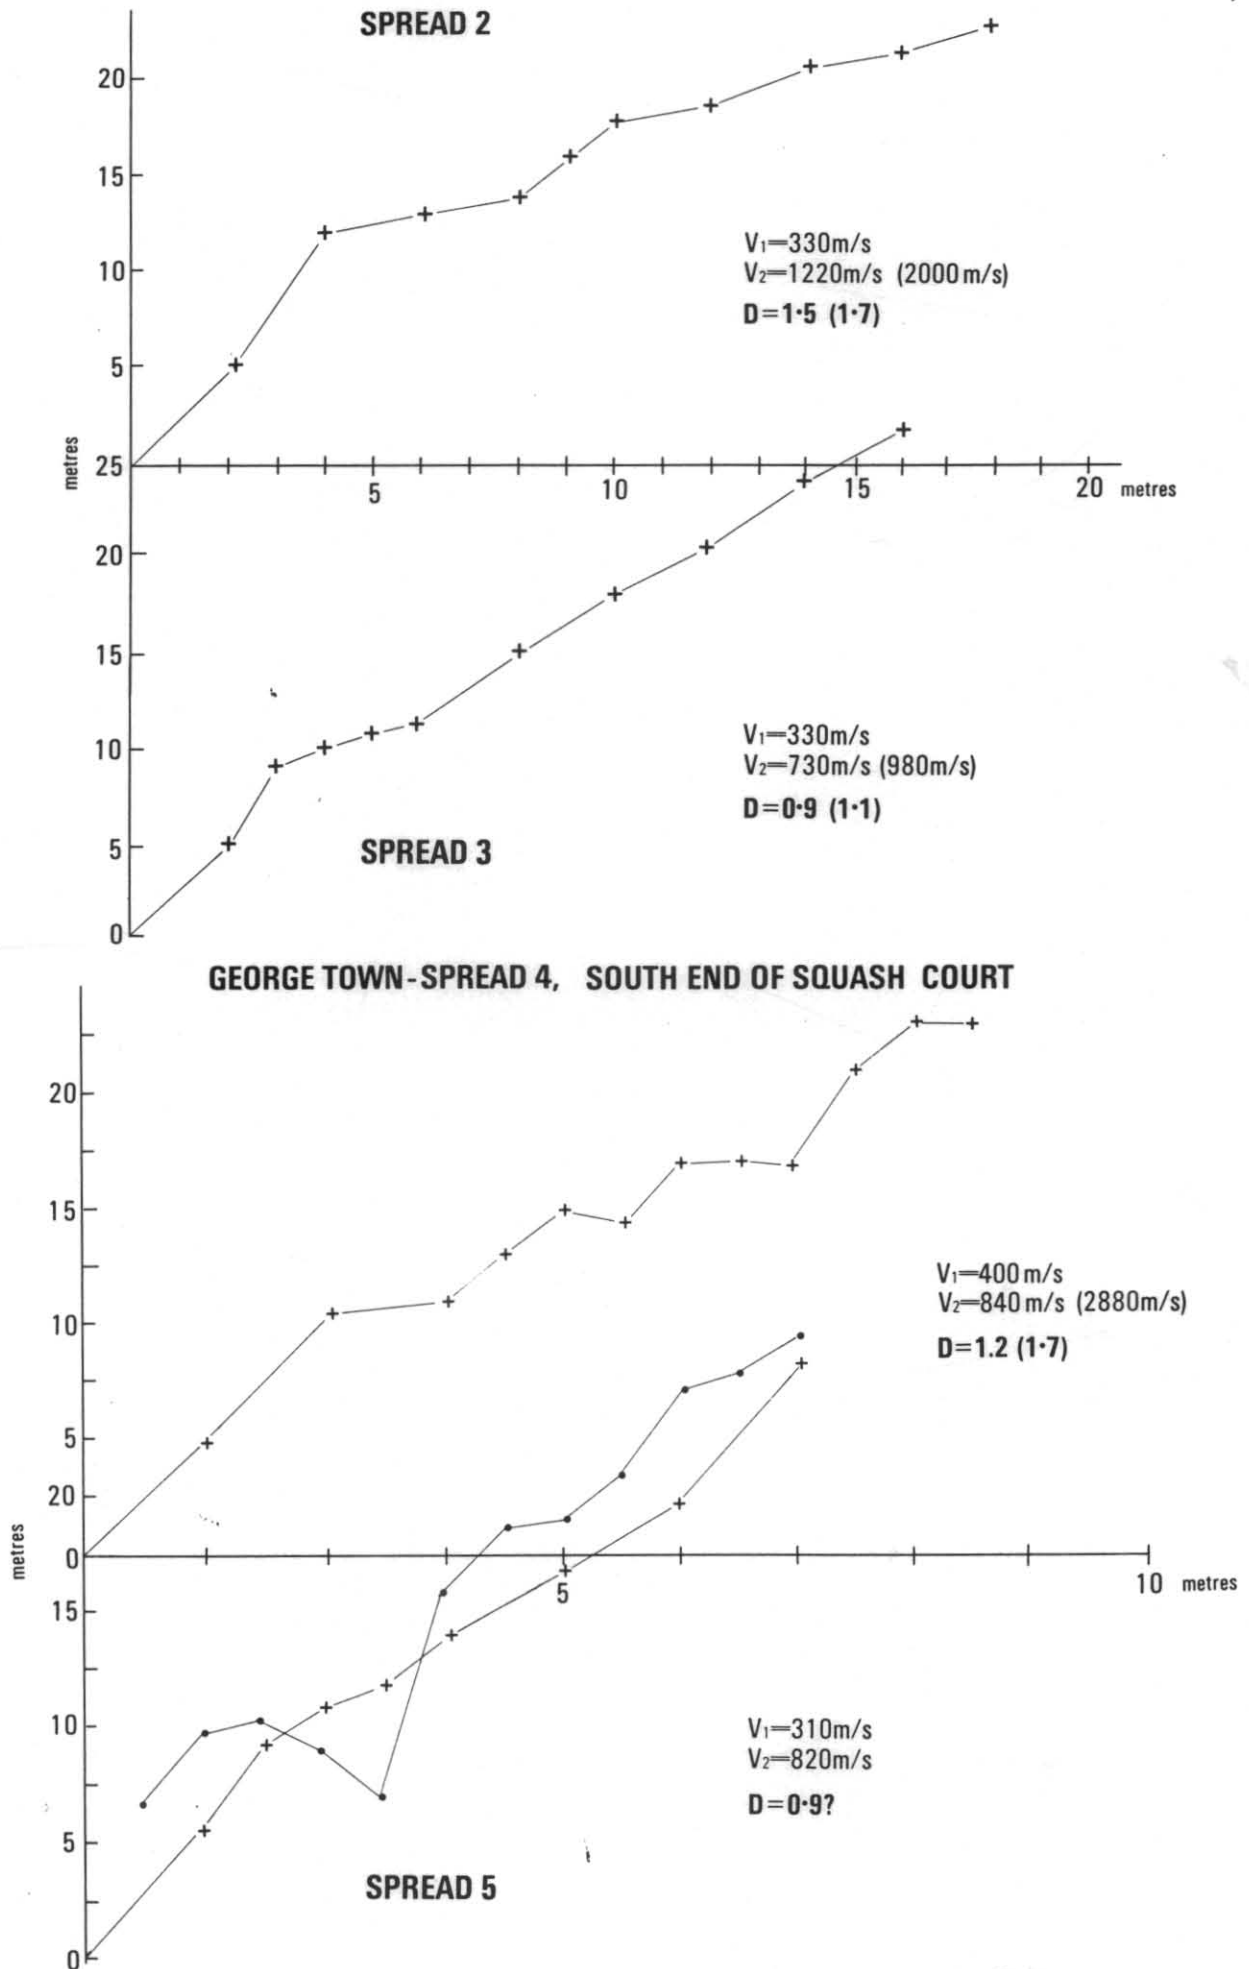
Figure 2. Seismic survey, George Town Golf Club

The observed seismic velocities and resistivity values are given in Figures 2 and 3. Irregularities (anomalies) thought to correspond to clay filled open joints that could affect the projected building are present on spreads 2, 3 and 7. Similar features are also present on spreads 4 and 5 away from the projected building.

It would be prudent to examine the foundation rock by means of trenches along the lines of spreads 3 and 7 excavated to rock or to 3 m depth. The rock conditions, and particularly the state of the rock joints can then be determined and the risk to the building extensions estimated.

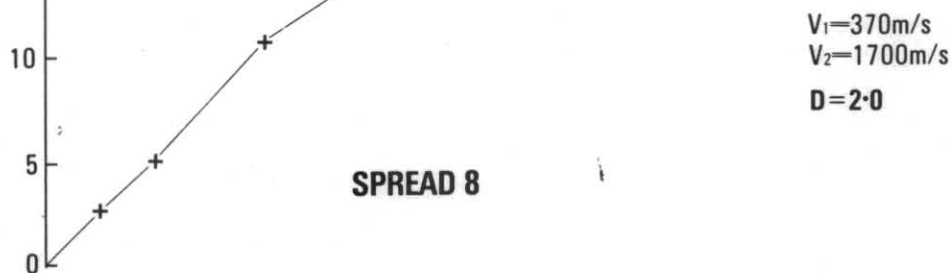
SPREAD 8

Some confirmation of the direction of the open joints is provided by spread 8. This is parallel to the escarpment crest and so parallel to the possible open joints. It shows no irregularities and would not be expected to if the open-joint picture is a correct one, since open joints will be shown only by spreads crossing the joint direction.
