1979/51. Foundation Conditions at Norwood House, Norwood

D.J. Sloane

Abstract

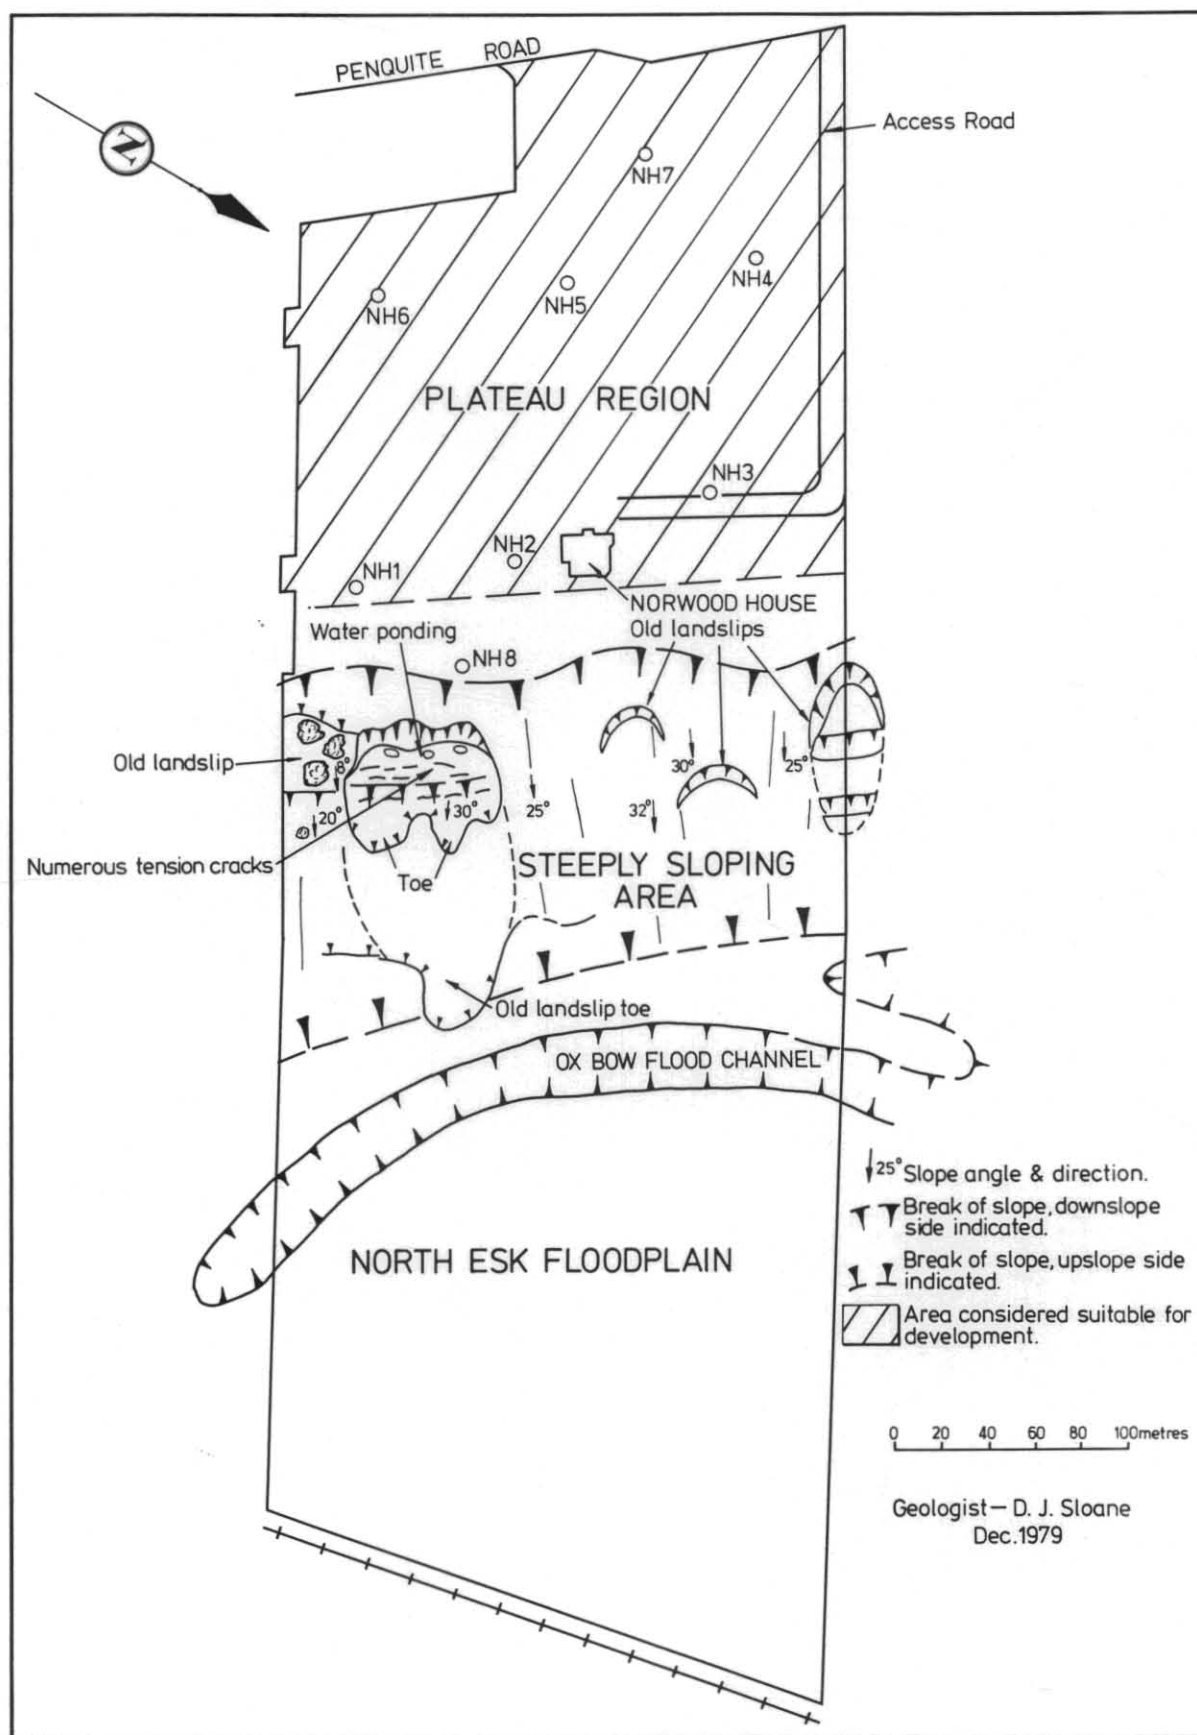
Figure 1.

The area can be divided into three distinct topographic units (fig.1). These are (1) The North Esk River floodplain

(2) The steeply sloping escarpment adjacent to and west of the floodplain

(3) The flat plateau region adjacent to Penquite Road and on which Norwood House is situated.

This area has an average slope of about 25° with some slopes as high as 32°. One large currently active landslip and several old landslips are present. The steep slopes with underlying Tertiary clay and the landslip evidence indicate that development of this area is not advisable. The area is located in Zone V of the Tamar Valley Landslip Zone Map, an area described as 'active landslips and adjacent areas'.

An active landslip has occurred on the steeply sloping area adjacent to Norwood House. The slip can be attributed to water originating from a clayey sand aquifer at a depth of 12.6 m to 14.5 m below the plateau area adjacent to Norwood House. This water has saturated the clayey Tertiary sediments and slope mantle deposits which undoubtedly exist, which when

combined with the steep slopes of the area, has caused instability. The removal of trees is also a major contributing factor, as the area where the active landslip has occurred has been cleared of trees, while the adjacent area has not. The adjacent area contains old landslips which appear to have stabilised, probably due to the eucalypt vegetation. The currently active landslip appears to be a reactivation or a head scarp failure of a much older slip which has large pine trees growing on the old toe. These trees are estimated to be about 100 years old.

Referring to previous comments, it is undesirable to develop the steeply sloping area adjacent to Norwood House. The stability of the area can be maintained and attempts may be made to stabilise the existing active landslip. This landslip has occurred in an area along the hill-slope which has been cleared of trees. This is considered to have been a contributing factor in the development of this landslip. It is therefore unwise to remove any trees from the steeply sloping area. More trees could be planted in the old landslip areas and certainly on the active landslip area. Species of eucalypt, pine and oak trees are suitable but the advice of the Department of Agriculture or Forestry Commission can be sought. Obviously a quick growing, deep rooting tree is required which can grow in a variety of conditions, including wet seepage areas. Surface drainage of the active landslip will also contribute to stabilisation. Some ponding has occurred at the base of the headscarp. This should be drained from the area and drainage maintained to prevent water accumulating on the slip area. The aquifer intersected by drilling should intersect the hillslope in the region of the water ponding, assuming the aquifer is horizontal. Efficient draining of this area could prevent most of the water from penetrating the slip mass.

- (1) A herringbone French drain system with rockfill and 'agpipe';
- (2) Horizontal drainage pipes, drilled to intersect the aquifer;
- (3) Lime stabilisation by drilling a grid of vertical holes over the area and backfilling with lime or a lime-clay mix;

- (4) Vertical drainage pipes drilled above the slip area to intersect the aquifer, with water to be pumped from these holes;
- (5) Pile driving, soil anchors etc.

A thirty metre zone in which development should not occur is required, west from the upper break of slope of the steeply sloping region.
