1979/53. Notes on the Aerodrome Hill landslip area

D.J. Sloane

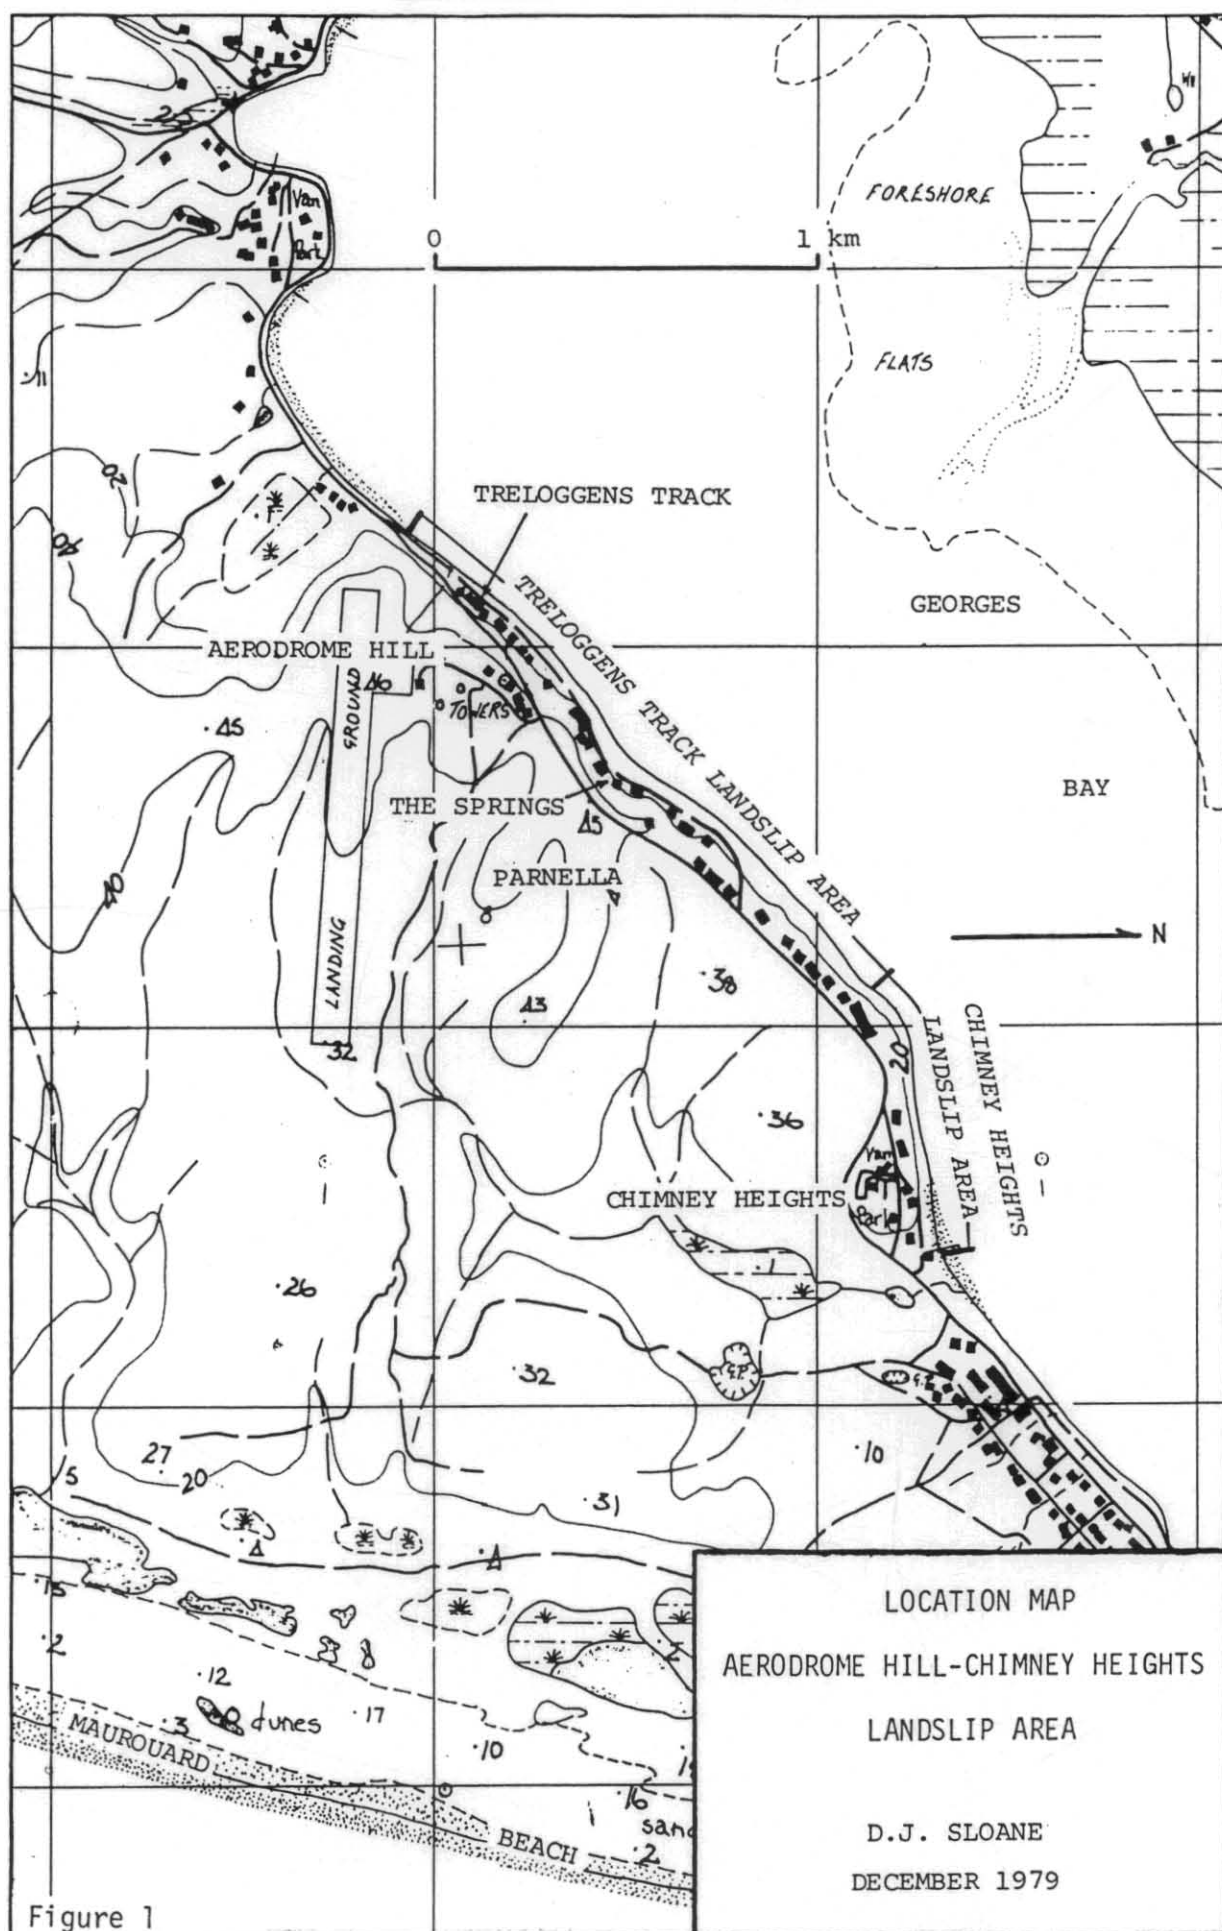
The landslip zone can be divided into two distinct areas (fig. 1).

The first, or Treloggens Track area, is characterised by some minor recent slip activity and failures of the semi-rotational slump movement type. One large landslip affecting Treloggens Track and two adjacent holiday homes has been periodically active for at least the last ten years. When Jennings and Mortimore inspected this landslip in 1970, it had just reached the foreshore edge of Treloggens Track with a tension crack on the opposite side of the road. The base of the landslip is apparently located on the grey clay exposed at sea level. The toe of the landslip encroaches onto the beach in a distinct bulge, subsequently eroded by wave action. Numerous tension cracks and well defined near-vertical arcuate head scarps and side scarps are prominent features. There is evidence of a much older headscarp located to the rear of the foundations of the holiday home which has been removed. Renewed activity of this old scarp was shown by a 50 mm vertical displacement tension crack in this region during mid-1979. It therefore appears that the well defined and currently active slip involves parasitic failure of the toe of this much older landslip. Another similar large slip has occurred in a section of bush near the northern end of Treloggens Track. Further north, the landslips are not as distinct and arcuate in nature but numerous tension cracks are present towards the foot of the steeply sloping region. The area known as The Springs is considered to be a very large old landslip. This feature is recognised by the disruption of the general hillslope by a large 'amphitheatre' embayment. The area within the embayment is low lying, of shallow slope and swampy. The large seepage area probably originated from exposure of an aquifer in the old headscarp region. This old landslip could have originated some 5000 years ago towards the end of the Last Glacial period. Some small old slip blocks occur further to the north. In one case, a slip block has a large eucalypt growing on it, but leaning at a steep angle towards the slope, a result of the old rotational movement. Adjacent to this area is a section of the Crown Reservation which has retained its natural vegetation. This area shows no sign of movement, with a good interlocking root mat exposed at high water mark. Adjacent to the north of this stable area is a very large landslip, partly rotational and partly slab and mudflow in type. There appears to be an upper and a mid-slope gravel aquifer at this slip. This large landslip approximately marks the boundary between the two landslip areas. The Treloggens Track area shows little foreshore erosion. Only one area shows foreshore cliffed erosion and this occurs at the southern end of The Springs where the side-scarp of the old landslip intersects the regional south-west facing slope.

The northern or Chimney Heights landslip area is a more recent and obvious failure area, with common bare cliffs, mudflows, debris slides and planar slab failures exposing the clay and gravel in the slope face. The majority of the failures seem to have become more obvious during the last three years and several headscarps have extended into the adjacent building allotments. Marine erosion is a contributing factor to slope failure. The base of the slope has been undercut by wave erosion resulting in near vertical clayey gravel cliffs. These cliffs have been deeply gullied by runoff and mudflows from the overlying clay. The main aquifer occurs at

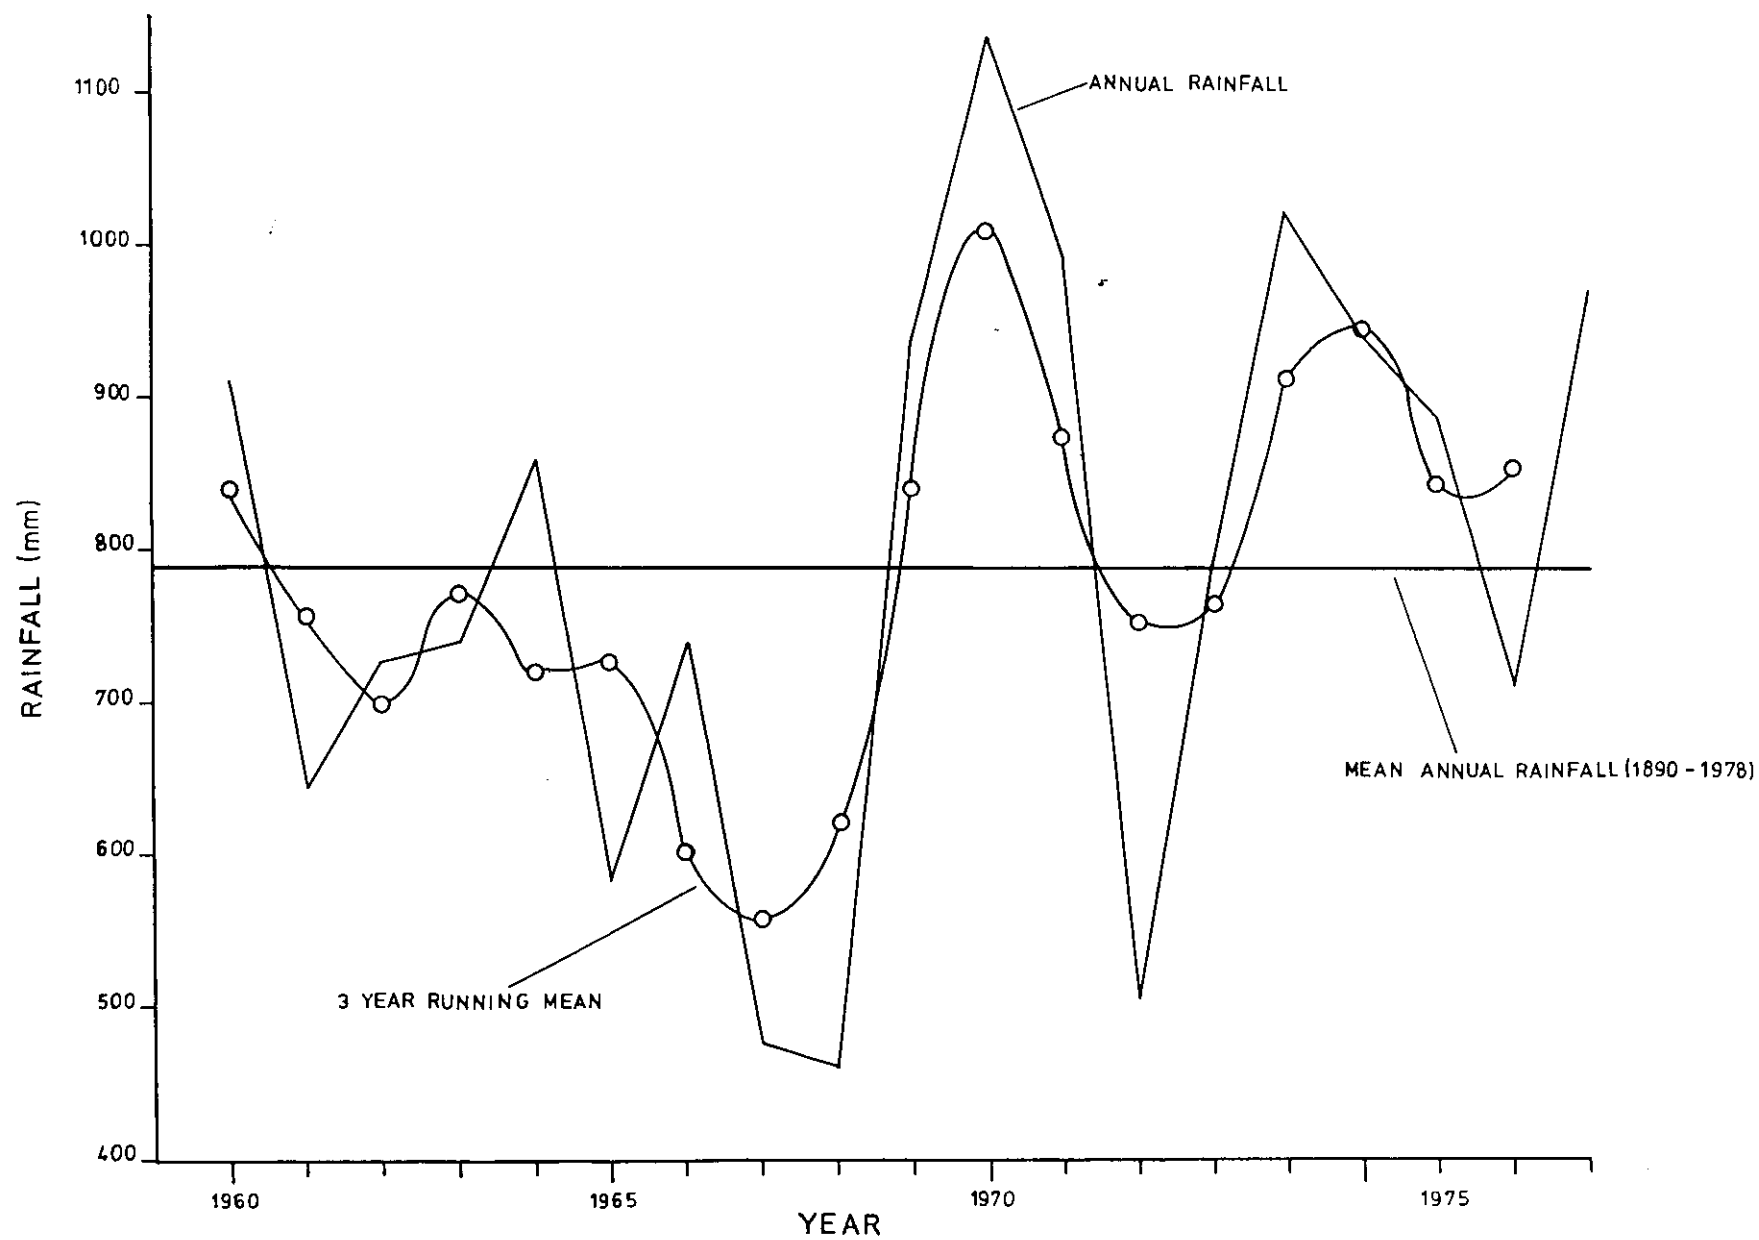
Figure 2. Twenty-year rainfall record, St Helens

For eight of the past ten years, total yearly rainfall has been equal to or greater than the mean rainfall for the period 1890-1978 (fig. 2). There has been a noticeable peak over the last five years. Of the preceding ten years (1959-1969), seven have been below average. This suggests that the heavier rainfall over the past ten years, and especially the last five years, must contribute to the landslip problem to a considerable extent.

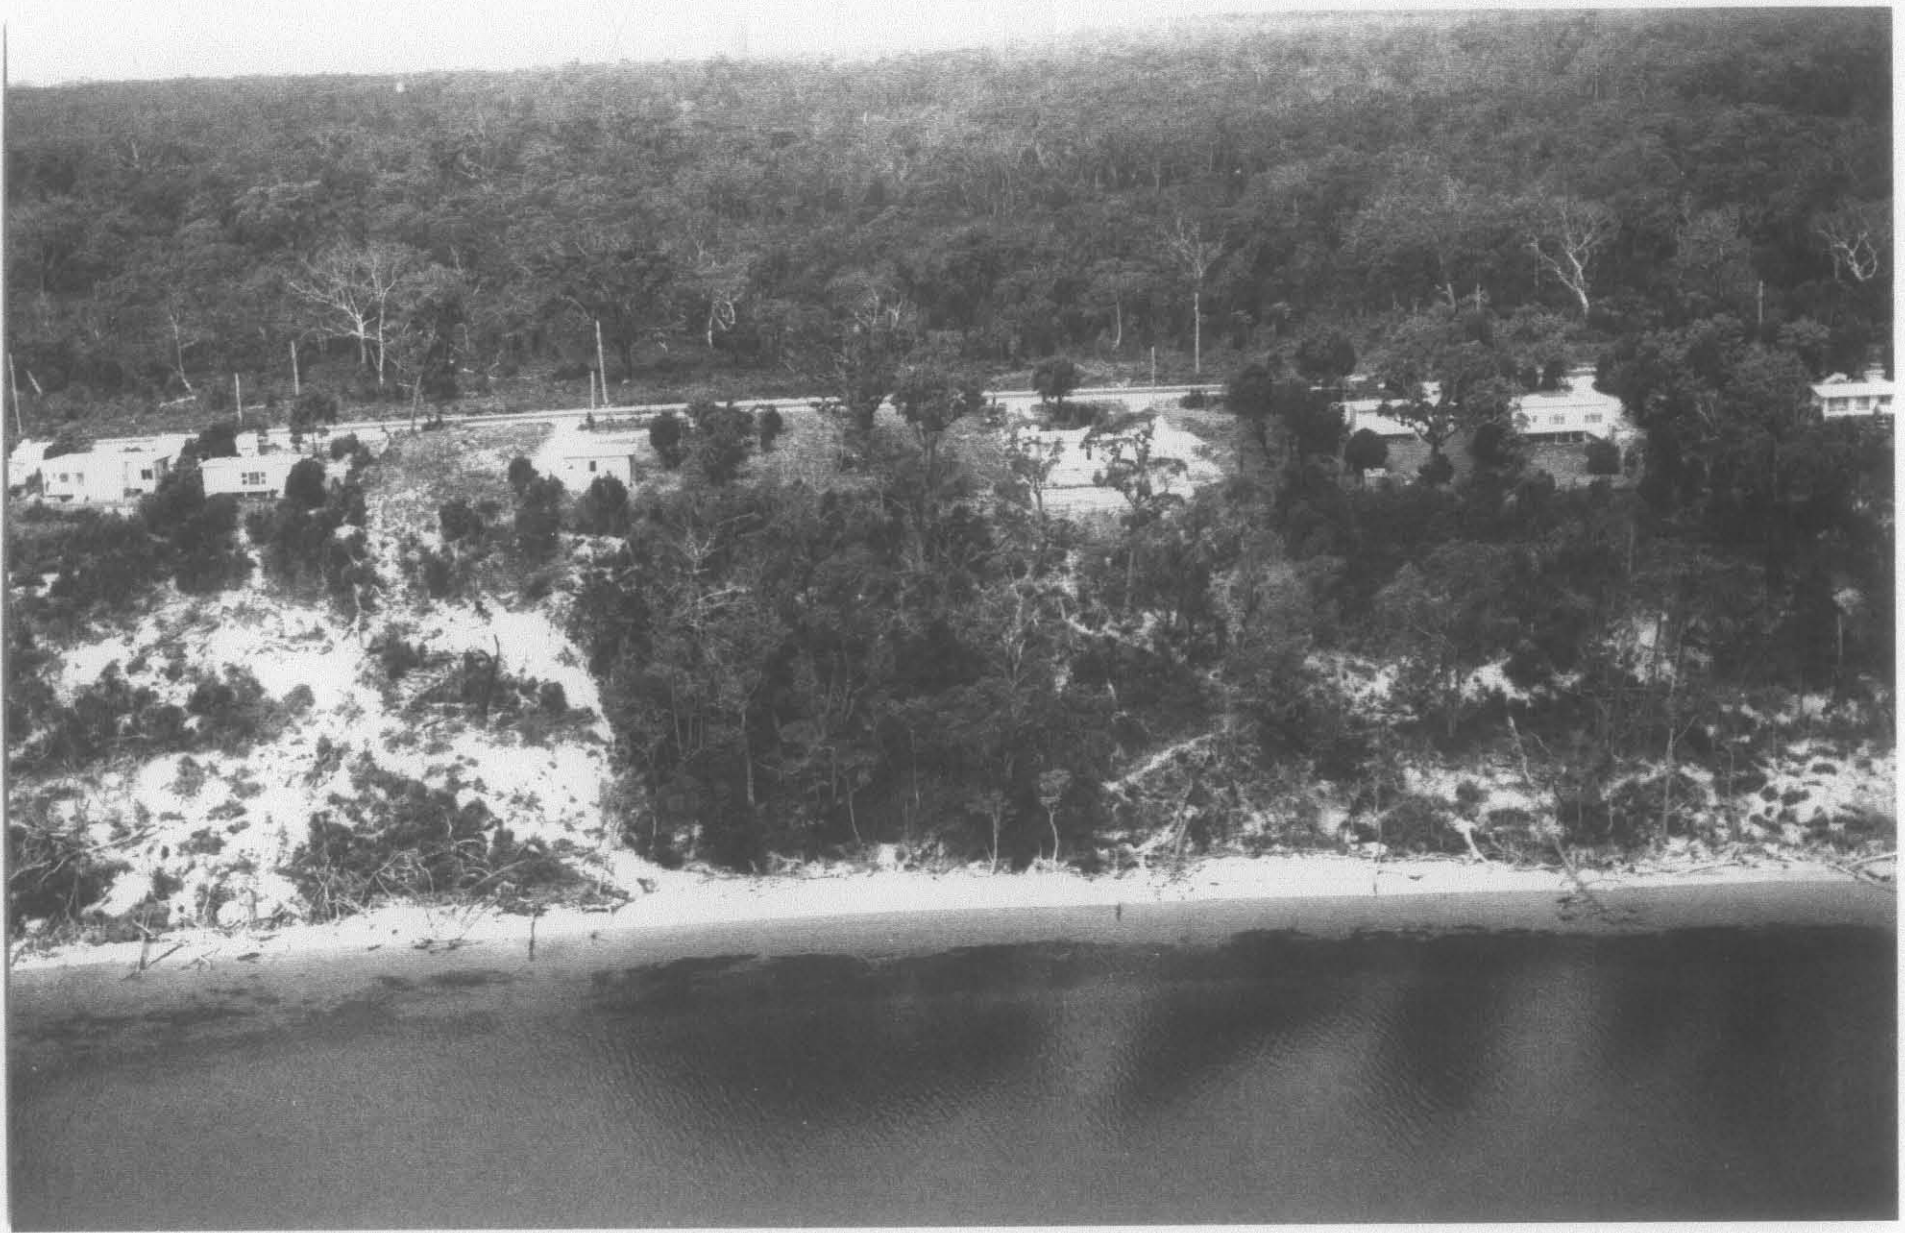
The removal of vegetation from the Crown Reservation along the foreshore and house allotments has definitely contributed to landslip failure by the loss of root binding support and the introduction of water normally taken up by plant transpiration and evaporation.

Areas of instability where vegetation has been partly removed. The central region still retains the natural vegetation and stability.

The planting of trees in areas of instability. Species of eucalypt, oak, willow and pine are suitable, but the advice of the Department of Agriculture or the Forestry Commission should be sought. Obviously deep rooting and quick growing species are desirable, but these must be able to withstand swampy conditions. In other areas all trees should remain wherever possible. The removal of trees is controlled by Part IV, Division 5, Section 45 of the Tasmanian Building Regulations, 1978, and will consequently apply in the landslip B areas between St Helens Point Road and the foreshore.
