**TASMANIA DEPARTMENT OF MINES
UNPUBLISHED REPORT 1981/56**

Investigation of road movements on Rosevears Drive

by W. C. Cromer

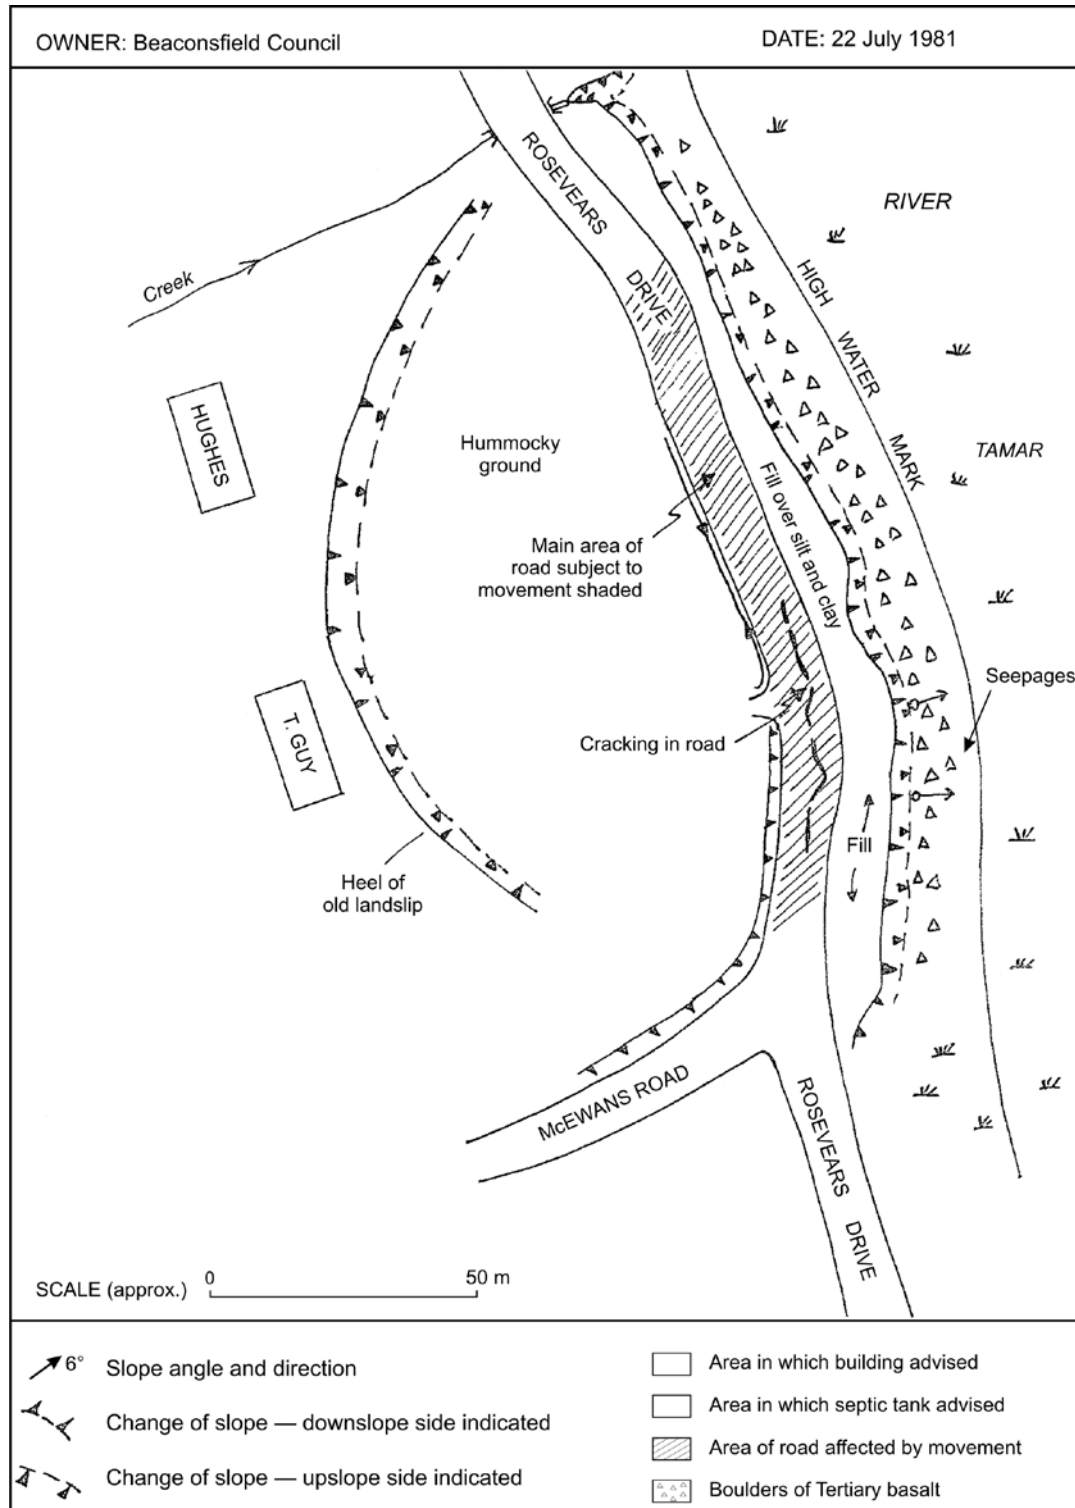
Figure 1

The general layout of the area recently visited is indicated on Figure 1. An old arcuate landslip scarp occurs above the road, and extends from the road intersection to the creek alongside Hughes' residence. The scarp is stable, with no obvious signs of recent movement. Between the scarp and the road, the ground in places is hummocky, and underlain by brown pebbly silts. These materials are exposed in the road cuttings and in an eroded channel cut at river level at the outlet of the culvert immediately north of Hughes' residence.
