1983/12. The erosion of granite-derived soils in eastern and north-eastern Tasmania, with reference to forestry operations.  
Part 2: Investigation of erosion at forestry coupe EL1,  
Chain of Lagoons

D.J. Sloane

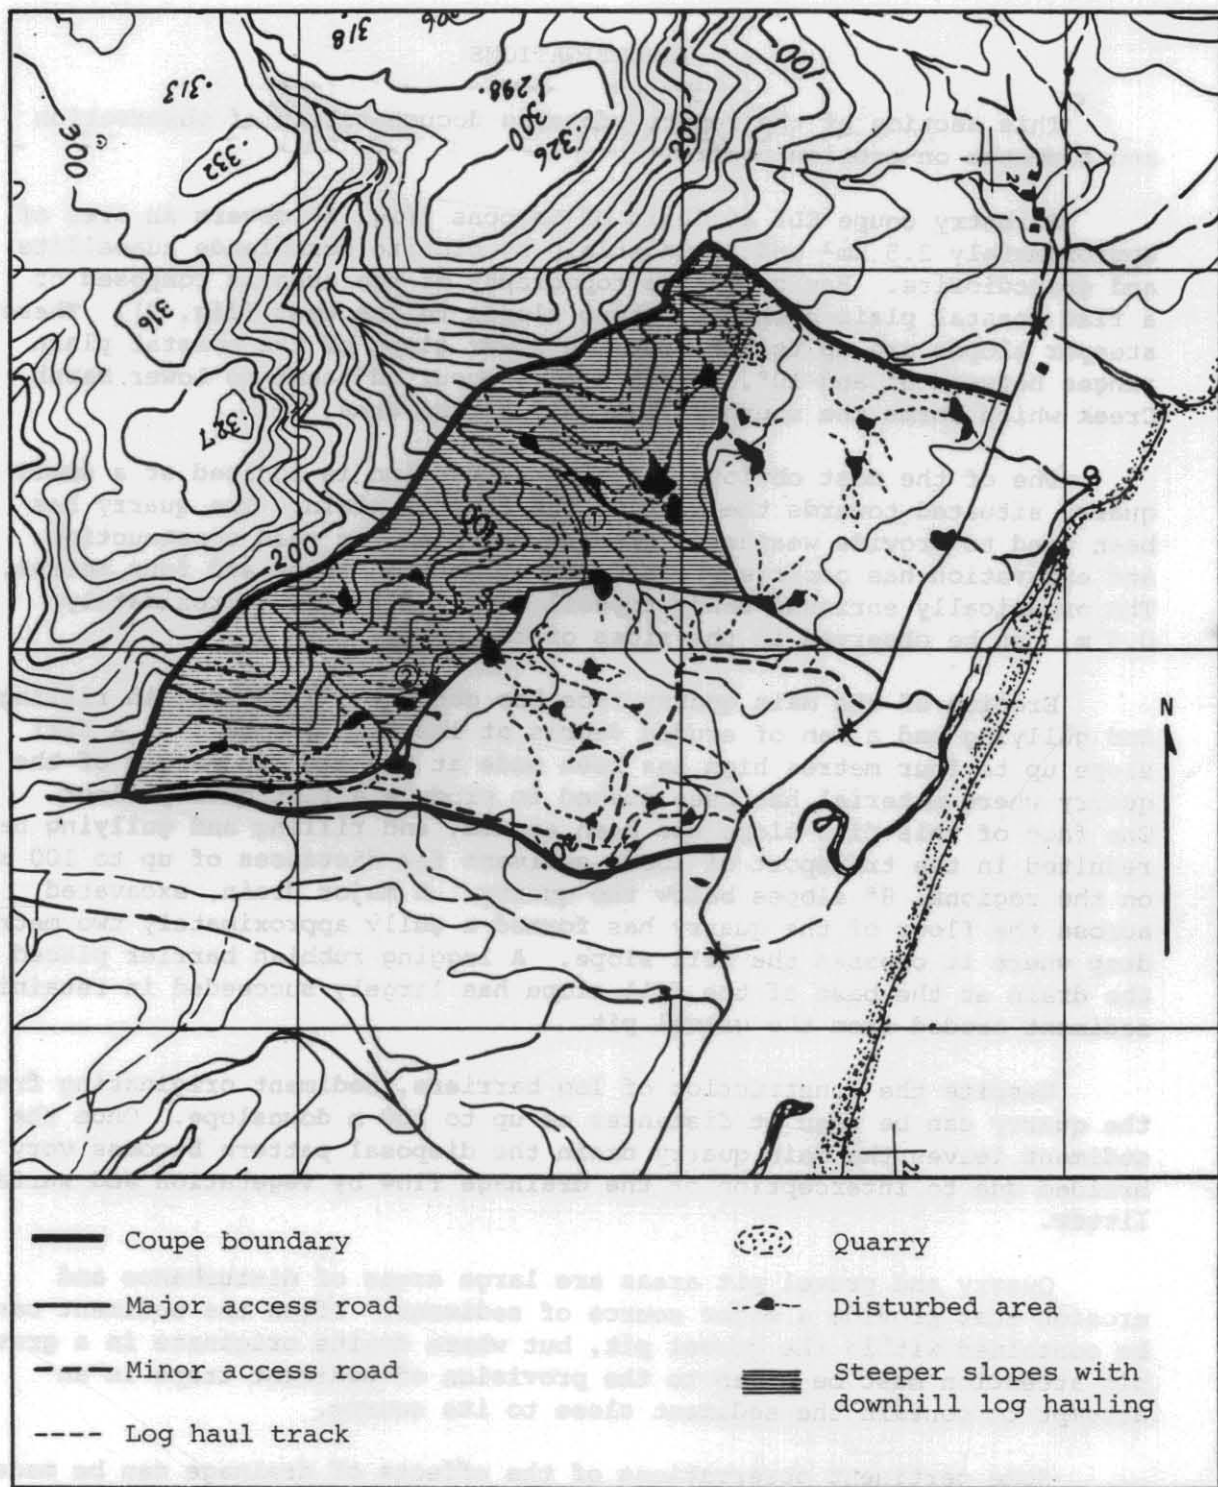
Figure 2. Map at EL1 forestry coupe showing snig tracks and major access roads. Good location of major tracks along the foot of the steeper slopes. Major snig tracks generally follow ridges. Gullyng generally occurs where snig tracks depart from this pattern, e.g. along road (1) and on slopes above. Gullyng also evident in area (2) where major snig tracks converge and snig tracks close to large landings follow contours, consequently collecting runoff from large areas upslope.

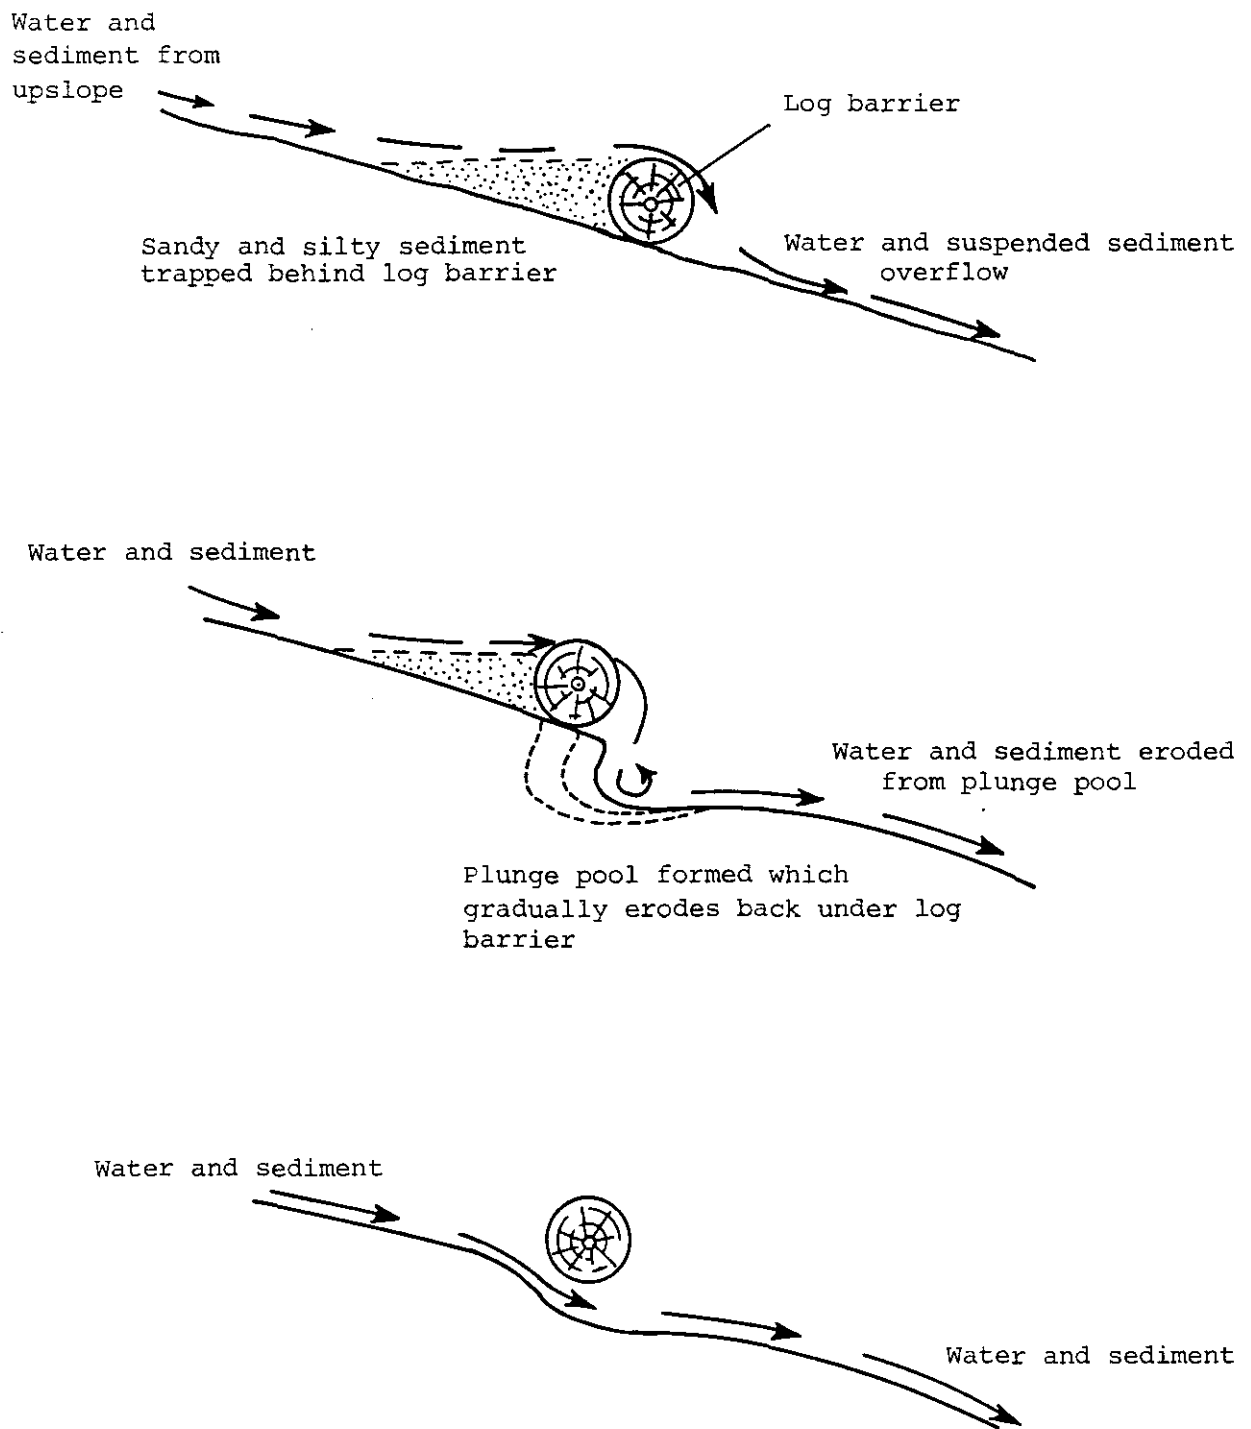
Initially tree heads provide good barriers, the leafy fronds providing a good sediment trap, but once the leaves dry out and fall off, or burning occurs, many of the remaining stems and branches are generally not in contact with the ground. Additional examples of failed barriers occur where logging debris has been placed in small gullies in an attempt to prevent further erosion. In many cases such barriers have not worked and gullying has continued, as it is difficult to place the logging debris in close contact with the base of the gully to provide a continuous barrier. This case will be mentioned later when snig track drainage is discussed. Logging debris barriers are therefore not favoured unless they are used as a supplement to other methods.

Figure 3. Cross-sectional diagram showing stages of the effectiveness of a log sediment barrier.

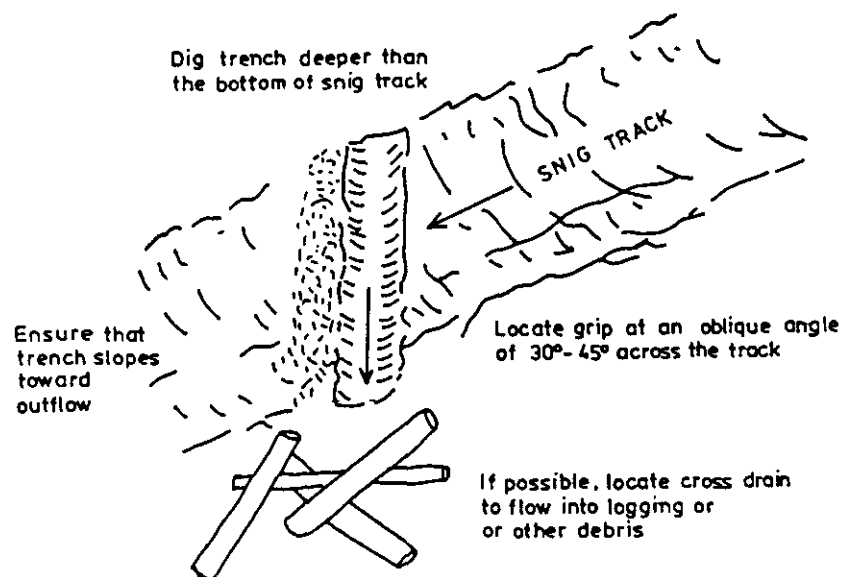
Figure 4. Diagram showing proper grip construction. Logs placed in the snig track are generally not sufficient to provide a water and sediment barrier.

The construction of grips is essential on all snig tracks and large machinery ruts, especially in areas of downhill snigging. The spacing of these grips as indicated in the 'Guidelines' (1981) appears adequate, provided they are carefully constructed as per the diagram (see fig. 4). Perhaps the important feature is to dig the grip deeper than the bottom of the snig track. Logging debris is not favoured as the sole means of providing a water and sediment barrier for reasons previously discussed, but debris can be used as an adjunct to grip construction, and is considered to be very effective when used in conjunction with other drainage methods. Due consideration must be given to the direction of discharge of grip drainage, as there is little benefit if runoff is directed into an adjacent track. Scoops could also be constructed where practical, especially near the discharge points of major snig tracks.

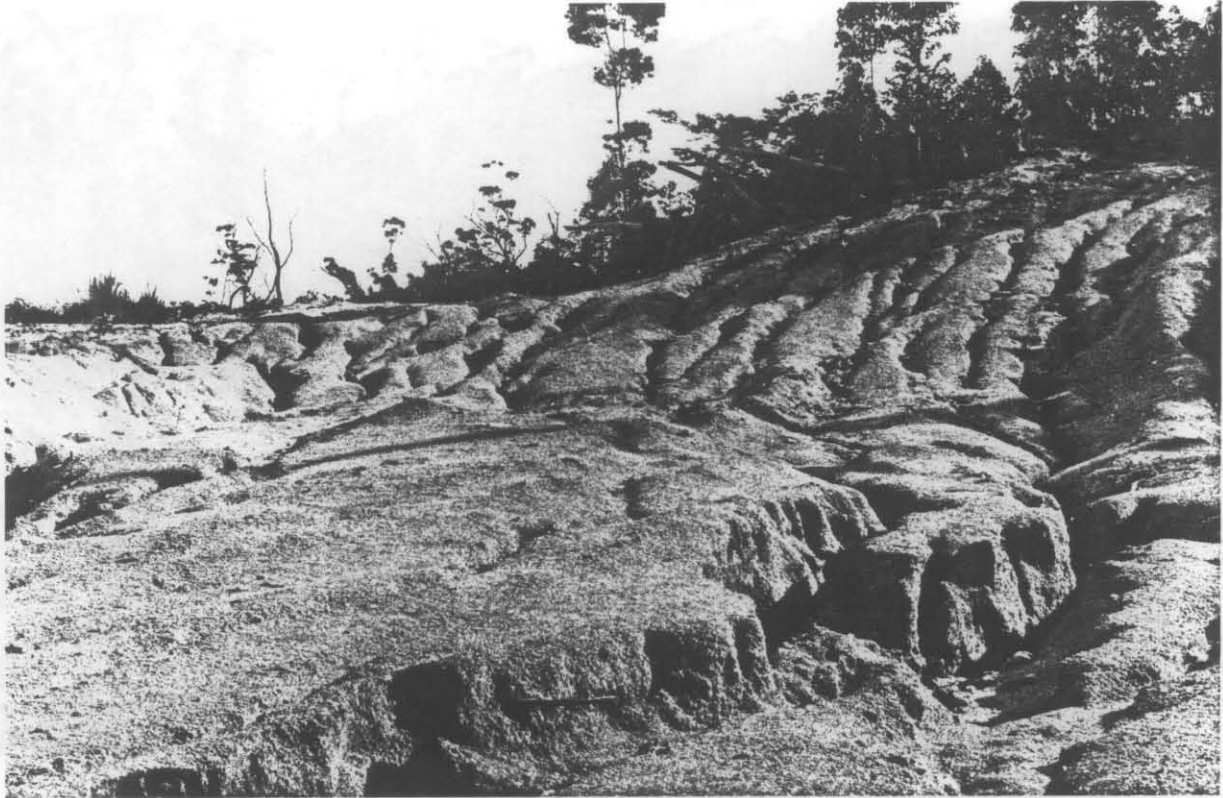
Erosion of the main quarry face has occurred, resulting in rilling and gullying and a fan of eroded debris at its base (Plate 1). A fill slope up to four metres high has been made at the eastern margin of the quarry where material has been pushed to produce a flat quarry floor. The face of this fill slope has been eroded, and rilling and gullying has resulted in the transport of loose sediment for distances of up to 100 m on the regional 8° slopes below the quarry. A major drain, excavated across the floor of the quarry has formed a gully approximately two metres deep where it crosses the fill slope. A logging rubbish barrier placed in the drain at the base of the fill slope has largely succeeded in retaining sediment eroded from the gravel pit.

Plate 1. Gullying in weathered granite at the main quarry.

Quarry and gravel pit areas are large areas of disturbance and erosion that provide a major source of sediment. Often the sediment can be contained within the gravel pit, but where drains originate in a gravel pit attention must be given to the provision of sediment traps in an attempt to contain the sediment close to its source.

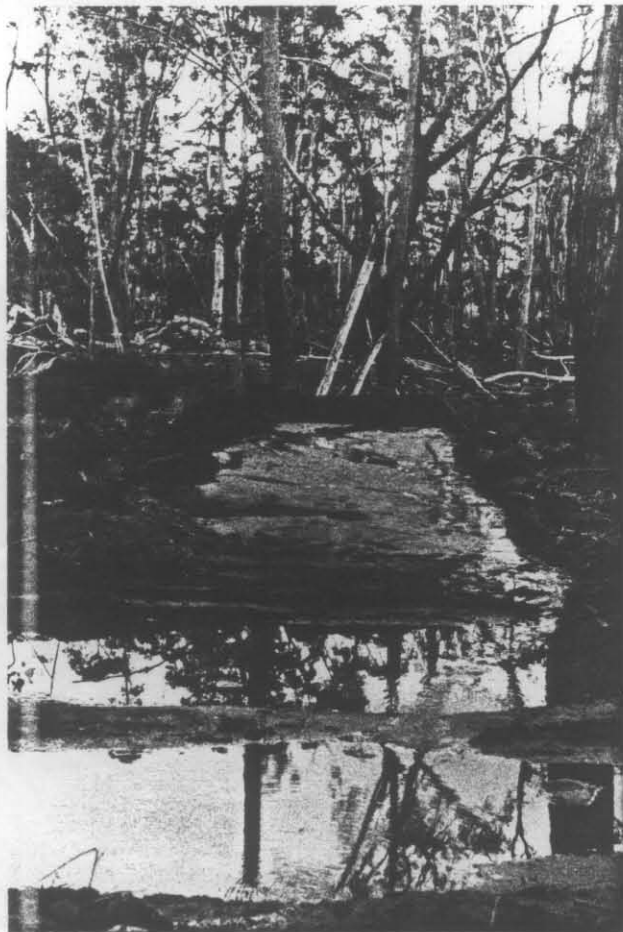
Plate 2. 'Scoop' or roadside push-off area (Central Highlands) in an area of easily eroded windblown sand. 'Scoop' acts as settling pond providing a good sediment trap.

The construction of bulldozer scoops (Plate 2) at the end of short side drains is desirable. These scoops trap and retain sediment close to the source and prevent distribution in a broad fan. Scoops appear to be easy to construct and inexpensive, being formed by the bulldozer operator dropping the blade to produce a small dam, the walls of which are formed by the debris pushed in front of the blade. Logging debris can also be used in conjunction with the scoops, so that any overflow will be intercepted by the debris. Two or three such scoops may be constructed to provide a drainage succession where there is a large area contributing runoff and sediment.

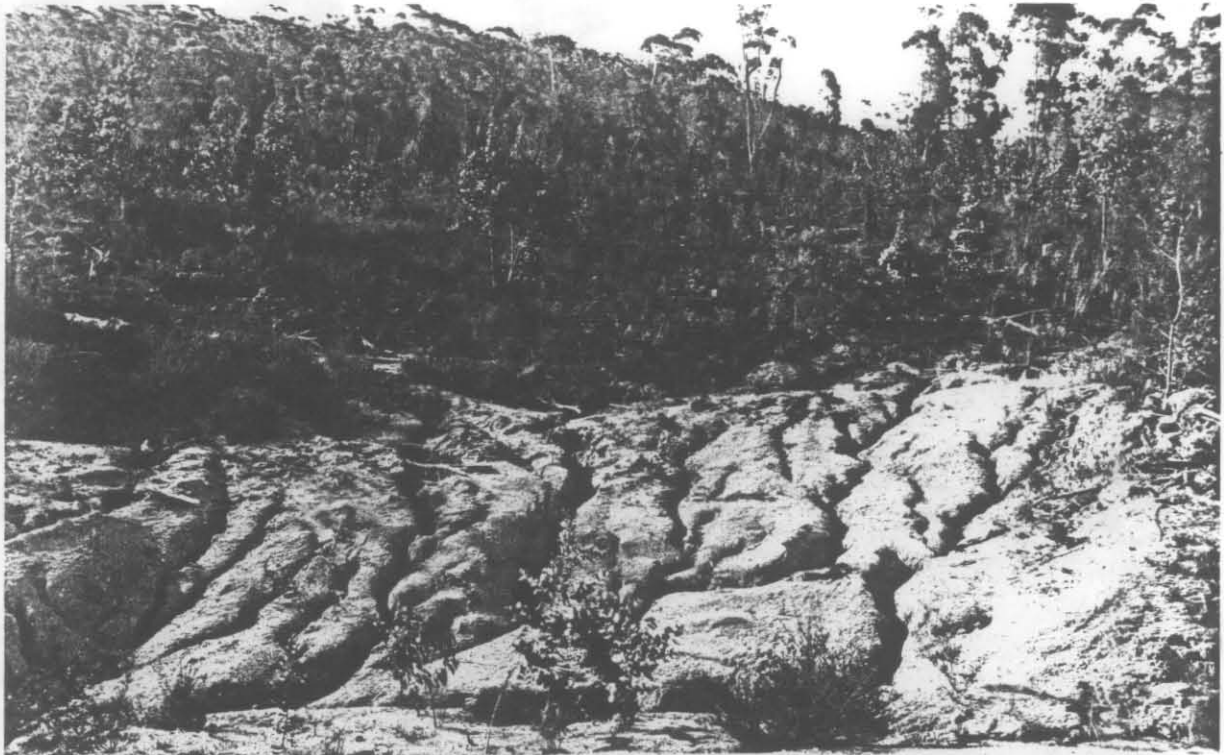
Another source of erosion and sediment can frequently be found adjacent to roads where small excavations have been left after providing fill for road surfaces (Plate 3). These, together with road embankments, are frequently rilled and gullied in the head and side scarps. Topsoil is absent in such areas and re-vegetation is slow or non-existent.

Plate 3. Gullying on embankment excavated for road fill and surfacing.

As they are prone to erosion, roads, culverts, embankments, and roadside excavations act as major sediment sources. Embankments and roadside excavations for road fill and surfacing material should be kept to a minimum and attention must be paid to the drainage and restoration of such features. Embankments in granite areas can be constructed quite steeply, as the material is relatively stable with regard to landslipping and slumping, whilst steep embankment batters reduce the area of weathered granite exposed. Restoration of embankments, gravel pits etc. is desirable, but limited by cost. Replacing topsoil or mulching, together with seeding and tree planting, not only reduces sources of sediment and erosion, but also reduces the cost of maintenance of culverts and drains. This type of restoration is often cost effective and the seeding of roads reduces the general maintenance drastically and preserves the access and drains for further use, little work being required when the area is to be re-harvested (Haupt and Kidd, 1965; Kochenderfer, 1970).

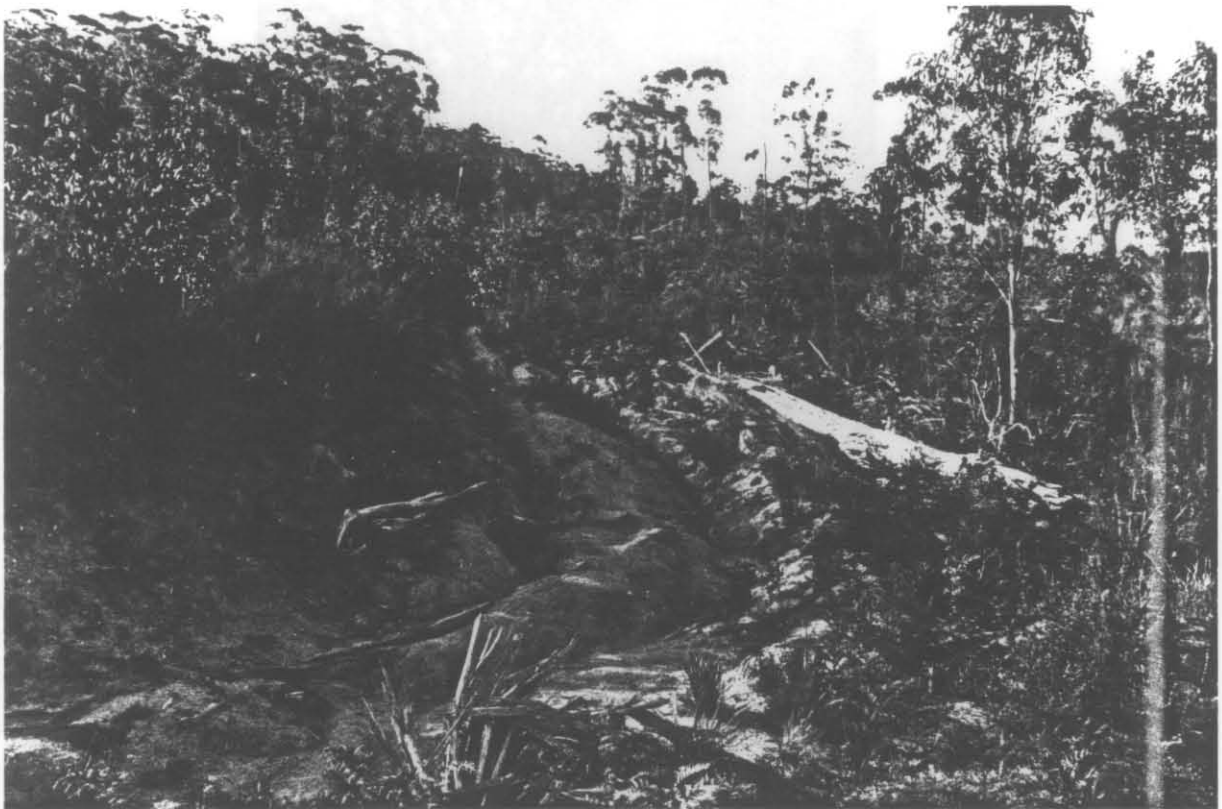
Gullying is the main observable evidence of erosion at EL1. Virtually all gullying is confined to snig tracks or machinery ruts on the middle to lower slopes (Plate 4). 'Grips' or cross drains have been constructed across the snig tracks and gullies to divert water and prevent a downslope increase of water flow and velocity which is responsible for the lower slope gullying. Few of these cross drains work efficiently. In some cases the cross drains or grips merely divert the water to an adjacent snig track or machinery rut, allowing unobstructed downhill flow of water. At one location, parallel machinery ruts following a small depression on the lower slopes have resulted in gullying up to two metres in depth.

Plate 4. Gullying initiated along wheel and track ruts.

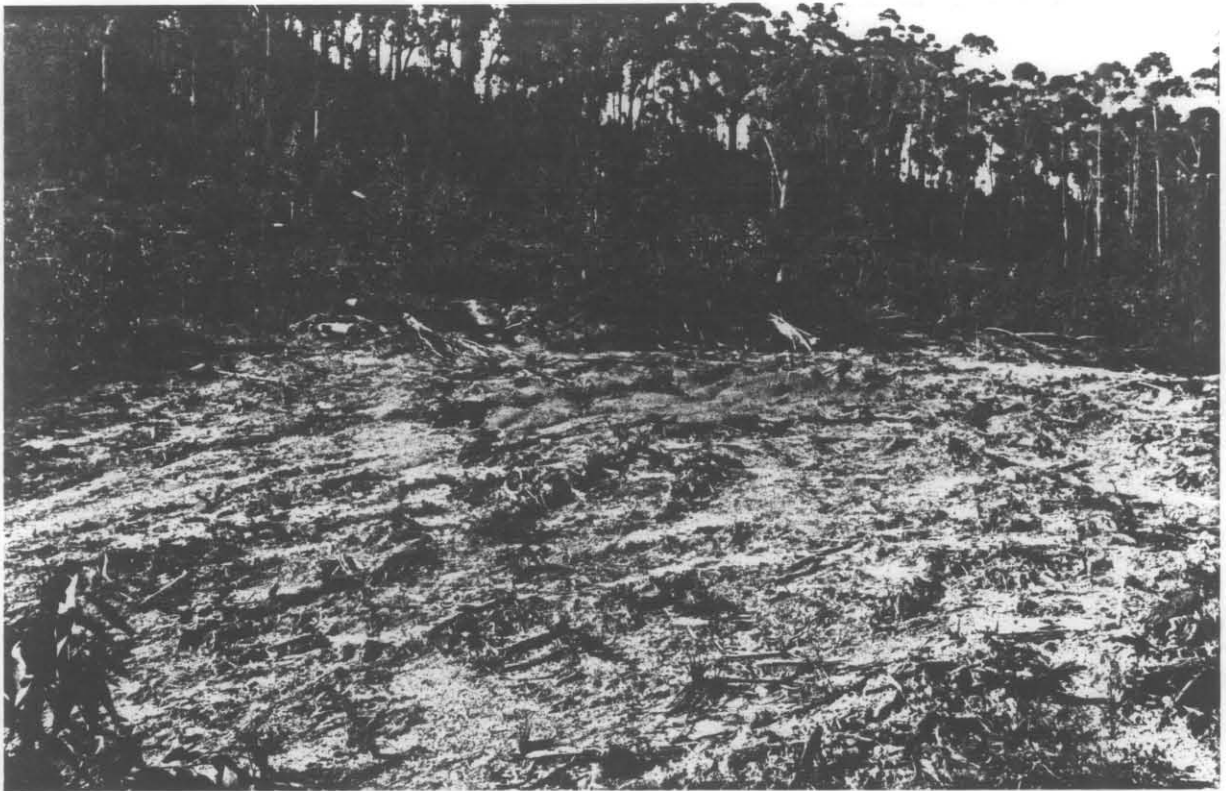
Landings in the area do not appear to have eroded to any great extent (Plate 5). Landings are generally located on flat areas and on ridge crests, with drainage being diverted away. Landings do provide a large area of ground disturbance but the main problems appear to be associated with the difficulty of revegetation due to the loss of topsoil.

Plate 5. Large area of disturbance around log landing with little revegetation. A major source of sediment runoff if drainage and location is inadequate.

Landings should be located on high ground or ridges and attention to landing drainage is important. At EL1 landings are properly sited and little runoff and sediment dispersal is evident. This is due to the choice of location and the fact that the area is 'randomly' disturbed. In consequence it has a high retention storage with few major ruts available for uninterrupted water flow. Problems can occur on poor sites and landings may provide large amounts of sediment, especially as re-vegetation of these areas is slow or difficult (Plate 5).
