1984/42. House damage at 'The Grange' Kempton

R.C. Donaldson

House damage at 'The Grange' Kempton is not due to an active geological fault, but to a variable thickness of expansive clay soils which had been subject to localised wetting.

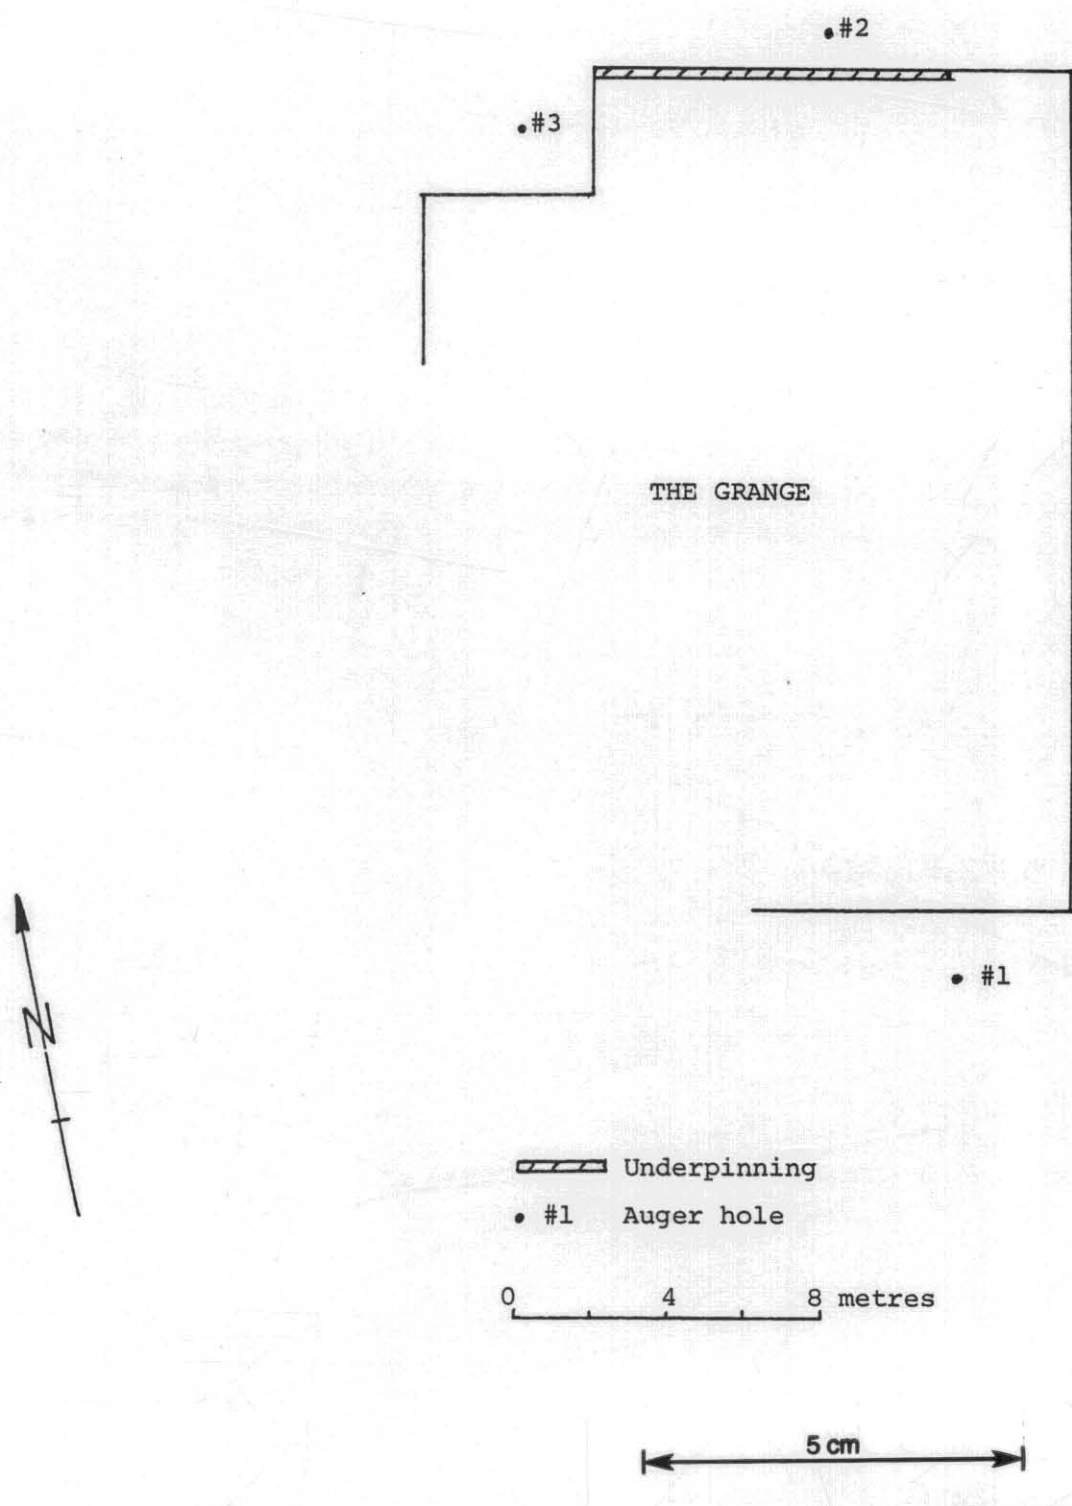
Figure 1. Location of auger holes.

A series of shallow auger holes was recommended to identify the nature of the soils beneath the foundations. Three holes were drilled; detailed descriptions of material encountered are contained in Appendix 1 and their locations are shown in Figure 1.

Results of drilling show that the house is underlain by Triassic sandstone and its weathering products rather than Jurassic dolerite which crops out on the hill immediately behind the house. However, some dolerite rock fragments were noted in the upper section of Hole 2 and probably represent a veneer of transported material from further upslope. The depth to bedrock is variable over the site, ranging from about 1.0 m in Hole 1, to approximately 2.5 m and 3.5 m in Holes 2 and 3 respectively. As may be expected, the areas of severe cracking are associated with the thicker soil profiles overlying bedrock.
