1984/44. Seismic survey at the Craigow dam, Cambridge

W.L. Matthews

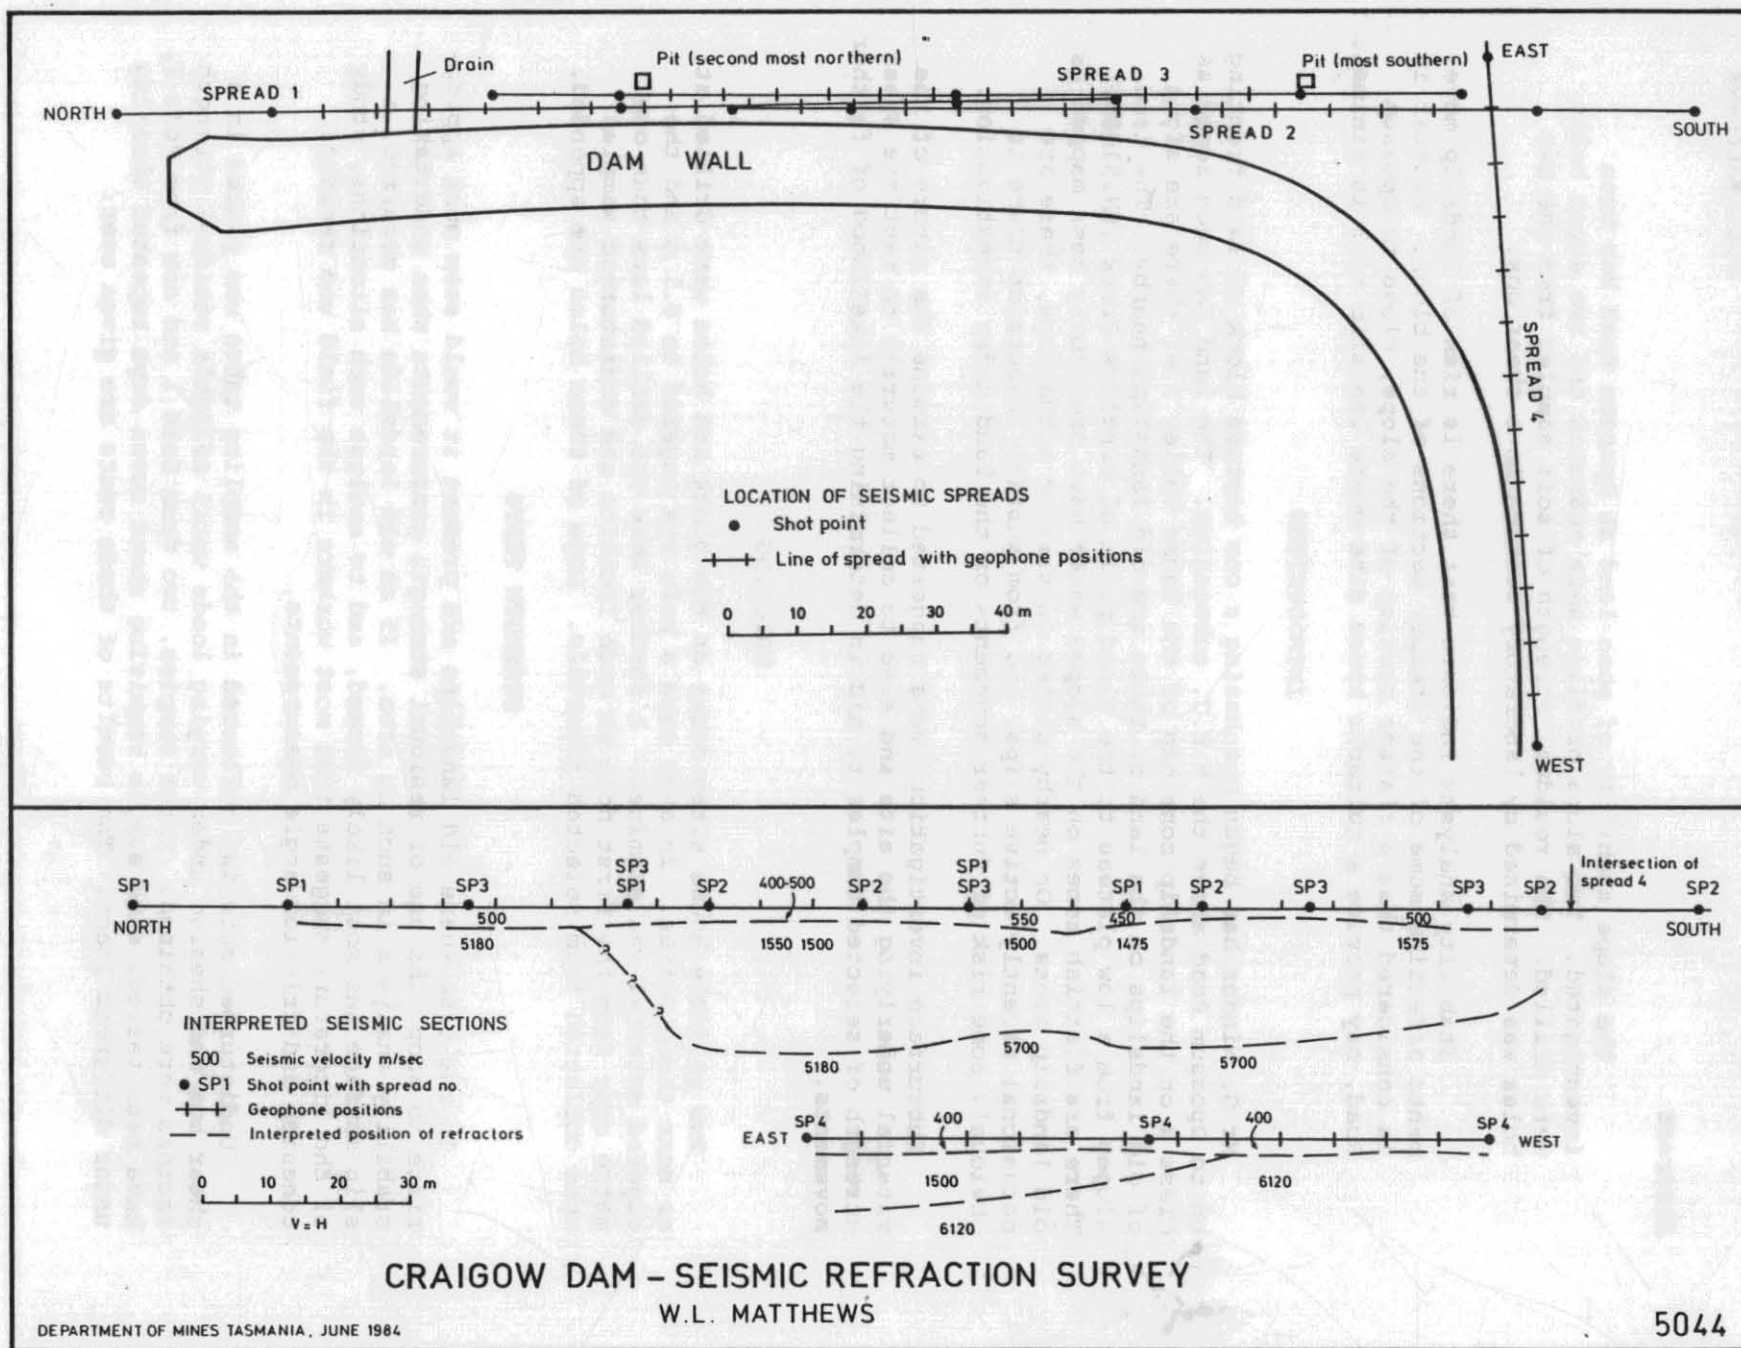
Figure 1

Four seismic spreads comprising twelve geophones with a geophone spacing of 7.5 m were fired in the positions shown on Figure 1. As there was insufficient overlap between spreads 1 and 2 in the zone of particular interest, a further spread was fired in this area.

Three general groups of seismic velocities were indicated in the Craigow survey (fig. 1). The material with a velocity range of 400-550 m/s is unconsolidated and unsaturated material up to about three metres thick. This is the material in which the test pits downstream from the dam wall have been dug. The material with the velocity of 5180-6120 m/s is almost certainly dolerite, as the other rock type in the area (Triassic sandstone and shale) is unlikely to have such a high seismic velocity.

There are suggestions that this material may have a slightly higher velocity range in the southern part of Spread 2. If this is a higher value, then it may make the first of the above alternatives a less likely prospect. Test pits dug to investigate a possible further irrigation dam upstream near Cross Rivulet have penetrated deeply weathered Triassic sandstone and shale, and this may extend to the valley of the present dam. Dolerite occurs on each abutment of the dam, so this rock cannot be ruled out as possibly underlying the whole of the dam wall.

The permeability of weathered Triassic sediments and dolerite can be large enough to allow significant leakage, while Tertiary to Quaternary sediments can contain sand or gravel horizons which may result in water loss. It will not be economic to attempt to install a cut-off to solid bedrock to prevent leakage through the material with the intermediate seismic velocity because of the thickness of the material.

Ensuring that the storage area has an adequate clay blanket appears to be the solution with the most likelihood of success, as well as having good prospects of being the cheapest method. Drill holes and test pits in the storage area to date have encountered good thicknesses of clay at most points. It may be only where the deepest excavations were made to construct the dam wall that would require the placement of a clay blanket.
