1984/50. A brief outline of slope stability problems at Savage River Mines

A.T. Moon

Abstract

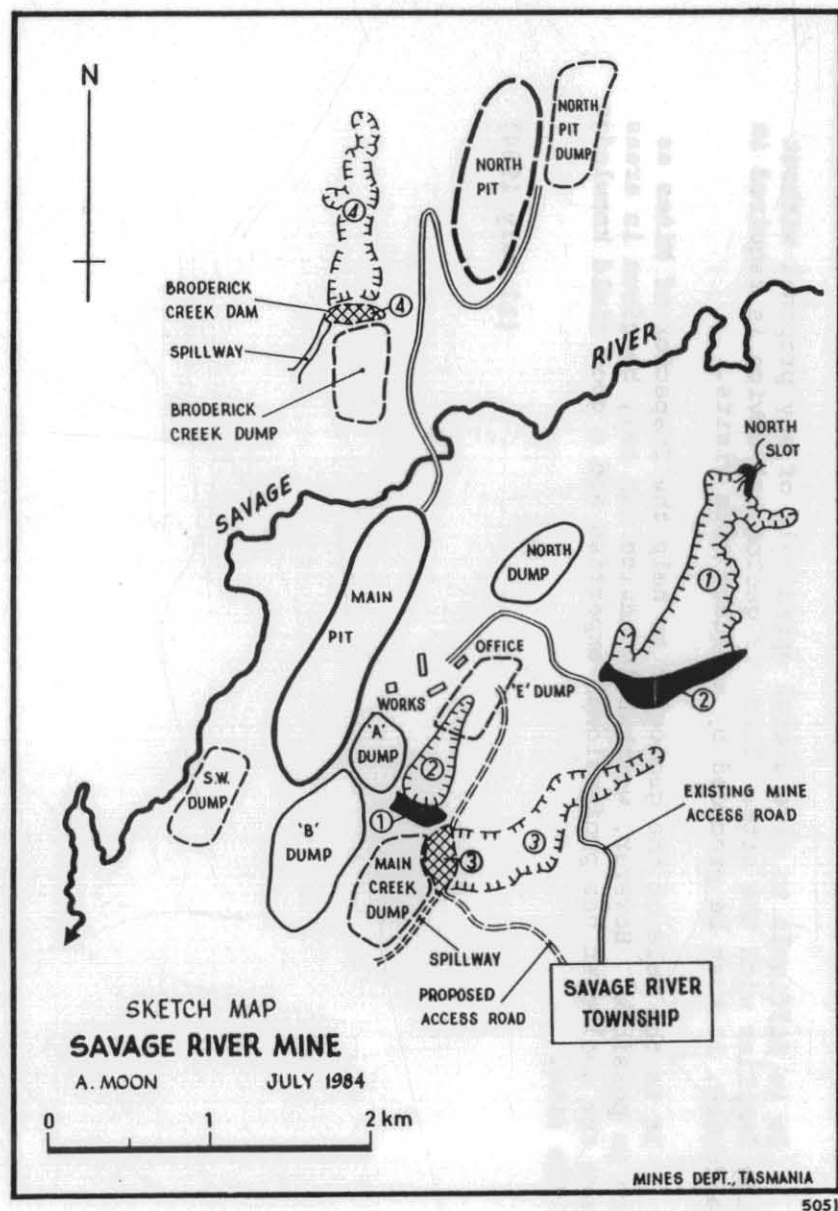
The locations of major waste dumps are shown on Figure 1. Of the eight dumps shown, North Dump, 'A' Dump, and 'B' Dump have been completed. No major stability problems are anticipated with these completed dumps. Surface drains prevent water from 'B' Dump entering the southern end of the Main Pit and these drains should be regularly maintained.

The Main Tailings Dam is located about two kilometres east of the Main Pit (fig. 1). The Main Dam is complete and the storage is filled to capacity with tailings. Water overflow is currently through the North Slot rockfill dam. It is understood that the H.E.C., who designed this dam, recommended that on completion of the Main Tailings Dam and storage, a permanent spillway should be constructed through a low saddle west of the North Slot Dam.
