UR1985-64

1985/64. Slope stability of Watchorn's Estate at Brickmakers Point, Deviot

W.R. Moore

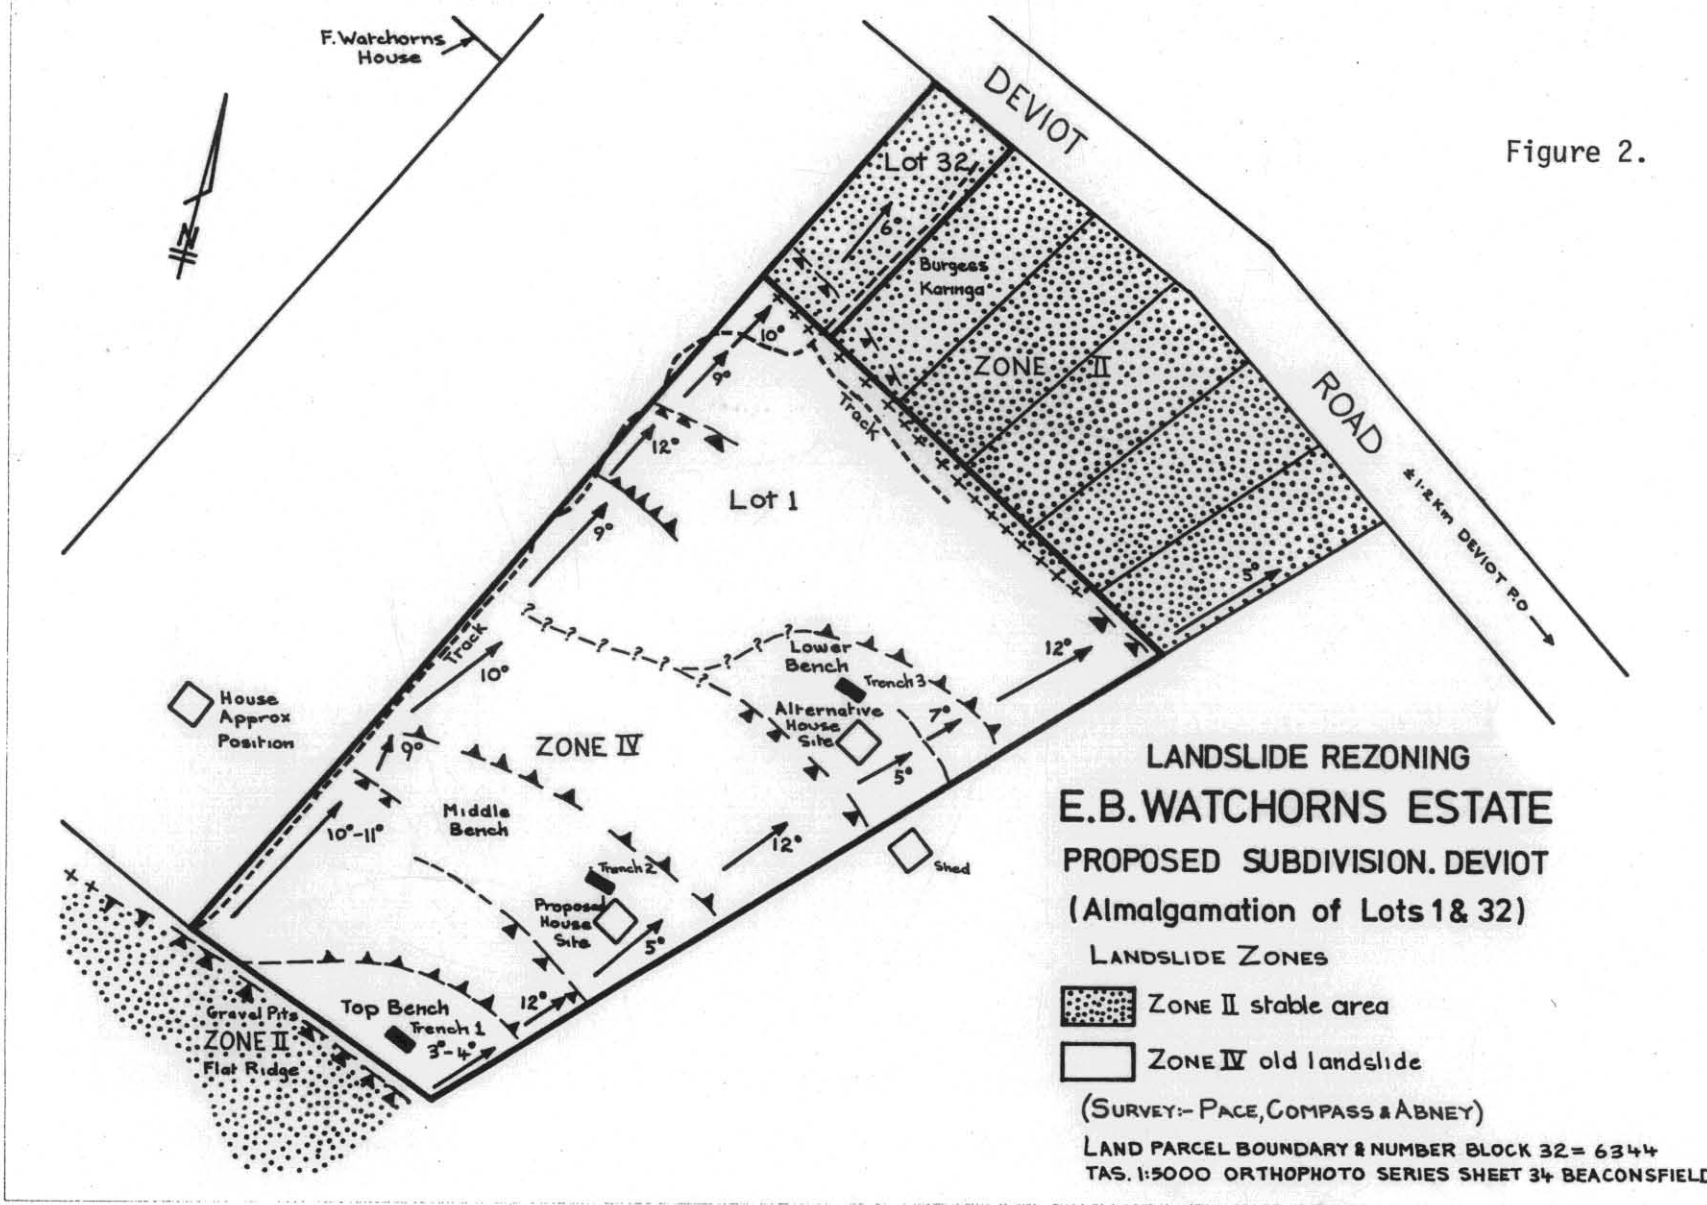
Figure 2.

Lot 1 has a complex slope, particularly along the south-east boundary, where three well-developed benches with bench slopes of 3° - 5° and fore slopes of 12° occur. Each bench has a well defined change of slope (fig. 2). Only the widest of these three benches (the middle bench) continues through to the vehicle track that follows the block's north-west boundary, the other two benches pinching out. The construction of this access track to the gravel pits along the ridge has considerably modified the landscape in this area.

This trench was dug on the highest bench immediately inside the boundary of Lot 1. The trench exposed the gravel and sand that crop out along the ridge in the old gravel pits. The gravel in the trench thickens by one metre towards the back of the bench. The underlying black and organic clay also had a dip on the interface towards the back of the bench as shown on the log.

The tilting of the gravel and organic clay layer and the fissuring of the clay indicate to the writer that the top bench was formed by slope failure, and if the other two benches are underlain by fissured clay they were also formed by slope failure.

- (1) The subsurface investigation indicates that the high bench has been formed by slope failure and is a Zone IV landslide area (fig. 2).
- (2) If clay of the Launceston Beds underlies the surface soil and cemented gravel exposed in Trenches 2 and 3 on the middle and lower benches, these benches were also probably formed by landslides. These benches therefore become Zone IV (old landslide) areas (fig. 2).

- (2) The most stable house site is considered to be on the low bench near Trench 3. The house foundations should be dug to the lateritic gravel surface exposed in this trench.

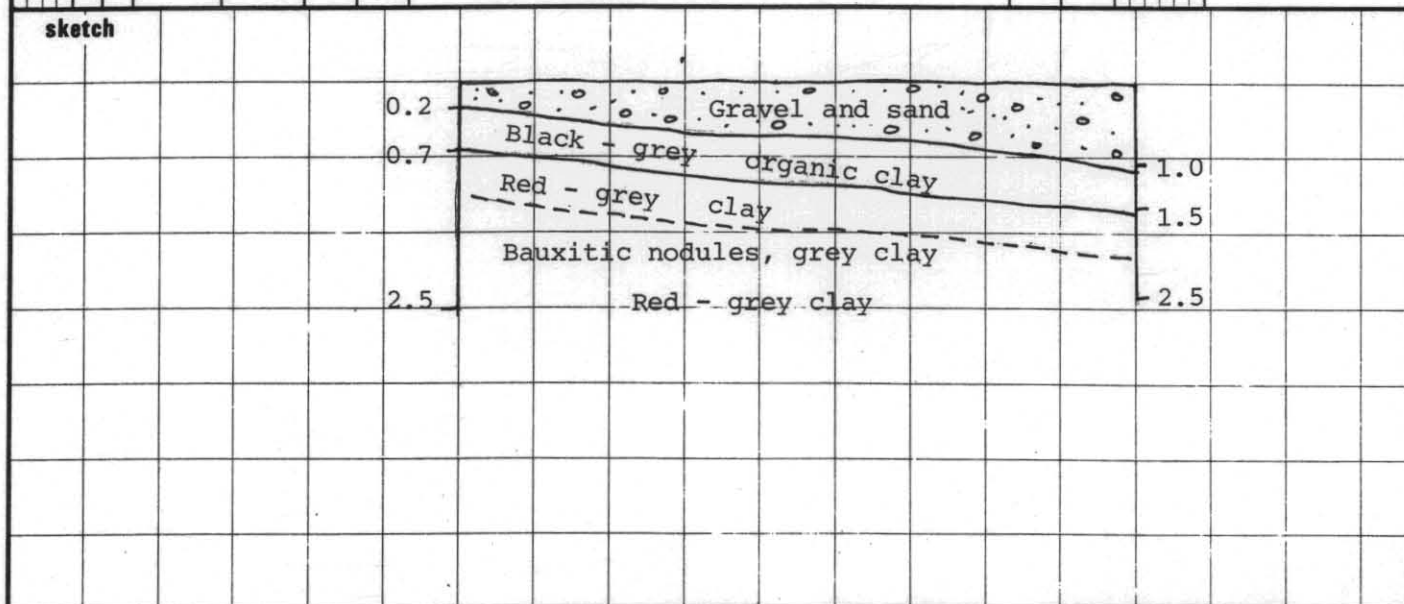
excavation no. 1

Below this organic clay layer was a grey-red and grey clay with bauxitic and limonite nodules at the base of the trench. The clay belonged to the Launceston Beds of Tertiary age (Longman, 1966). All the clay exposed was fissured, with polished faces on the fissures. No slickensides were seen. Four samples from this trench were collected for soil testing.

penetration 1 2 3	support	water	notes samples, tests	metres R.L. depth	graphic log	classification symbol	material soil type: plasticity or particle characteristics, colour secondary and minor components	moisture condition	consistency density index	hand penetr- ometer kPa 25 50 100 200 400	structure, geology
			S1			SG	Gravel and sand: Gravel quartz pebbles +2 mm angular. Sand, med-coarse, poorly graded.	D	L		Quaternary terrace sand & gravel
			S2	1.0		CH	Clay: grey-black, highly plastic, sheared, organic - roots	M	St		Sheared
			S3			CH	Clay: grey-red - highly plastic, sheared ↓ changes to grey	M	St		Clay of Launceston Beds
			S4	2.0			red-grey - bauxitic and limonite layer and nodules				
							Capacity of backhoe reached.

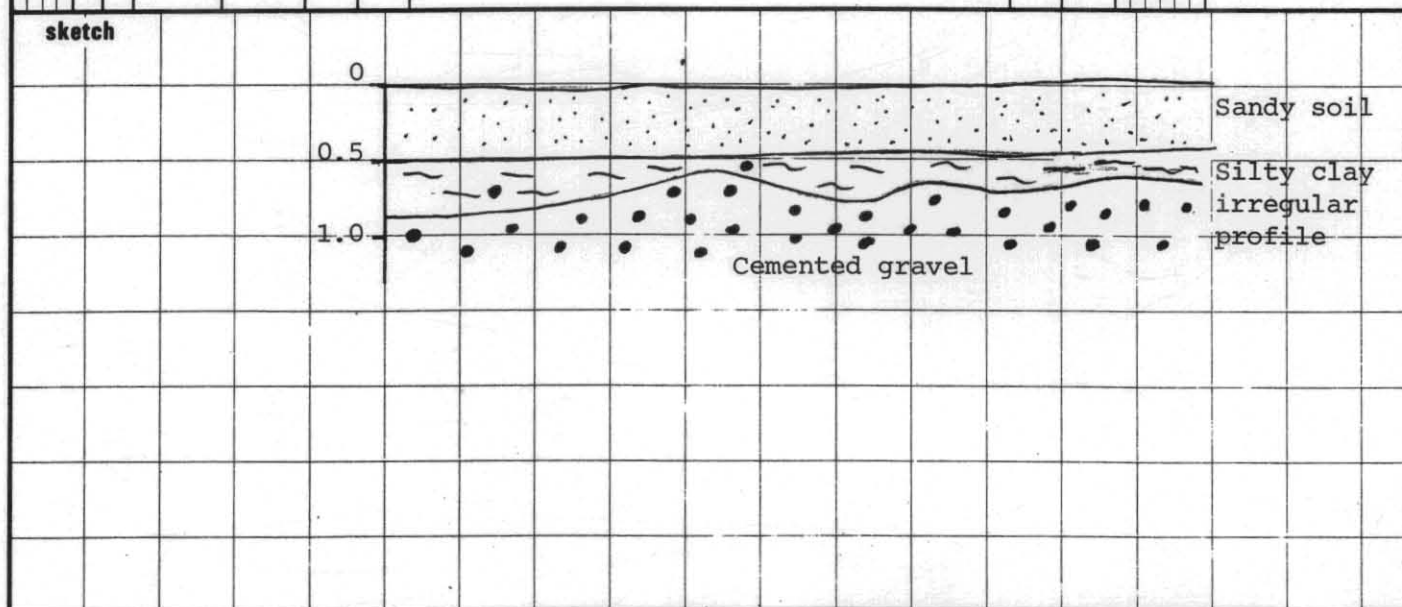
excavation no. 3

In Trench 3 was a very hard, black-brown laterised gravel with pebbles up to 40 mm but averaging 10-20 mm. It appears to be lithologically similar to the gravel and fine gravel (grit) and sand seen in the abandoned gravel pits, except for its iron cementing.

SM	Silty sand: Grey, fine, graded (well-sorted). Organic, much root material.	D	L		Sandy soil

CL	Silty clay: With large pebbles and cemented nodule - irregular lens	D	St		Silty clay
			1.0

GP	Gravel: Fine, iron cemented. Poorly graded sand grains, grit and pebble +10 mm	D	VD		Iron cemented gravel
						Backhoe stopped by the cemented gravel
