1985/65. House cracking at Sandown Road, Launceston

W.R. Moore

Three holes were drilled in an investigation of a cracked house at 41 Sandown Road, Launceston. Sandown Road is an area well known in Launceston for house cracking which, by reputation, is thought to be caused by landslides. Two holes were auger drilled to 7.9 m and the third hand augered to 1.0 m. The deep holes were at the north-east and north-west corners of the house where most cracking has occurred and where a high brick wall is tilted.

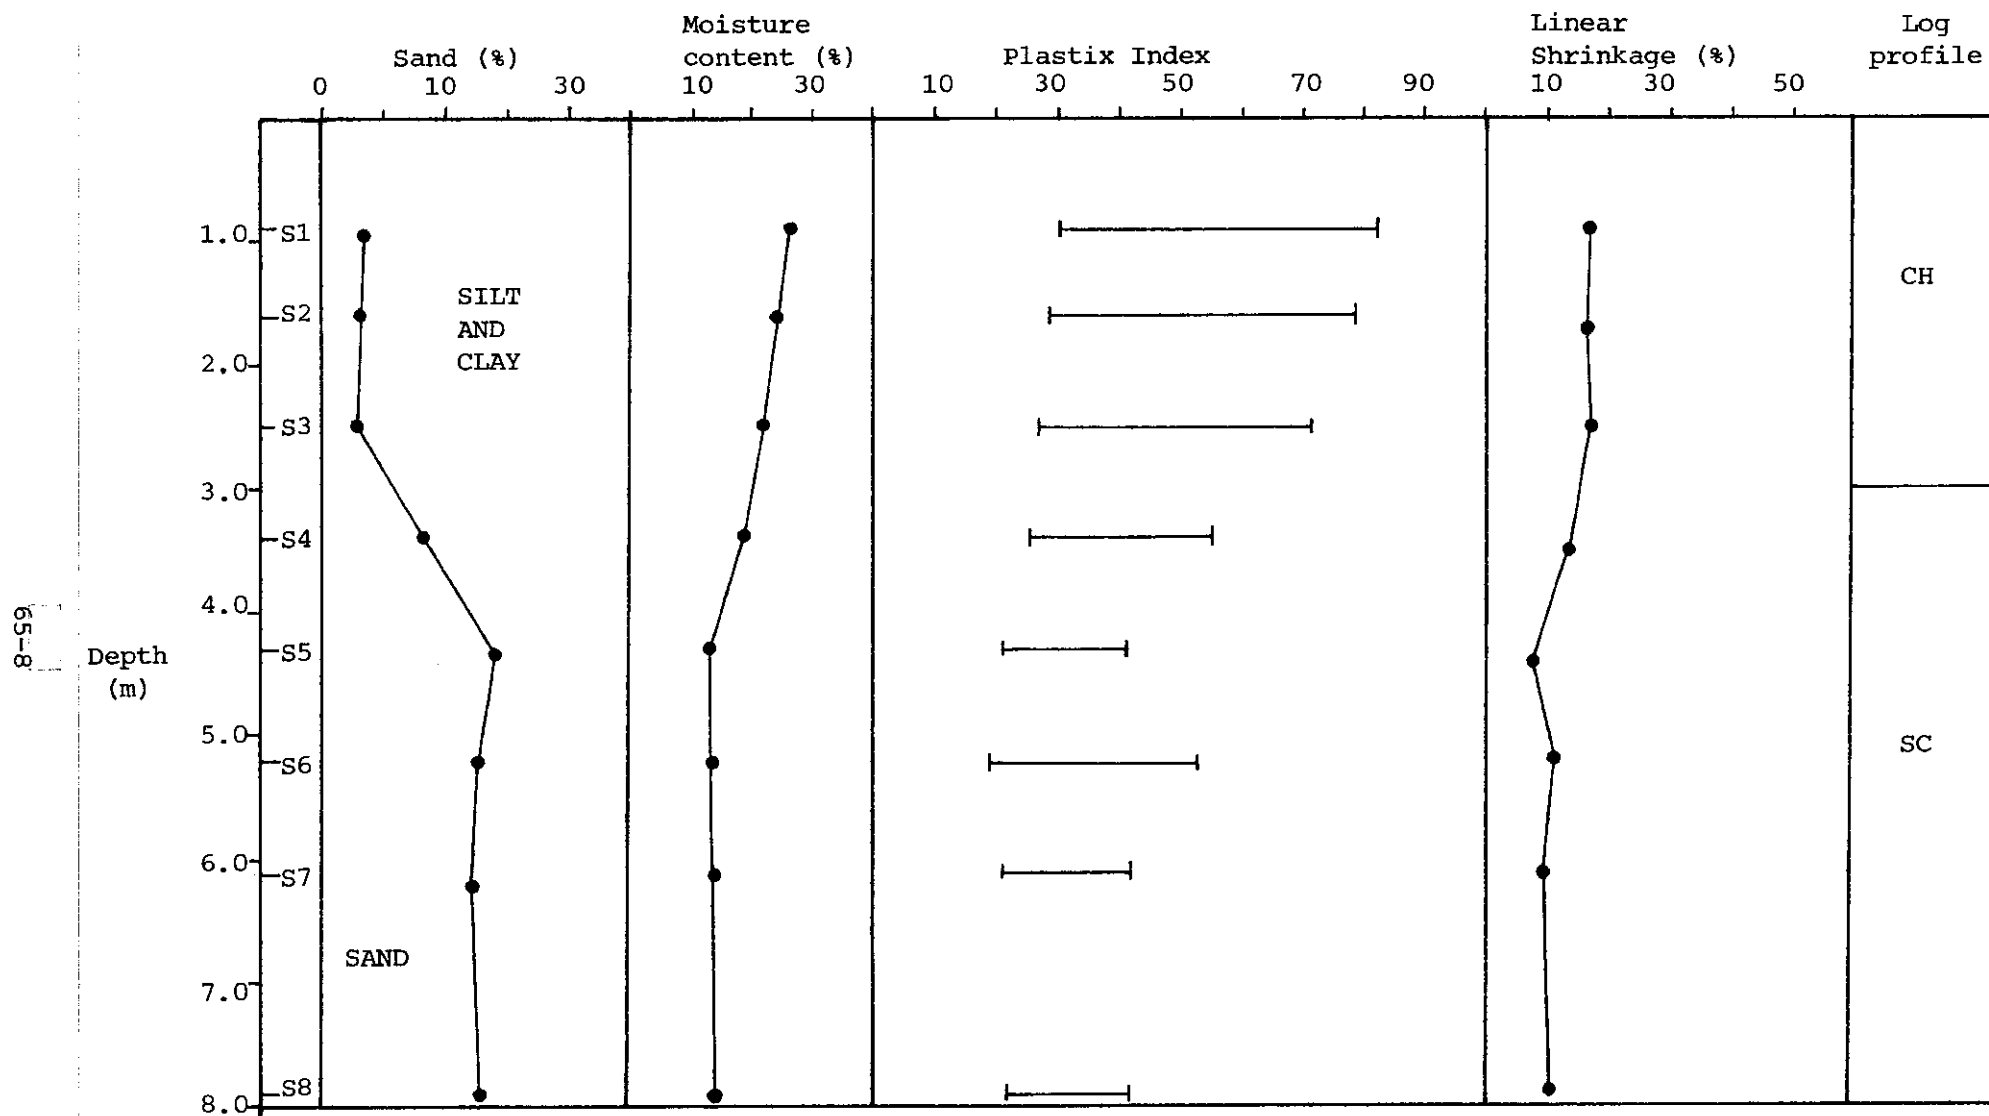
Figure 2(a). Soil testing results, Hole 1.

The soil laboratory results are given in Table 1 and the grain size analyses in Appendix 2 and diagrammatically in Figure 2. The grain size analyses show that in the top three metres of Hole 1 and two metres in Hole 2 the sand percentage was less than 20%. Below this depth, the sand percentage increases to 50%. This increase in sand content occurs at the cemented horizon in both holes and remains at approximately 50% below 4.0 m in Hole 1 and 2.5 m in Hole 2, throughout the sandy clay section of the holes (fig. 2). This sand content increase was noted when drilling and logging the hole, but on analysis the sand percentage was far higher than anticipated. This is probably because the sand is fine and well graded, giving the appearance that the clay material is dominant, with the fine sand being masked by the mixing of the auger drilling.

The moisture content is highest in the clay section of all the holes; 22-25% in Hole 1, 17-22% in Hole 2, and 23-25% in Hole 3. The moisture content declines with depth in the sandy clay section of the holes and remains constant at 13-14% below 4.0 m depth in Hole 1 and at 14-15% below 2.5 m in Hole 2 (fig. 2). These moisture contents are low compared with the 32% at 1.4 m and 28% at 1.8 m in similar clay in an investigation trench at 23 Sandown Road (Moore, 1984).

The plasticity of the clay in the upper sections of Holes 1 and 2 is high, with liquid limits ranging from 72-82 and plastic indices of 44-52. This plasticity declines sharply with the increase in the sand content below the cemented sandy clay layer. The liquid limits in the sandy clay section of the holes range from 42-55, with plastic indices of 22-34 (fig. 2).

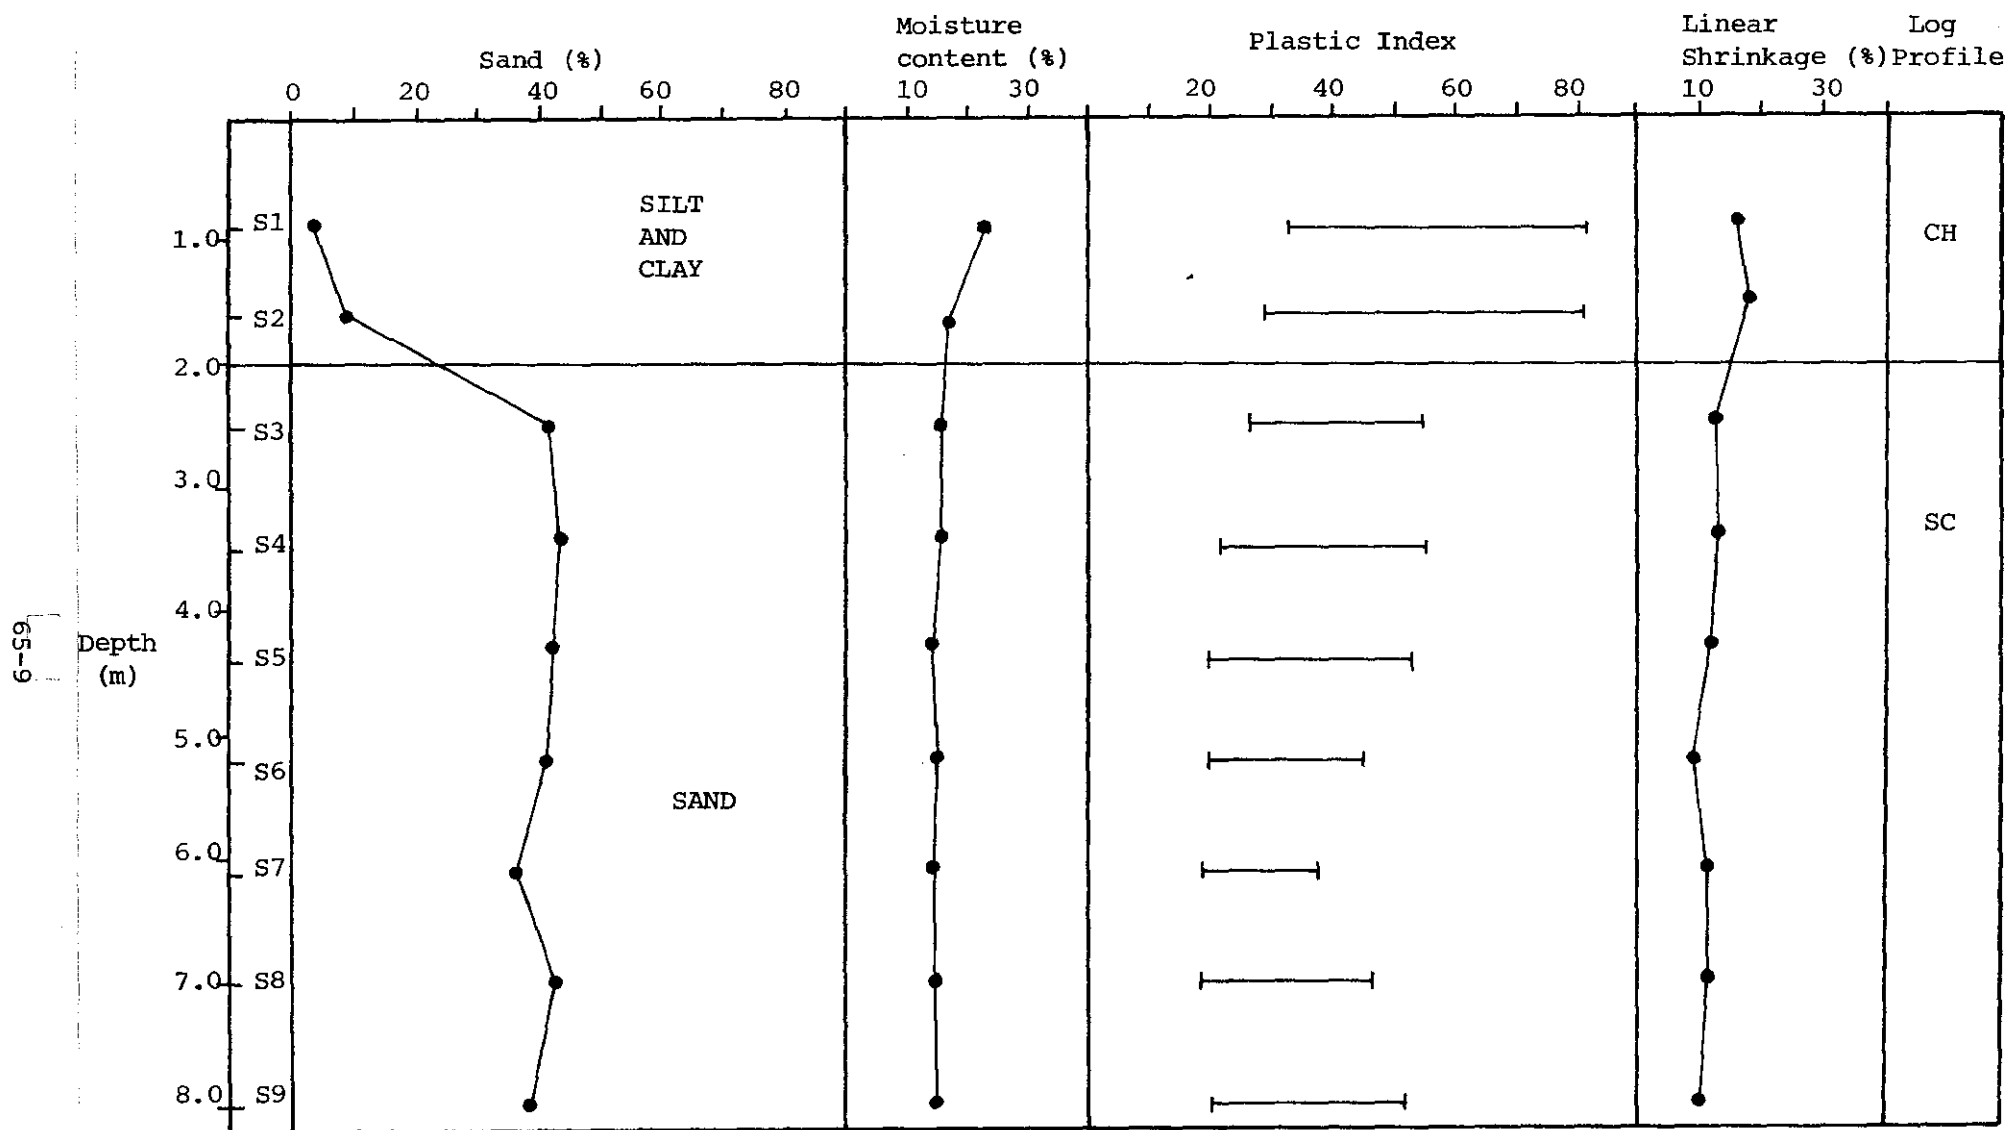
Figure 2(b). Soil testing results, Hole 2.

A similar sequence was drilled in Hole 2 at the north-east corner of the house, except that the surface clay sequence was 2.0 m thick compared with 3.0 m in Hole 1.

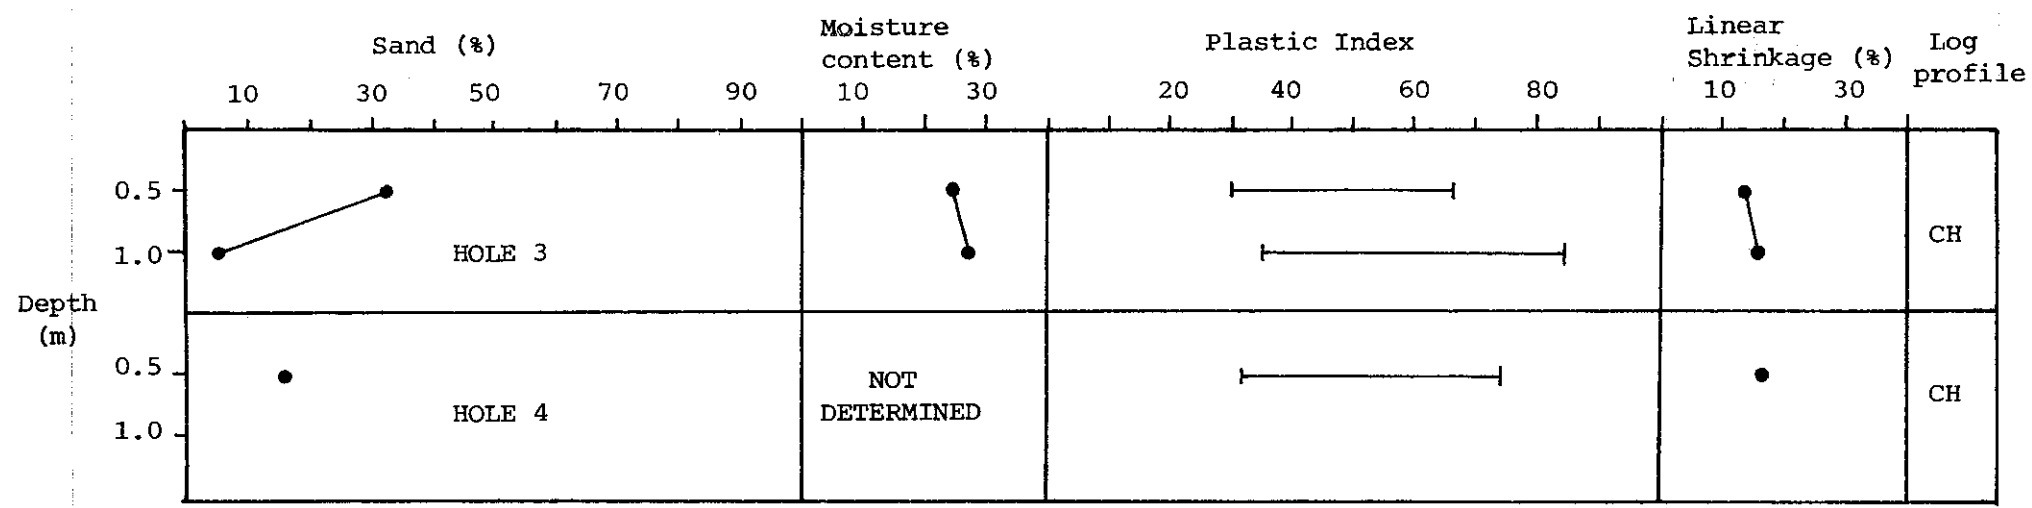
Figure 2(c). Soil testing results, Holes 3 and 4.

Because of the gardens and trees the trailer auger drill was not used in Hole 3 near the south-west corner of the house. A hand auger hole was dug to a depth of one metre. This was an adequate depth to obtain samples from the orange and grey clay. The cemented hard sandy-clay layer was not reached. Hole 4 was dug by the owner to expose the clay, from which a sample was collected using the hand auger. The hole was on the eastern side of the house.

The linear shrinkage is highest in the upper clay section of both Holes 1 and 2. In Hole 1 it is 14-17% which declines to 8-11% in the sandy clay. In Hole 2 it is 16-18% in the clay and 9-13% in the sandy clay. In Hole 3 it is 14-16% and 16% in Hole 4.

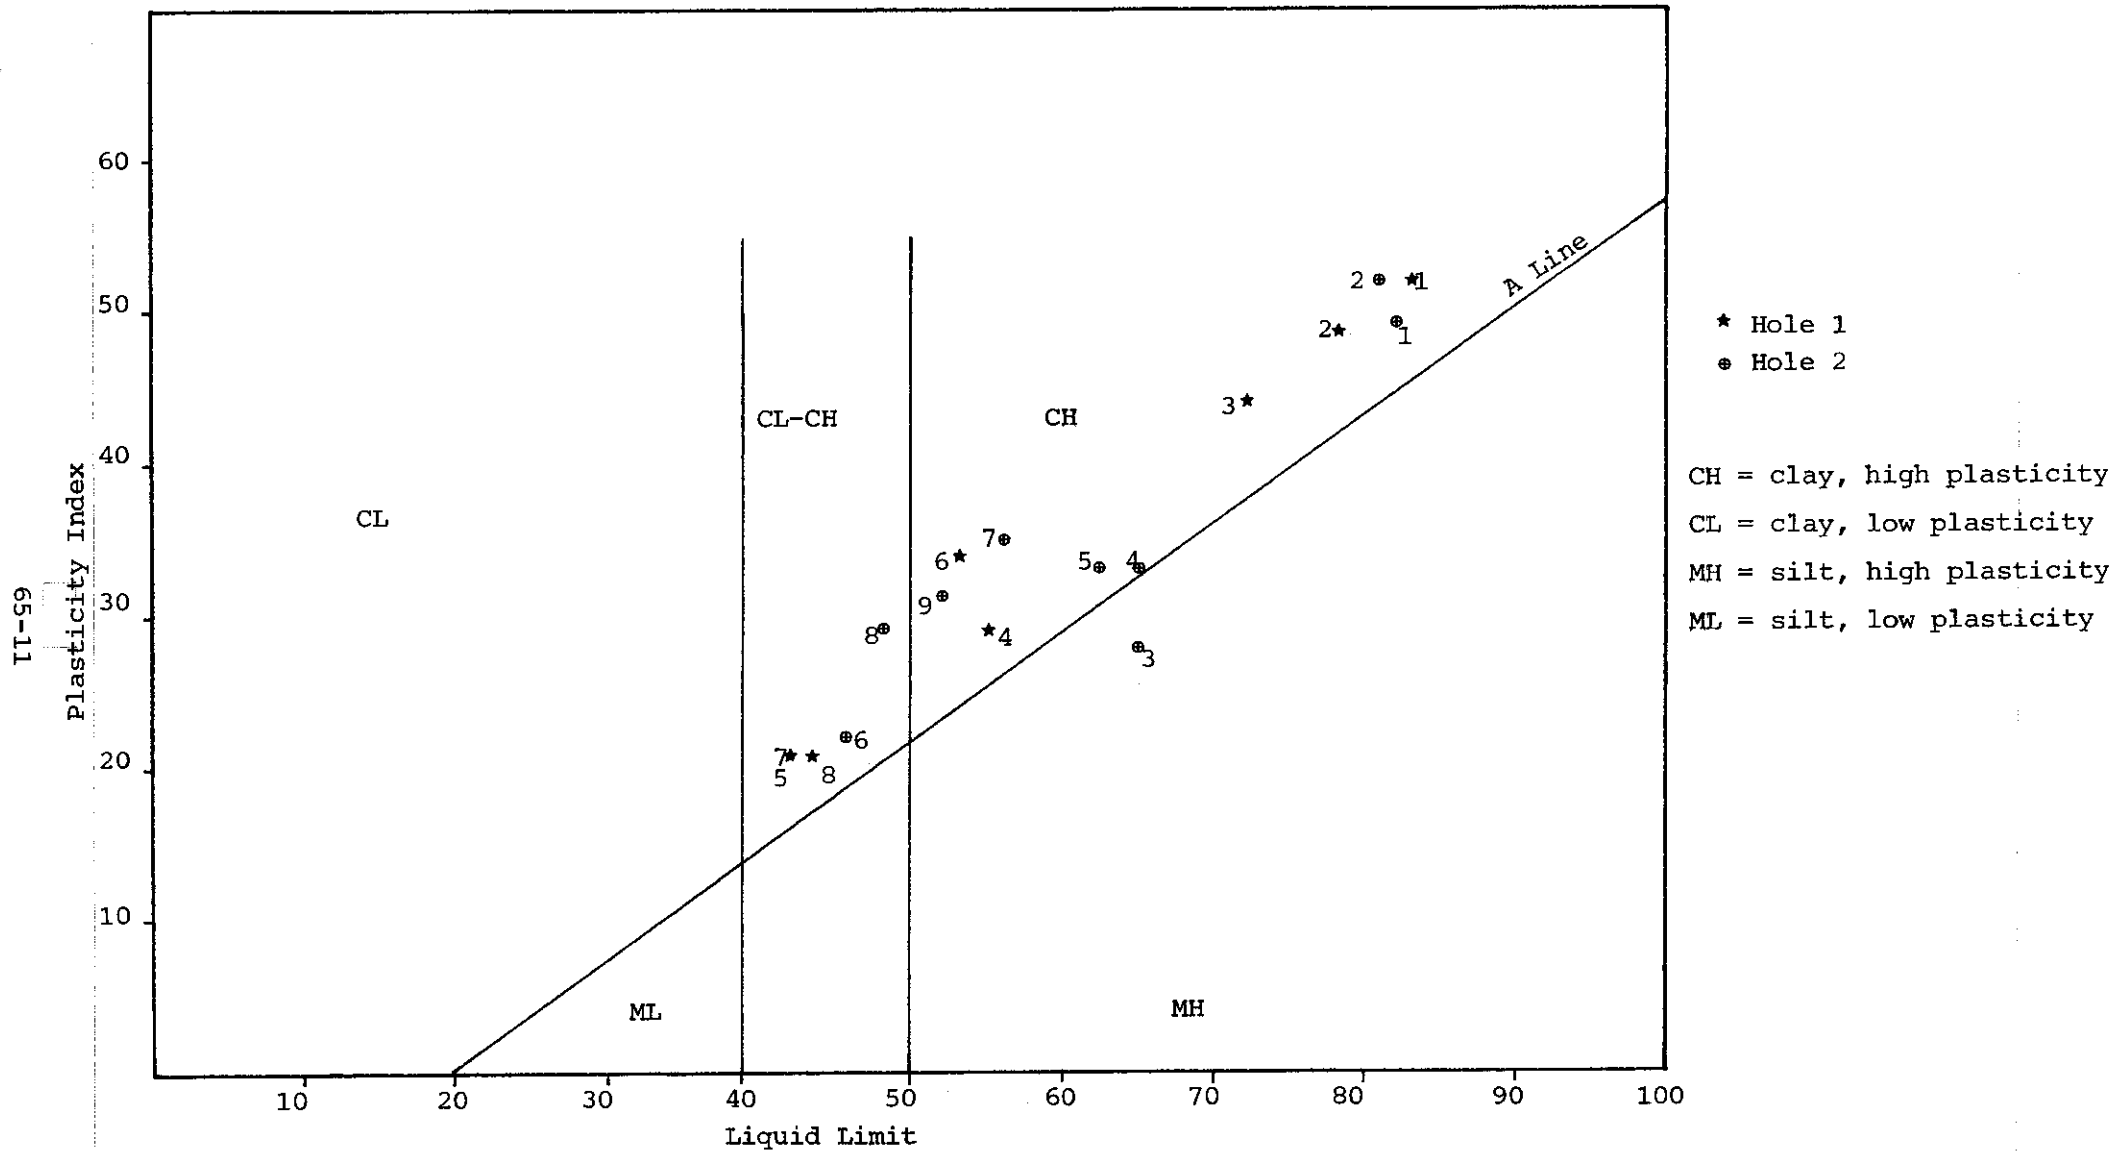
Figure 3. Laboratory classification of soil samples.

A general decline in the plasticity of clay occurs with increase in depth in Holes 1 and 2 as shown on the soil classification graph (fig. 3). In Hole 1 there is a uniform decline from very high plasticity down to low to high (medium) plasticity. In Hole 2 this decline is irregular but still persists (fig. 3).
