Landslide zoning at Beauty Point and St Helens

by D. J. Sloane

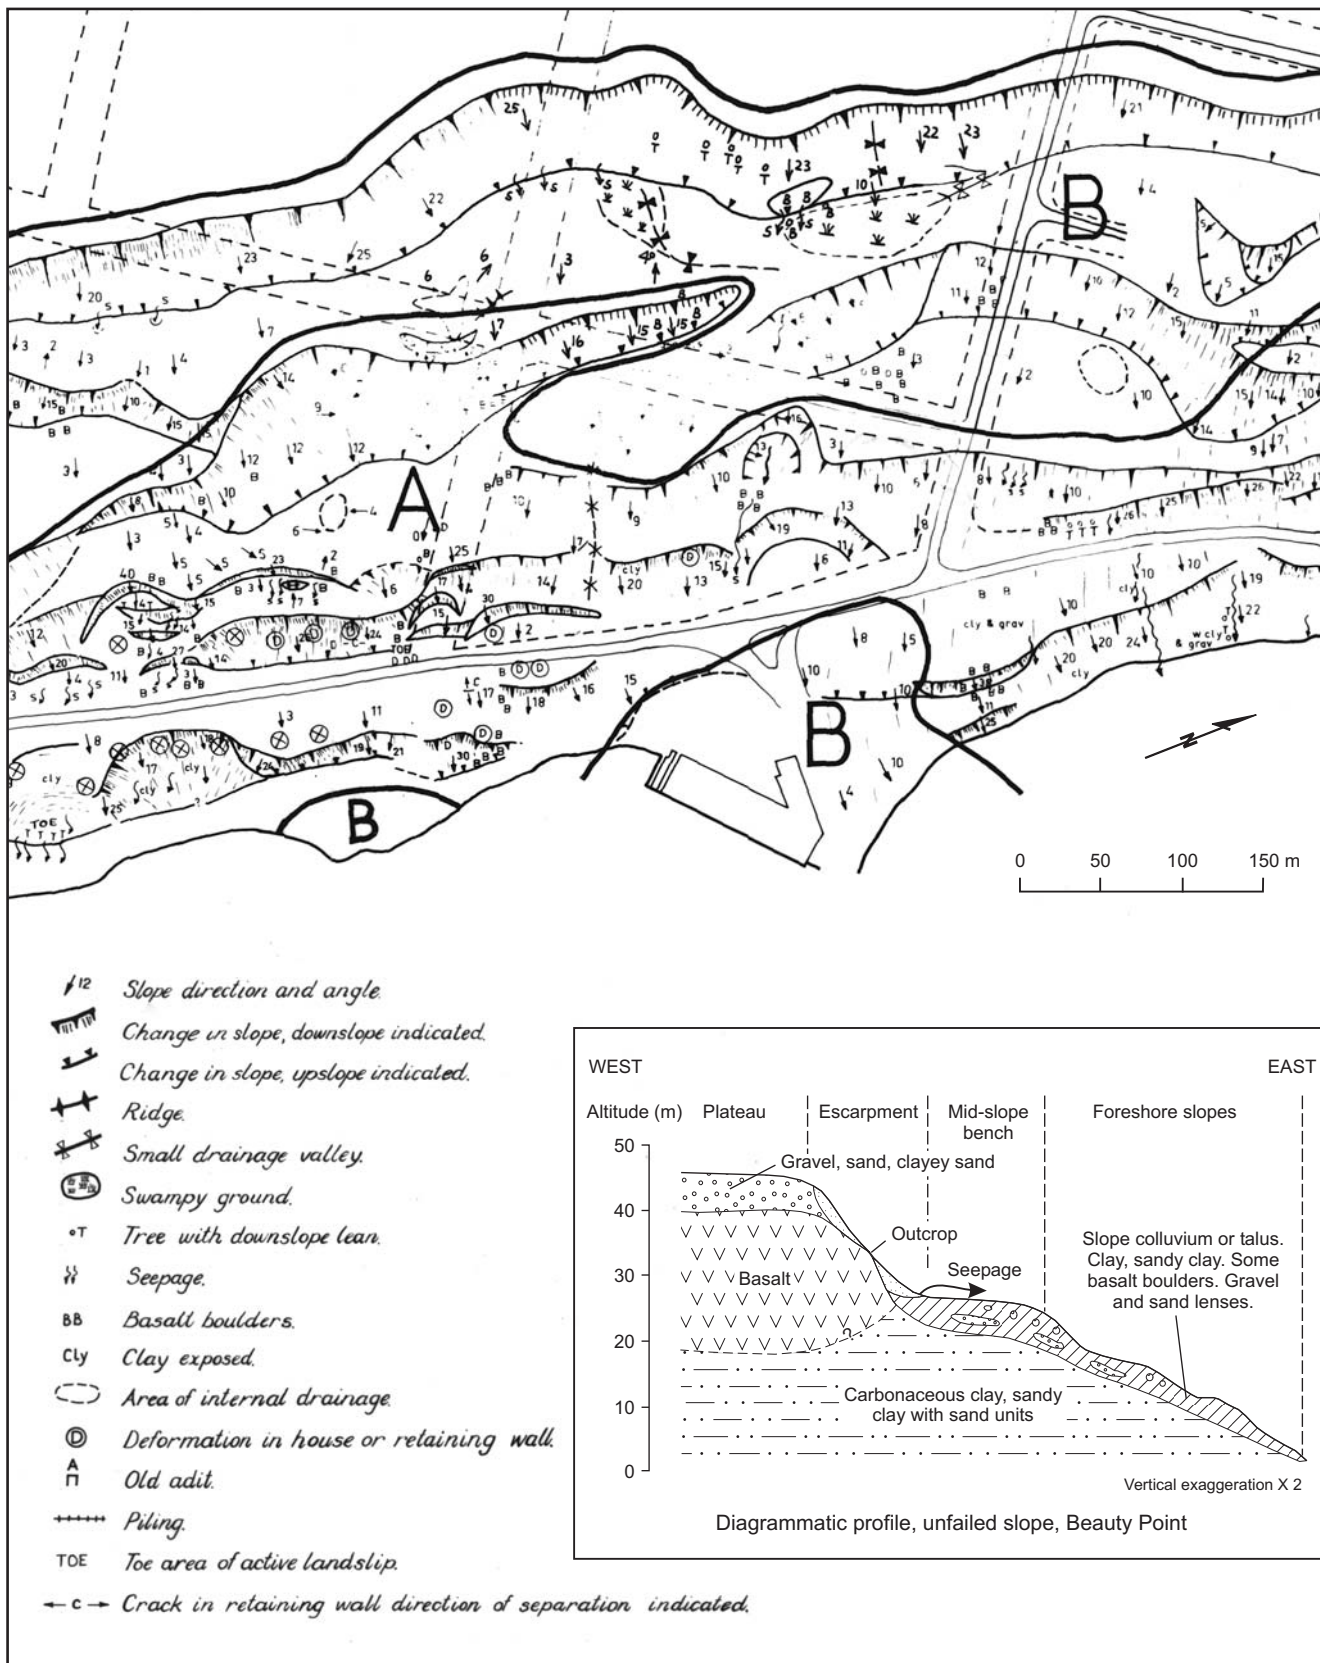
Figure 1
Part of the Beauty Point Landslip Zone Map.

Initially an assessment of the instability history of the area was made. A series of five detailed town maps at a scale of 1:2400 and a contour interval of five feet were readily available. These five base maps enabled morphological and other features to be accurately plotted. Slope angles, breaks of slope, seepages, depressions etc. were all plotted using a standard system of symbols. Additional features such as the occurrence of talus or colluvial boulders, deformed and destroyed houses, kinked or leaning trees, deformed and cracked retaining walls were also added to the map. The result was a detailed morphological map, at a scale where information could be seen on individual house lots. A section is shown (fig. 1) and the complex morphology of the slope in the vicinity of the main active landslide is immediately apparent. The morphology of undisturbed areas is considered to be similar to the slope profile at either end of the township (fig. 1).

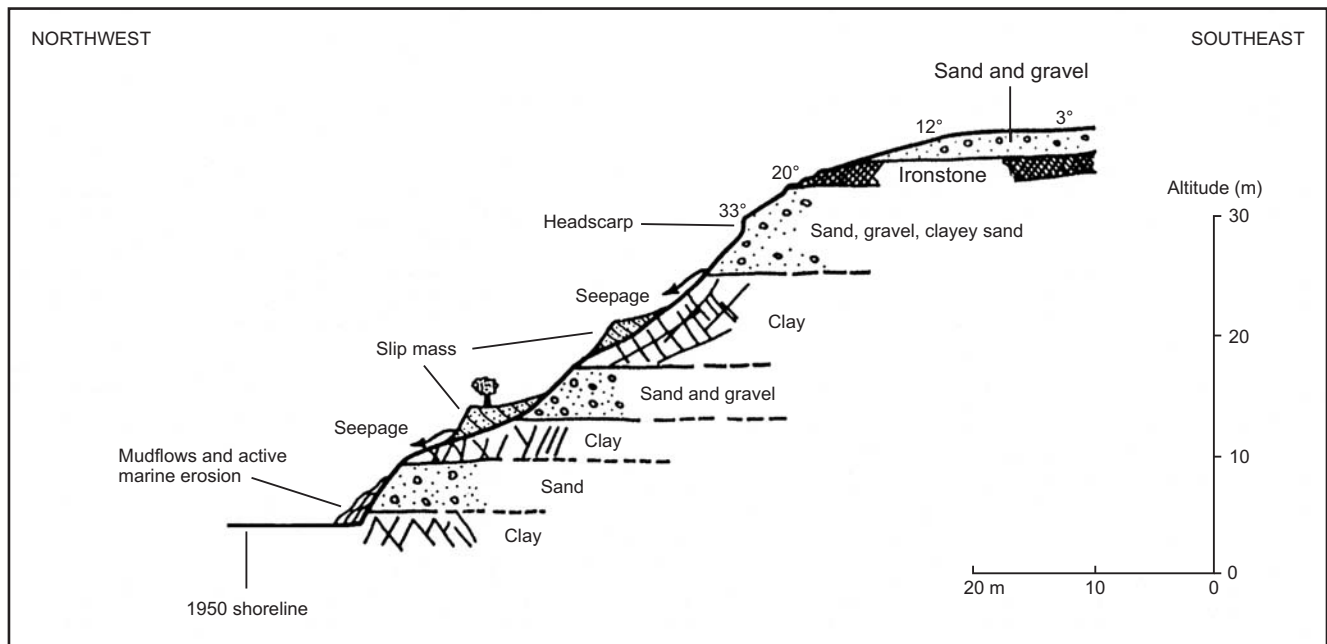
A resistant band of iron-cemented gravel up to one metre in thickness is exposed at the top of the bayside slopes. The iron-pan is consistent over the upper plateau, at a depth of one to two metres from the ground surface, and is considered to be a soil profile feature (fig. 2).

Figure 2
Slope profile, Chimney Heights, St Helens, showing simplified geology and slope failures in an area of active marine erosion.

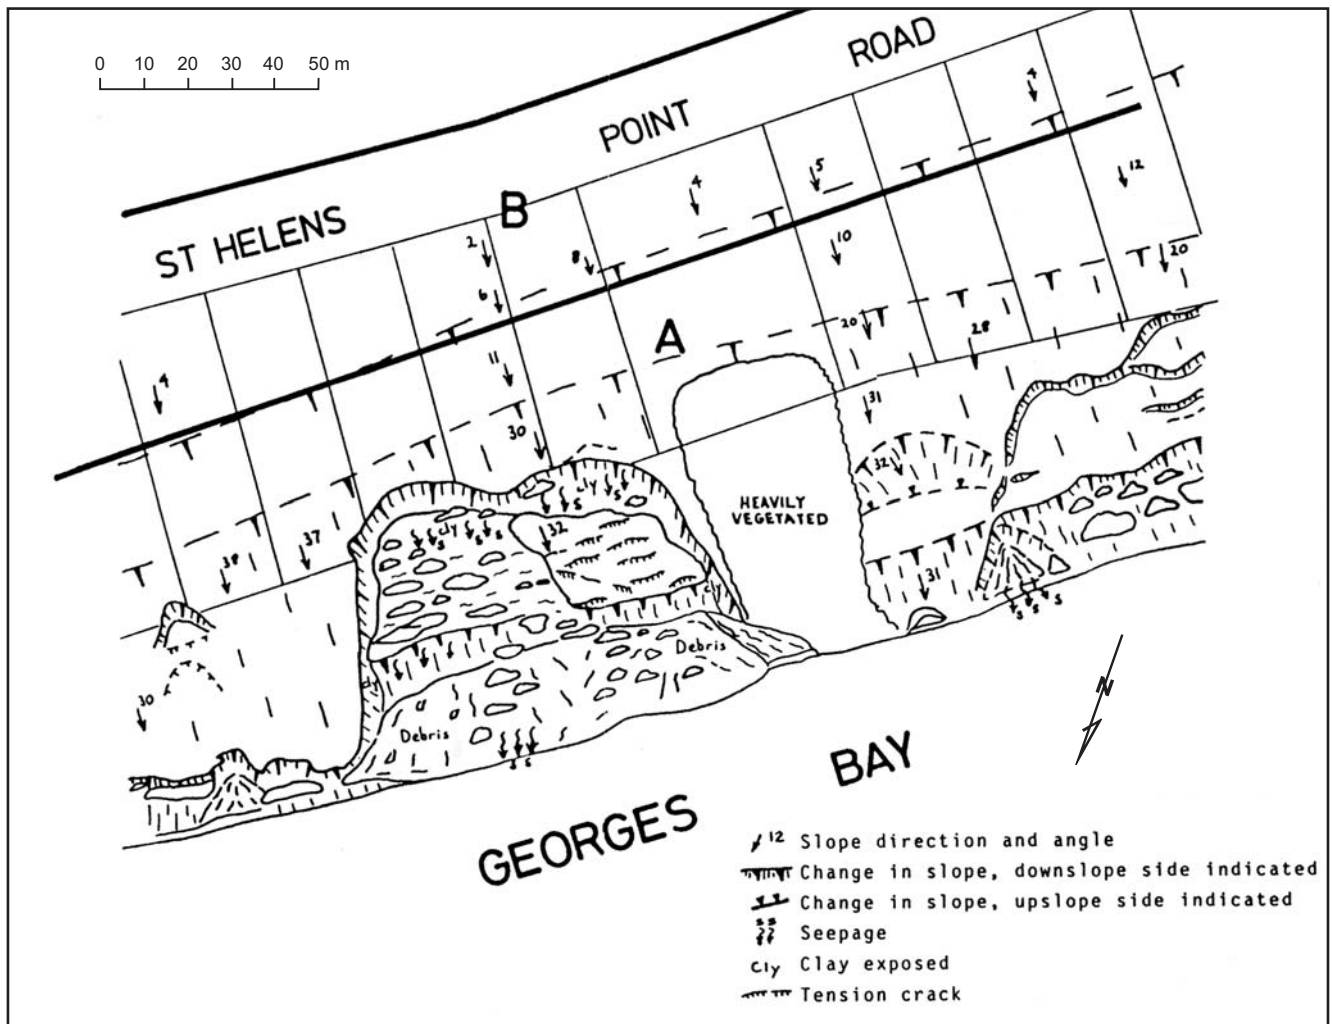
Figure 3

A section of the Landslip 'A' and 'B' Zone Map, Chimney Heights, St Helens.

The Chimney Heights area was relatively simple to zone as the upslope segments range from 28° to 38°. Above this is a small slope facet of 10° to 20° centred around the iron-pan outcrop before the major break of slope at the plateau edge. Only a relatively short unfailed slope segment is present below this point. The major break of slope was therefore considered to be a convenient boundary for the 'A' zone. A 15 m set-back from the plateau edge was included, to prevent development immediately on the break of slope. As the watershed is located along the upper road the area from here to the plateau edge was zoned a 'B' landslide area, in order to control development in this area, considered as influencing the stability of the steep slopes below (fig. 3).
