**TASMANIA DEPARTMENT OF MINES
UNPUBLISHED REPORT 1985/74**

Inspection of Ambrose's subdivision at Windermere

by W. R. Moore

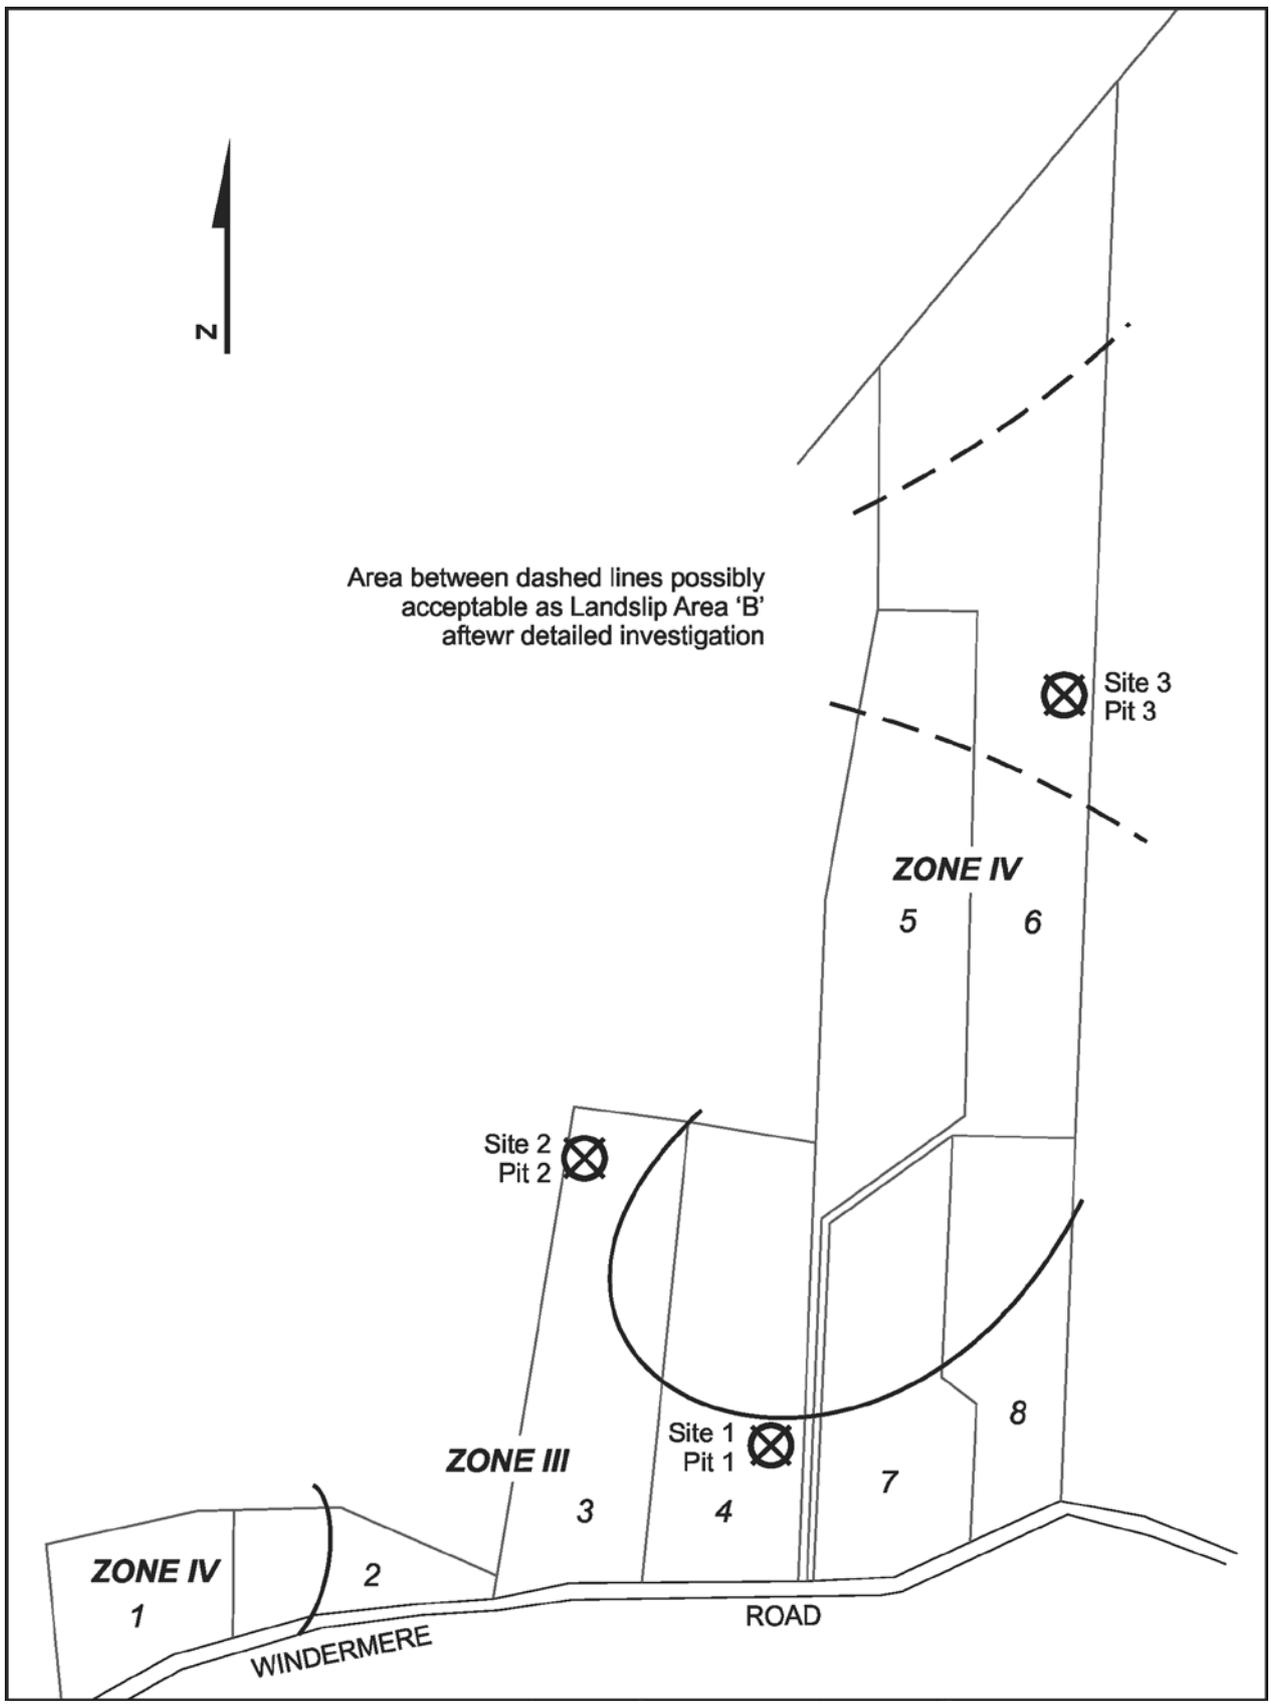
Figure 1
Location of test pits

At the request of the developer a proposed subdivision in Windermere Road was inspected on 24 October 1984. Three proposed house sites were tested by digging of three pits as shown on Figure 1. The laboratory results of these samples are shown in Table 1.

No shear box testing was undertaken on these two sites as they are thought to be outside the old landslide, the toe of which is outlined as the boundary of the Zone IV and Zone III areas on Figure 1. The laboratory tests on the three samples taken at a shallow depth (Table 1) show that the subsurface clays at these two sites are highly plastic, with plasticity indices of 79–90. The clays are also high-shrinkage expansive clays with linear shrinkage values of 27–28%. X-ray diffraction testing shows the clay composition to be strongly montmorillonite and kaolinite.

This site is thought to be on a section of a parasitic slide which is considered to be younger than the large old landslide outlined by Stevenson in 1974.

This old slide appears to cover the Zone IV area of the proposed subdivision. This site has all the problems of sites 1 and 2 plus the shear box tests indicate that the clays have a low residual angle of friction and cohesion. These tests are still continuing and will need to be followed by slope stability analysis modelled under varying conditions. When this work is completed a further report will be written. Site 3 may have to be moved higher up the slope, just within the tree line where it will be at the head of the old landslide but away from the later parasitic slide. This alternative site will most likely require a new investigation trench.

1. One house site only be permitted on the two blocks of the proposed subdivision and at the locations shown on Figure 1, provided that septic tanks have been or will be approved by the Health Department, or Council officers.

2. It is recommended that the septic tank and overflow drains be lower down on the slope, in the areas discussed on the site visit of 24 October.
3. With the presence of underlying subsurface clay and slopes of 5 to 7 degrees, both sites have a potential for landslide failure and should remain in a Zone III landslide risk area.

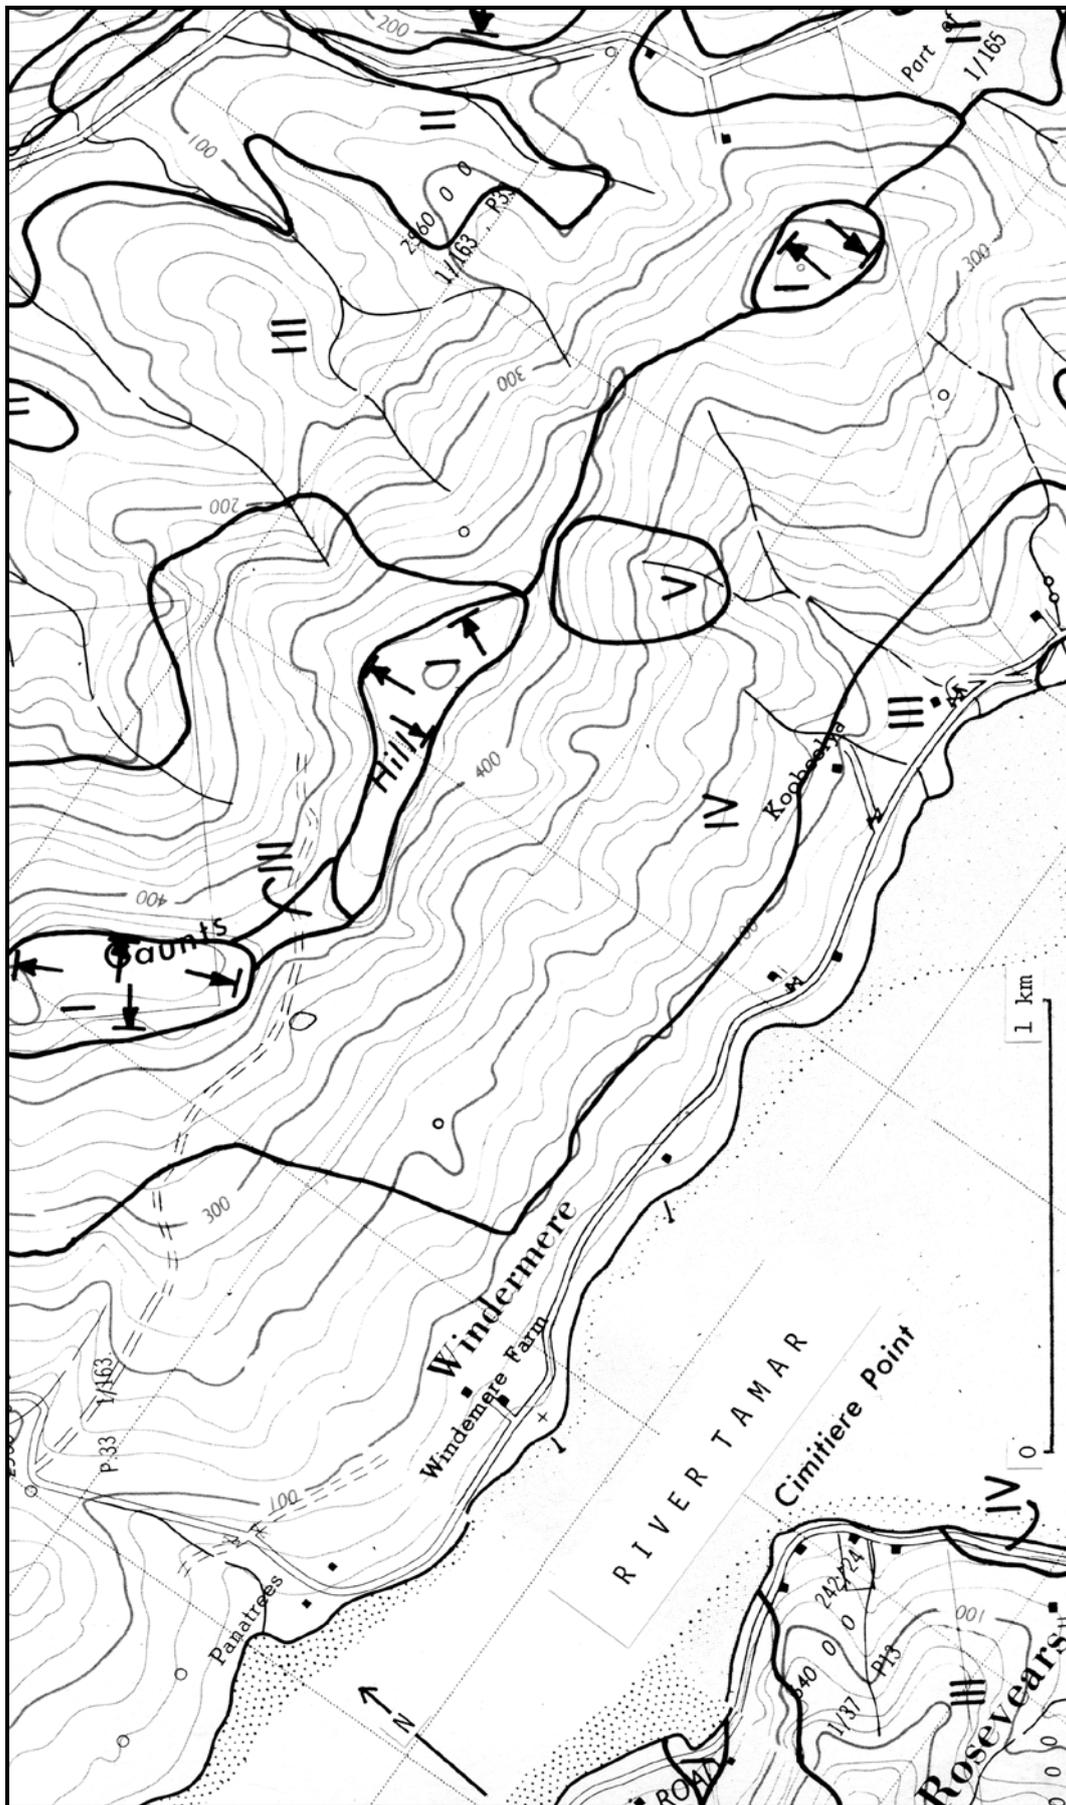
Figure 2

Highly plastic, strongly montmorillonite clay on slopes of 5° to 7° are known to have failed in Windermere and the sites under investigation have a potential risk of slope failure. This risk is considered to be no greater at these two house sites than for any other houses already built on the upslope side of Windermere Road in areas shown as Zone III landslide area on the Department of Mines Tamar Valley landslide risk map (fig. 2).

4. The risk of slope failure is considered to be no greater at these sites than other Zone III areas on the upslope side of Windermere Road, as shown on the Department of Mines Tamar Valley zonal map.

Landslide zone map, Windermere

Even though the area is a Zone III area within the discretion of the building inspector, adherence to the special building code of 1978 for building within landslides would appear prudent at these two sites.
