**TASMANIA DEPARTMENT OF MINES
UNPUBLISHED REPORT 1985/78**

Inspection of Lot 6, Ambrose's Subdivision, Windermere

by W. R. Moore

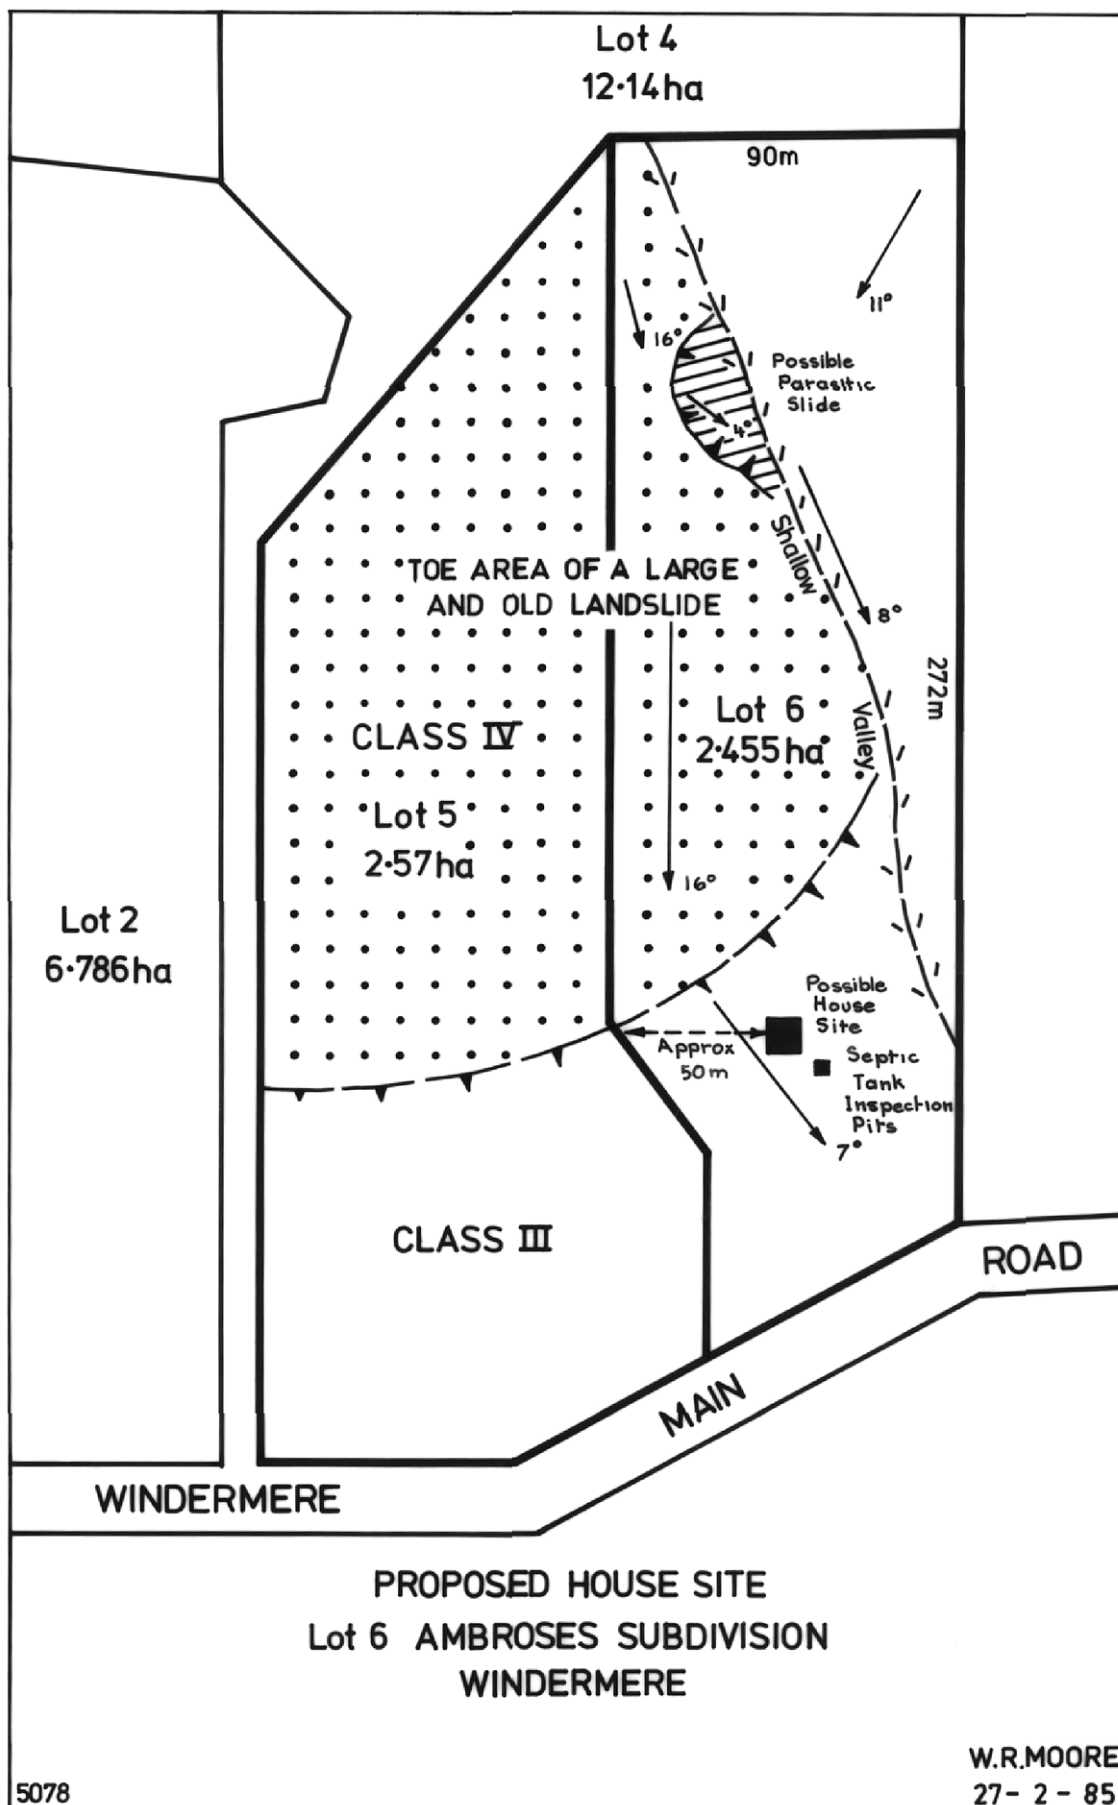
Lot 6 of Ambrose's subdivision at Windermere was inspected on 21 February, with a house site being selected in the Class III potential landslide risk area on the block (fig. 1).

The site is situated in a shallow depression with a flatter area than the overall slope of 7° that occurs over most of the Class III area. The site is located approximately 50 m east of the fence post where the western boundary changes direction northwards upslope. The location is close to, but at a higher level to where two septic tank inspection pits had been dug. From the position of these pits and the survey pegs scattered on the ground it appears close to where a previous house site had been selected.

The remainder of the block upslope is a Class IV landslide risk area because it is part of a very large old landslide that covers much of the Ambrose subdivision. In the Class IV area there is only one topographical area which may be a possible house site. This is a small flatter area, with a slope of 4°, in the northeastern corner of the block. This feature is thought to be formed by a smaller secondary landslide that has occurred on the eastern flank of the old landslide. A similar feature is known to occur at a higher level on the neighbouring lot 4, which was investigated by trenching for slope stability. On the field evidence and soil testing results the site was not recommended to the council for building. If this higher alternative site is chosen a similar subsurface investigation and soil testing program would be required. Unfortunately, after this work the site would probably still be rejected because of its inherent high instability. Therefore unless a strong personal preference for the higher site exists, as did occur on the lot 4 block, this site is not recommended.

Because the slope of 7° covers most of the Class III area and because of the properties of the clay, this site remains a potential landslide area. This risk cannot be eliminated for any of this section of land above Windermere Road as well as for much of the area below the road. All of this Class III area is considered at a potential risk from landslides. This site, as with other houses in this area, is situated on sensitive slopes prone to landslide even with slopes of less than 7°.

If the lower house site, as shown on Figure 1, is accepted no further investigation work is required, even though a sample of the clay from the inspection pit was collected. This sample will be tested in the soil laboratory but it is unlikely, on field evidence, to be different from samples recently collected and tested from the adjoining lots 1 and 2 of Ambrose's subdivision, where one house site was recommended for each block. The same recommendation is made for Lot 6, that one house site is recommended for the lot and no further subdivision be planned or contemplated for the block. The house should be sited on the flatter area shown Figure 1 and the septic tank should be installed in the area where the inspection pits were dug.
