UR1987-22

1987/22. Stormwater drainage study at Comalco Aluminium, Bell Bay.**B. D. Weldon****Abstract**

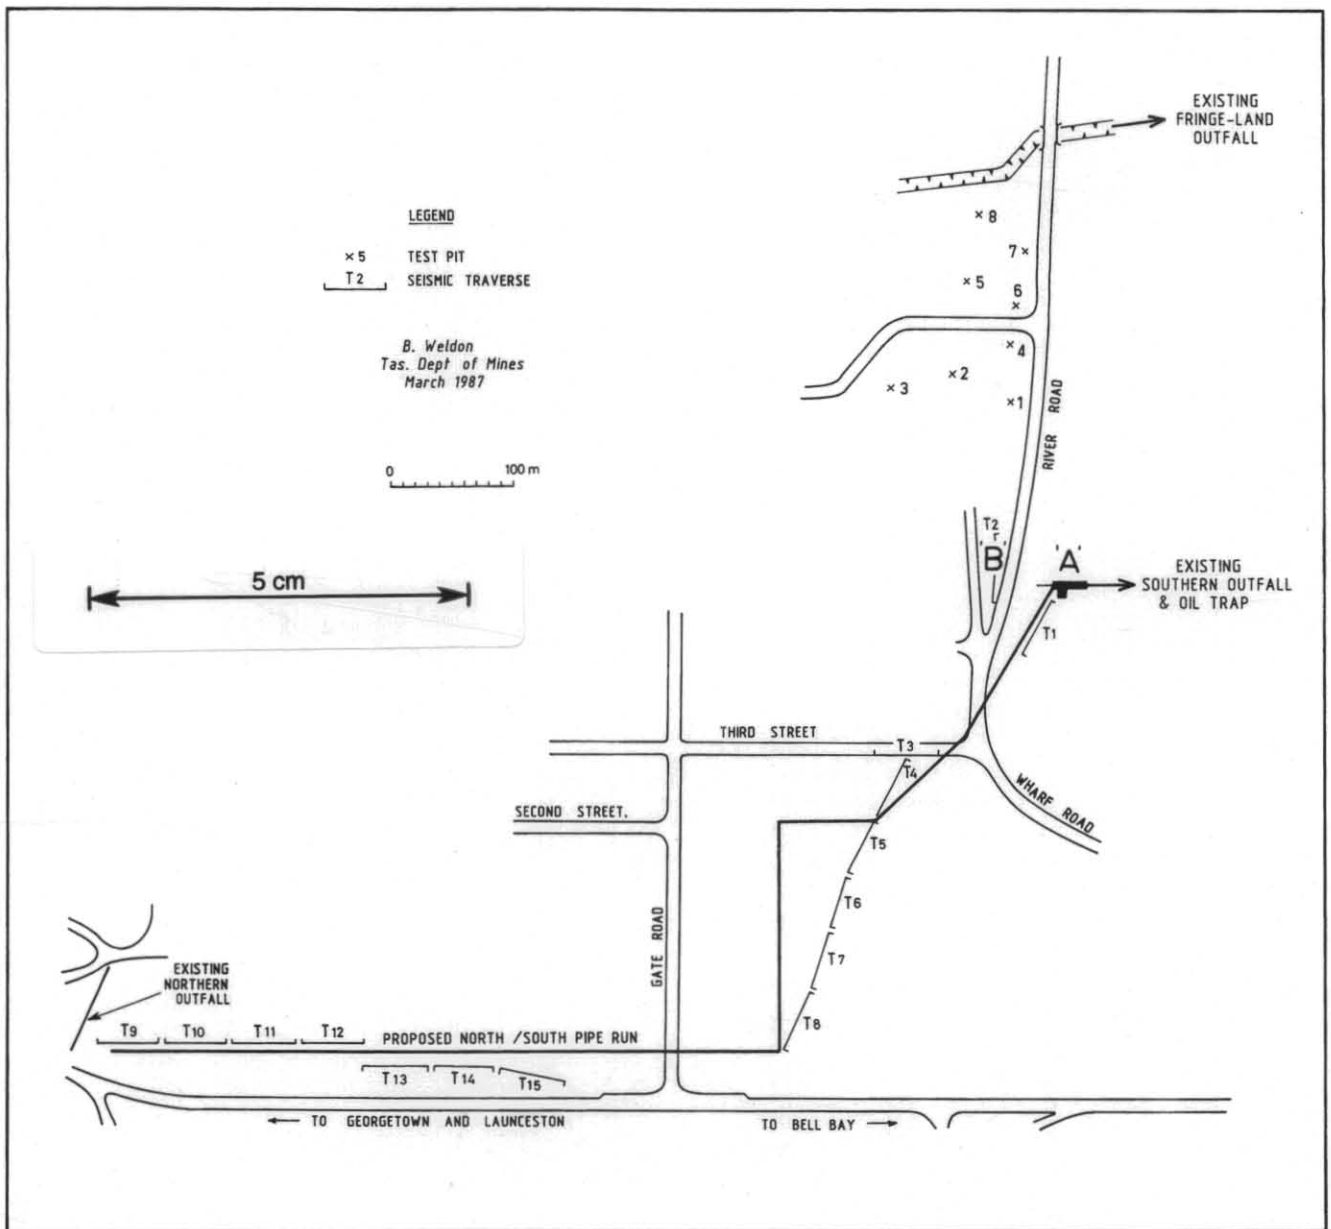
Figure 1. Location of test pits, seismic traverses, and proposed pump house sites 'A' and 'B'.

Two locations (denoted 'A' and 'B' on Figure 1) were considered for the pump station.

Seismic traverse T1 indicates that the oil trap is located in an area where the depth to the top of the basalt is in excess of ten metres.

This location is between River Road and the carbon production store. Seismic traverse T2 was made in this area. The profile on the top of the basalt suggests that a gully-like feature may exist sloping down from the north-east to the south-west. The materials in the gully have a seismic velocity of 1540 m/s which is indicative of clay, saturated sand, or highly weathered rock. Excavations in this material should be possible without blasting. Blasting will however be required in the fresh basalt which is calculated to occur at about five metres depth on the north-east end of the traverse. The basalt deepens in a south-westerly direction.

This location is between River Road and the carbon production store. As such, a buffer zone is created between the proposed pump-house and the slope down to the River Tamar. This location is the preferred site for the pump-house from geological considerations.

Any structure sited on the slope is therefore at risk (in the long term) from slope instability. In the absence of detailed geotechnical investigations into the thickness and condition of the basalt and other materials on the slope, a recommendation must be made against siting the pump-house in the immediate vicinity of the oil-trap.

A transfer pump-house is required at the existing southern outfall. The recommended site from geological and slope stability considerations is between River Road and the carbon production store, away from the slope (and the existing oil trap).

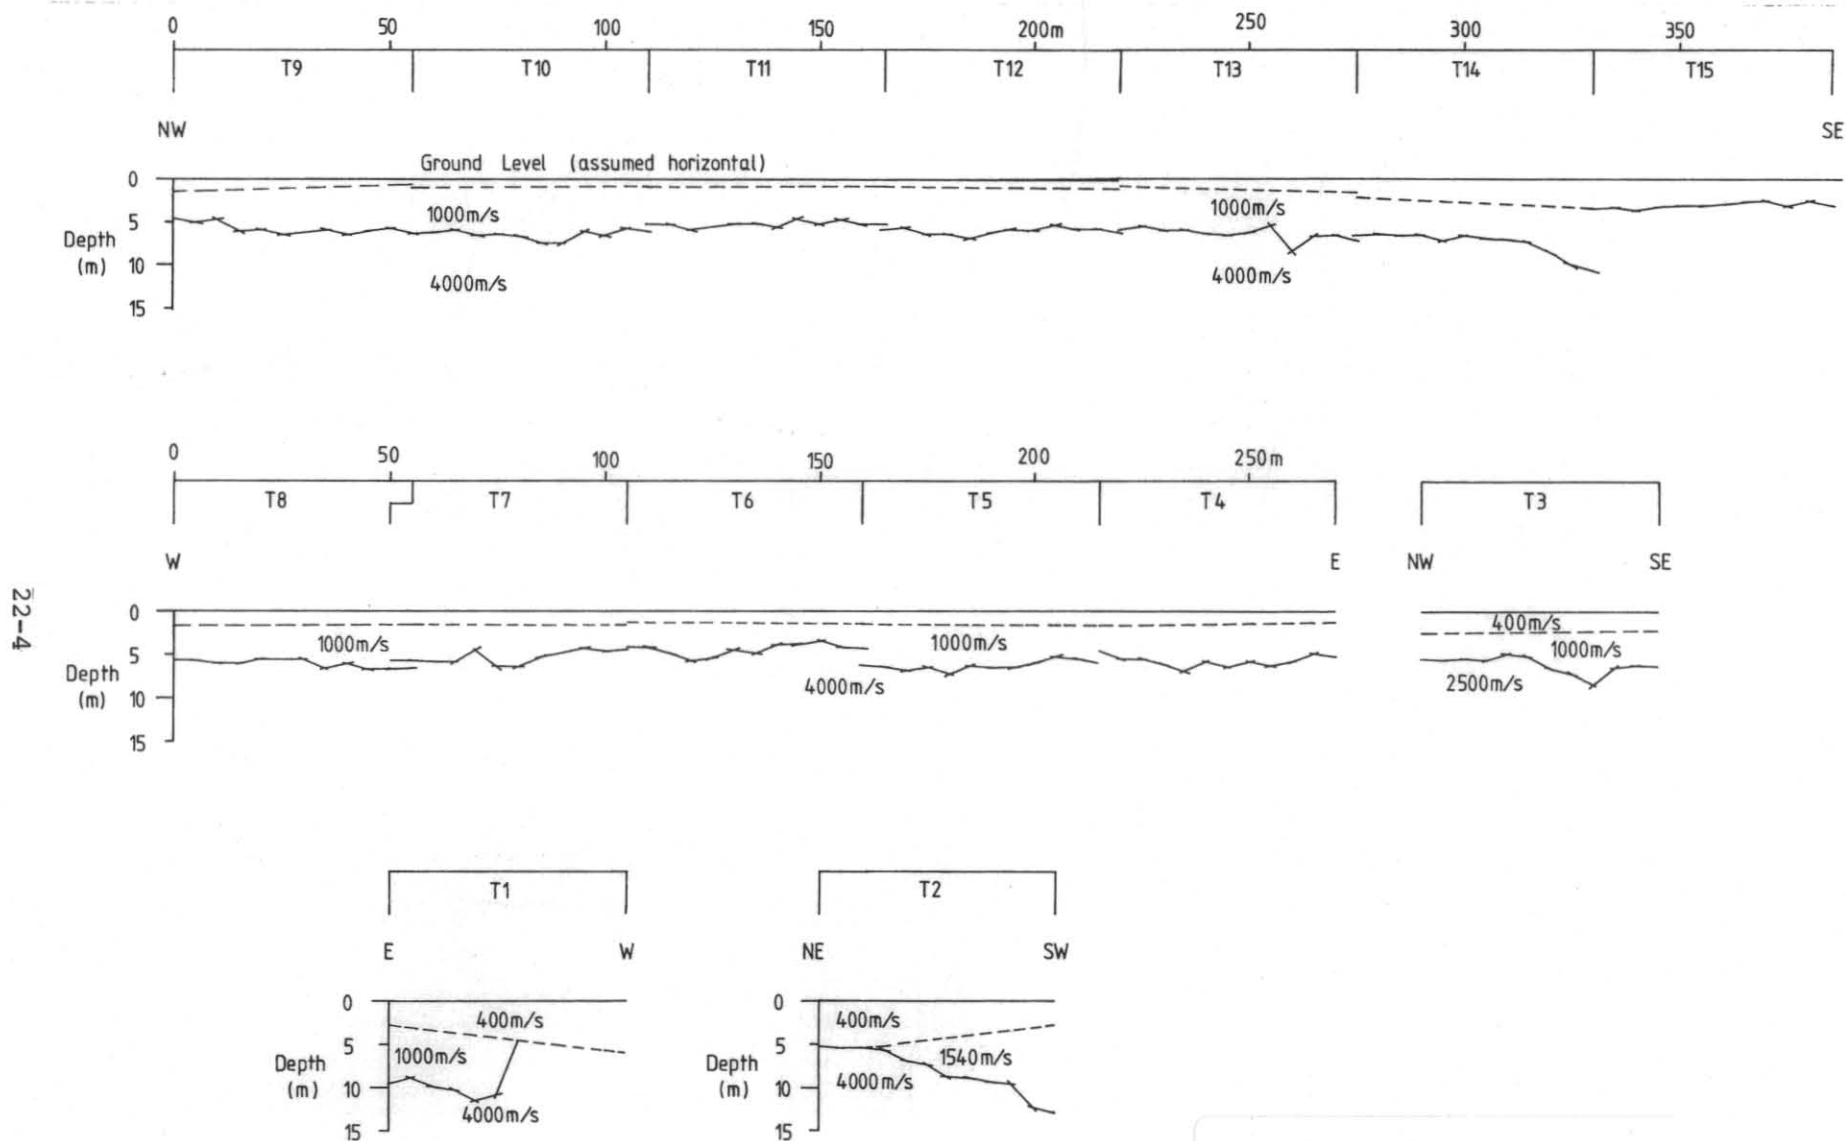
Figure 2. Seismic reflection profiles.

The seismic refraction profiles generally distinguish three types of materials. The surface layer has a seismic velocity between 295-525 m/s. This indicates sandy soil materials which are dry and should be easily excavated by back-hoe or similar equipment. The second layer of material produces seismic velocities between 830-1540 m/s. These velocities are indicative of cemented sand, cemented sandy clay and, clay which are interpreted to be the Tertiary age sediments. The velocity range is also typical of an *in situ* (highly) weathered rock profile. The material should be capable of being excavated with back-hoe or heavier equipment. The third layer produced velocities between 2500 and 5000 m/s. These velocities are that of moderately weathered to fresh rock and are interpreted as representing the basalt material. This velocity range usually requires blasting as part of the excavation procedures.

In this section the surface layer is usually about one metre thick, thickening to about 3.5 m some 340 m from the existing northern outfall. At about 320 m from the existing northern outfall the depth to the top of the basalt increases to between 10 m and 11 m below ground level. The top of the basalt was difficult to detect at traverse 15, indicating either the edge of the basalt flow or a palaeo-valley in the basalt.

In this section the surface layer is calculated to be between 1.3 and 1.7 m thick. The top of the basalt is calculated to occur between 3.4-7.2 m below the ground surface. Minor discrepancies in the calculated depth to the top of the basalt between adjacent traverses are attributed to variations in the first layer velocity.

The location of the seismic traverse in this area was far from ideal due to site limitations. The results are interpreted to indicate a surface layer 2.1-2.7 m thick with the top of the basalt occurring from about 4.2 m to 8.2 m below ground level.

This traverse was laid across land which varied considerably in level. A planar ground surface has been assumed for the interpretation. In the vicinity of Wharf Road, the surface layer, which here includes fill materials, is up to 5.9 m thick and directly overlies the basalt. Towards the oil trap, the surface layer is between 2.8 m and 4.2 m thick with the top of the basalt being calculated to occur between 8.9 m and 11.6 m below the natural surface.

This traverse is interpreted to indicate a surface layer some 5.4 m thick at the north-eastern end and 2.8 m thick at the south-western end of the

line. The intermediate layer is apparently absent in the north-east but is present on the south-western end of the traverse. The top of the basalt is calculated to occur 5.4 m below the surface on the north-eastern end of the traverse, increasing to 12.7 m below ground level at the south-western end.

Proposed improvements to the stormwater drainage system at the Bell Bay aluminium plant require a pipeline from the existing northern outfall to the existing southern outfall. This pipeline will be placed in a trench up to six metres below existing ground level. Seismic refraction surveys indicate that the top of the massive basalt, which will require blasting, commonly occurs between four to six metres below existing ground level.

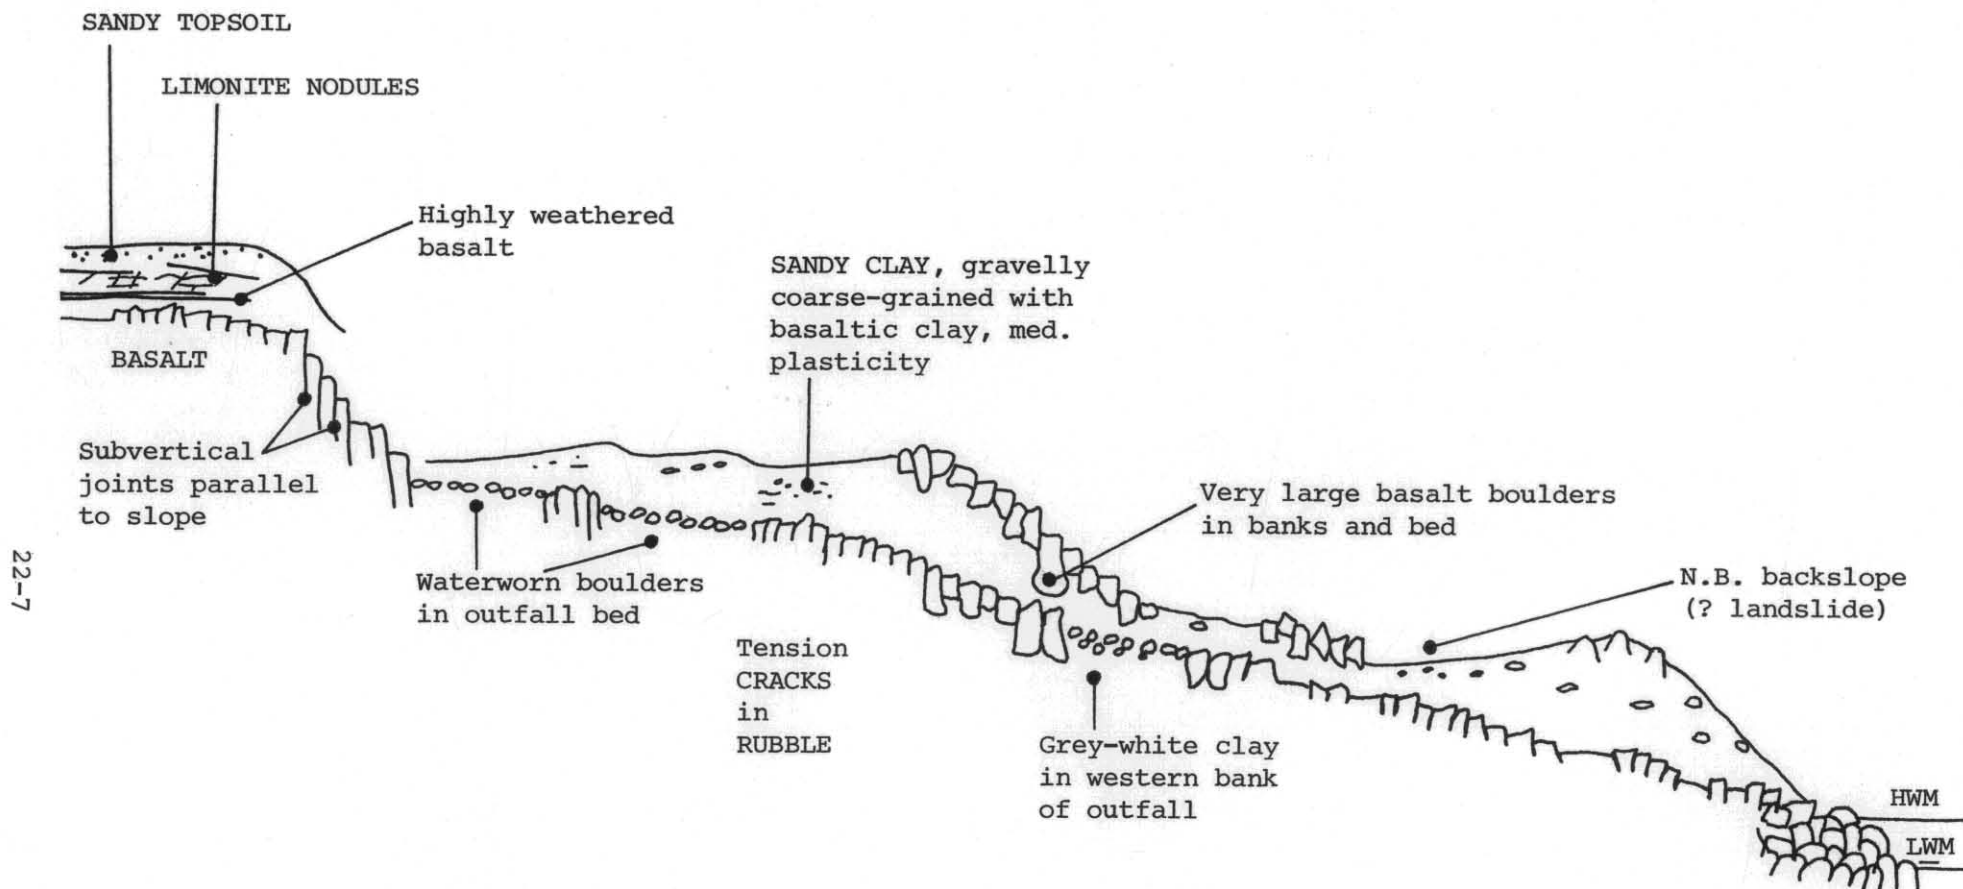
Figure 3. Schematic long section, Fringeland Outfall, Comalco Aluminium (Bell Bay) Pty Ltd

An inspection has been made along the length of the outfall from the culvert on River Road to the River Tamar. A sketch plan and cross-section, not to scale, is provided as Figure 3. The top of the basalt is clearly defined in the outfall and occurs beneath several metres of sandy and clayey sediments. The basalt is subvertically jointed with joints striking roughly parallel to the slope. These joints are relaxed and movement has occurred on the joints. The base of the basalt is not visible but at river level the materials are Tertiary age sediments, some having clearly moved down the slope.

The existing outfall discharges over ground which is mobile. In places the discharge disappears underground to re-appear elsewhere. This condition must be contributing to slope instability. A remedy may be rather elusive. The entire length of the slope will require attention.

The present fringeland discharge passes through a notch cut into the basalt on the slope. Tension cracks occur both upslope and downslope of the notch. The inference, which has not been demonstrated as fact, is that the mass of basalt has moved on the slope. If this is the case, then a rather large block through which the discharge must pass is unstable.

- (1) Slope grooming of a swath say some 20-30 m wide along the length of the discharge. This grooming should remove overhanging masses of materials and fill in any back-slopes where water may pond.
- (2) Extensive planting not only on the groomed swath but extending along the slope in either direction away from the line of discharge.
- (3) Foreshore improvements which will act so as to reduce erosion of the foreshore in the vicinity of the discharge at river level. These works would also act as a buttress for materials on the slope.

- (4) The discharge should be contained within a structure extending from River Road to the foreshore. The structure will contribute to stability by preventing water from entering the slope. The structure will need to withstand some movement and should be easily and inexpensively repaired or replaced.

The treated water will be discharged to the River Tamar via the existing fringe-land outfall. This outfall is currently a channel achieved by natural processes. Water disappears underground in places to re-appear elsewhere. It is recommended that the discharge be contained within a structure placed on a slope which has been groomed and planted with trees.
