# A review of groundwater monitoring at Rosetta (1991–2001)

A. Waite

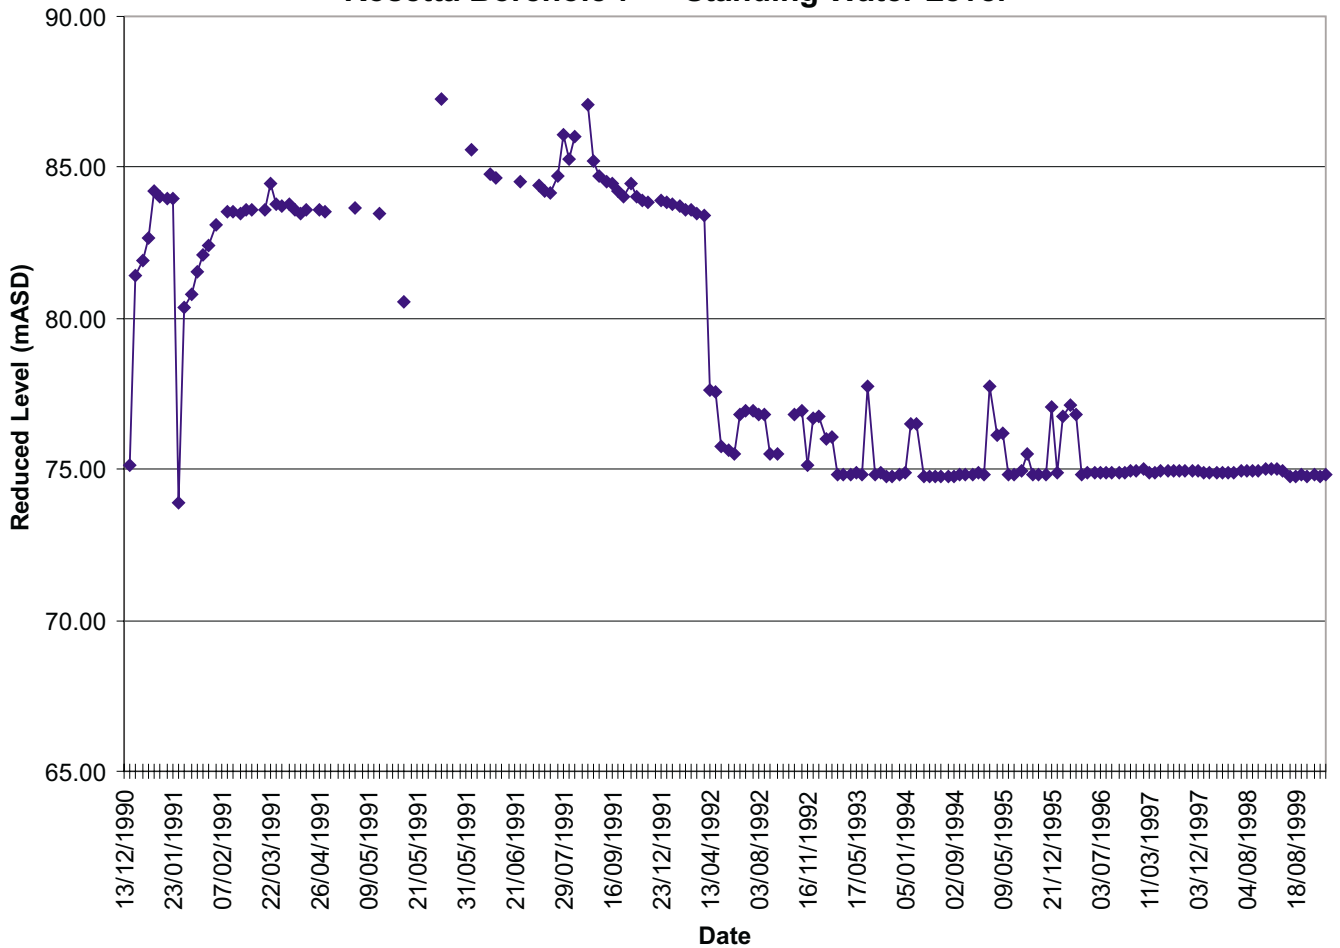
### Rosetta Borehole 7 — Standing Water Level

The greatest changes have occurred in the area with the greatest density of horizontal drains, with significant decreases (up to 10 m) in groundwater level observed in boreholes 7, 7a and 23. The holes showing the least or no difference are those wholly within geological materials other than Tertiary sediments, suggesting the presence of different hydrogeological conditions in these older fractured aquifers and

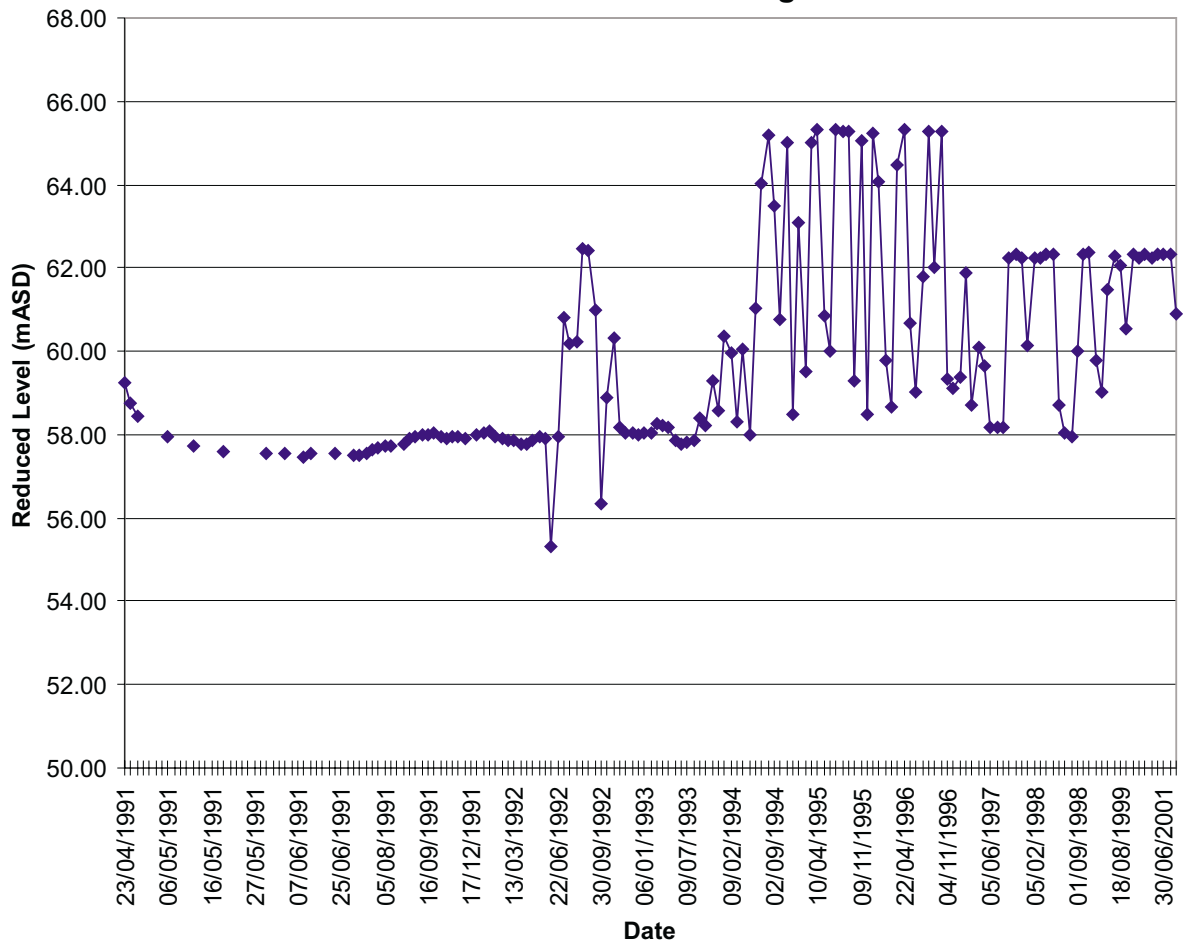
**Rosetta Borehole 18 — Standing Water Level**

Borehole 18 showed an increase in observed water level over the period, indicating a source of recharge to this location. This anomalous behaviour may also be influenced by the local hydrogeological conditions, resulting from the hole's proximity to a fault line.

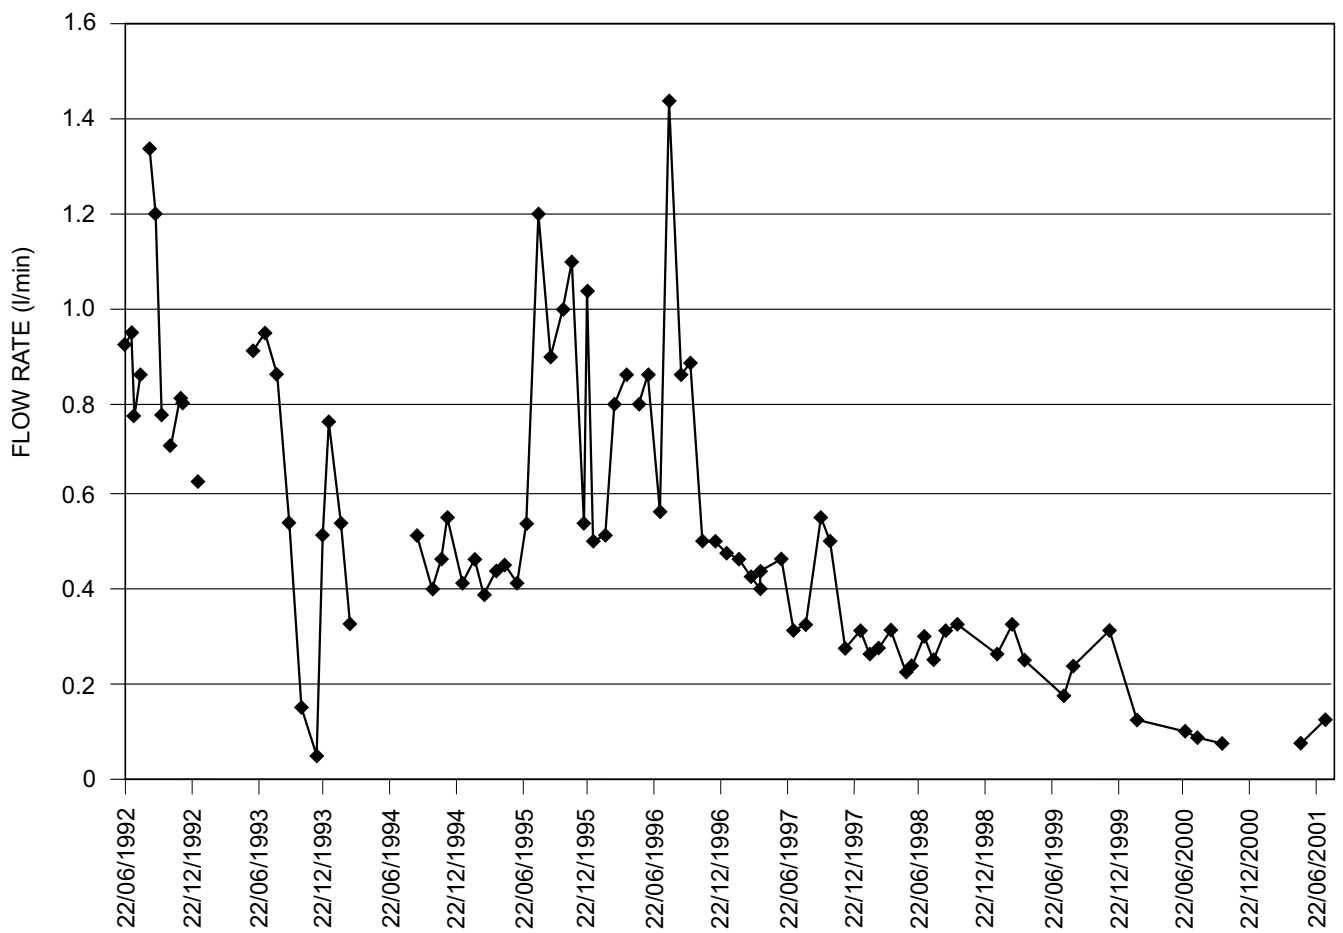
### Flow rates from horizontal drains

The 'crude but direct' relationship between rainfall and groundwater levels, with rapid response times to rainfall events (Donaldson, 1991), has generally become more obvious since 1991, indicating that the dewatering measures have probably significantly altered local hydrogeological conditions. The success of the dewatering is also indicated by the reduction in flow rates from the horizontal drains over time (Appendix 3).

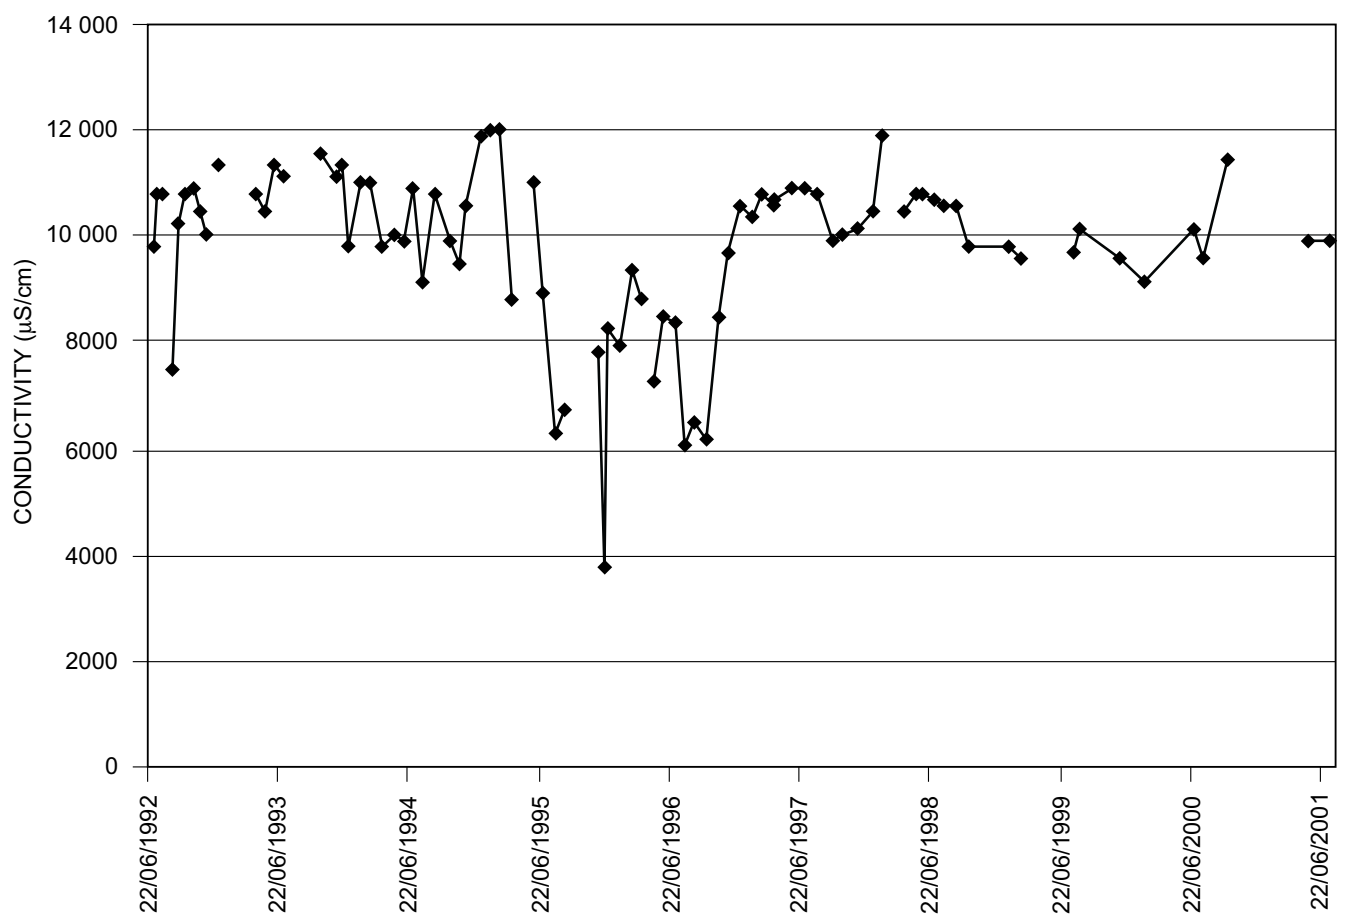
### Conductivity of water from horizontal drains

The sensitivity of the local groundwater to recharge is confirmed by the conductivity data (Appendix 4). There is a strong relationship between major rainfall events and the decreasing conductivity, in particular for the period of peak rainfall from 1995 to 1997.
