**Tasmanian Geological Survey
Record 2013/09**

Parnella landslide area, St Helens

Geomorphological mapping and a review of past investigations and mitigation works

by M. D. Stevenson

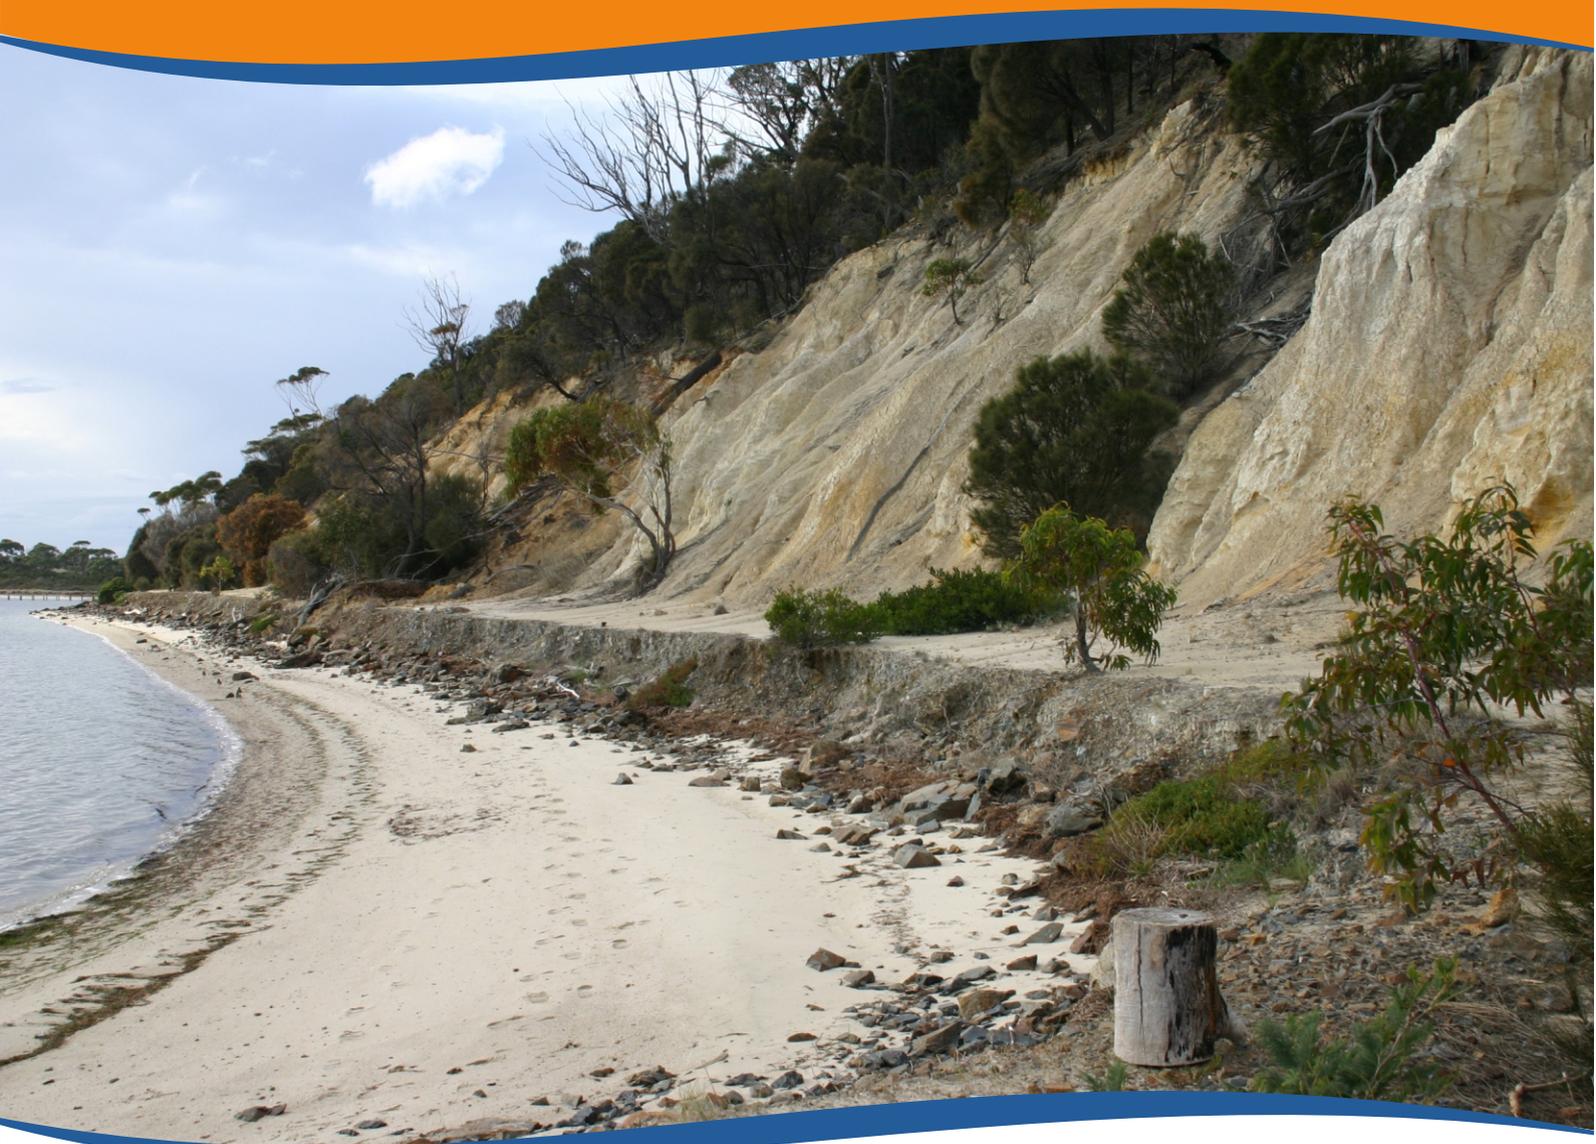
Cover: Eroding shoreline scarp in the Chimney Heights area in 2007 (prior to major failure in 2011), showing 1993–1994 shore protection works.

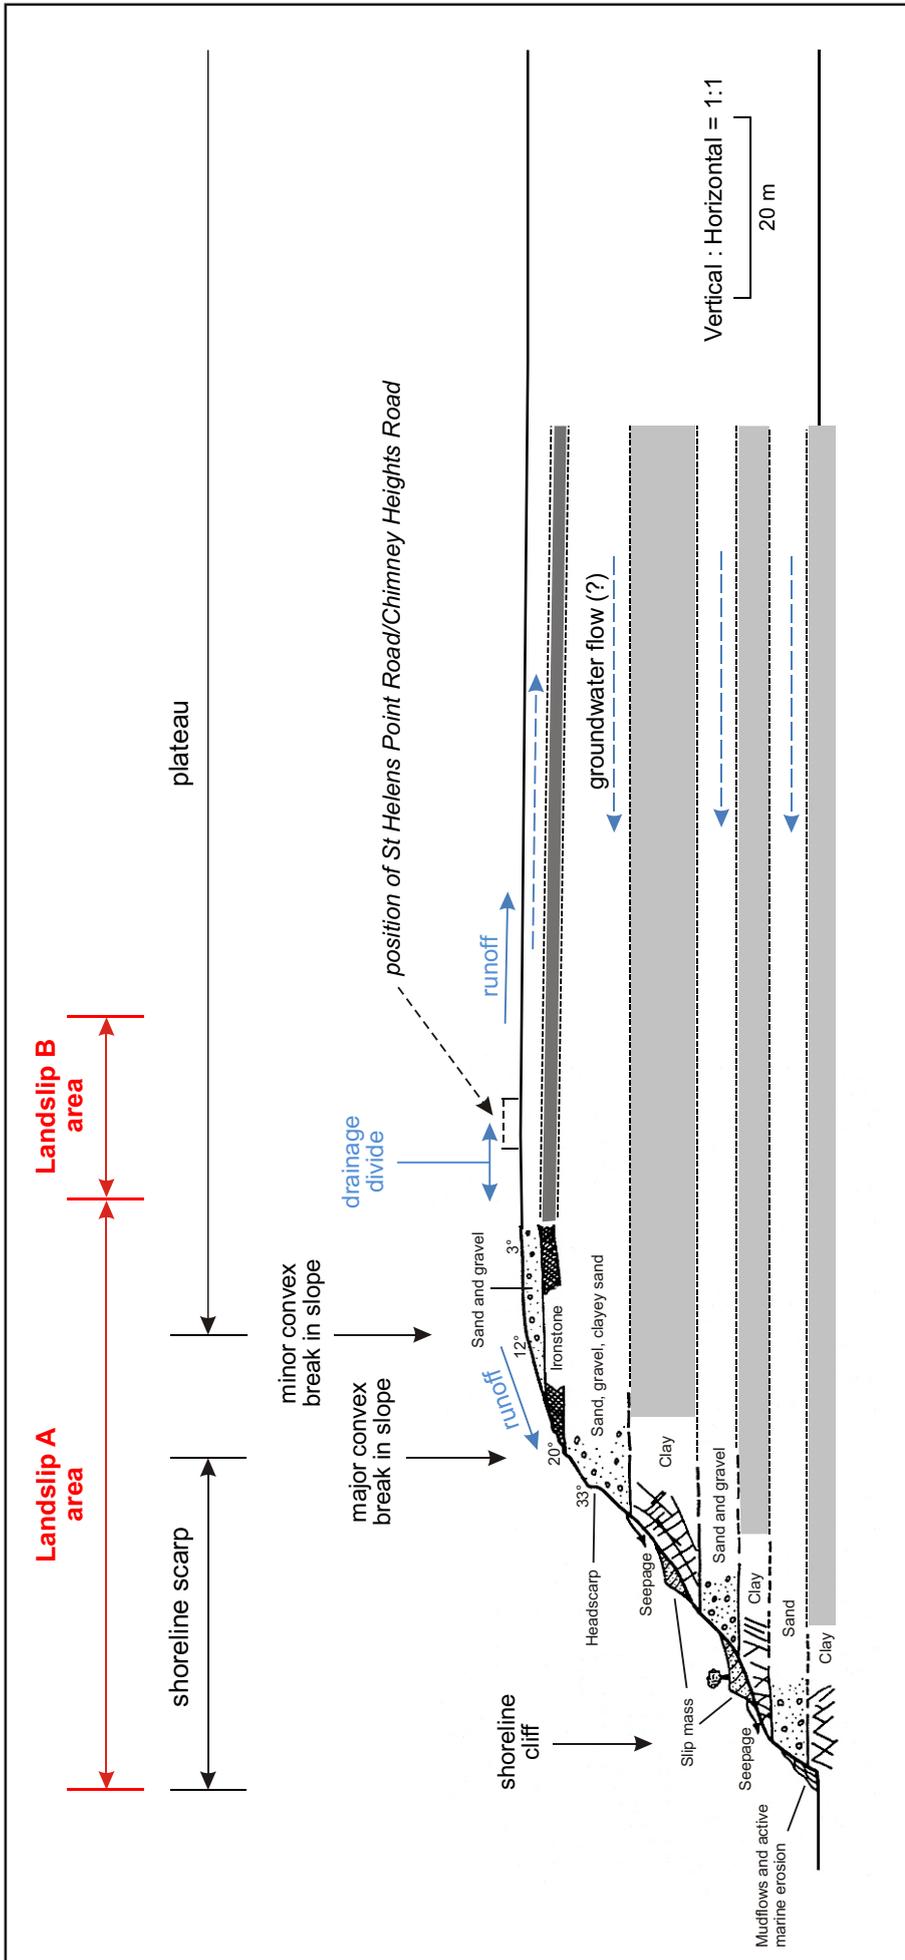
Figure 2

Typical slope profile with simplified geology and hydrology for the northeastern zone, Chimney Heights area (modified from Sloane, 1985a,b). Landslides on the shoreline scarp within this area are typically planar slab failures, debris slides and earth flows, most of which fall over the steeper lower slope segment (the shoreline cliff) and the landslide debris is then carried away by wave action. Note: the detailed stratigraphy is not well understood. Sloane (1985a,b) found that the subsurface iron pan ('ironstone') has a general dip inland and the upper surfaces of the sub-horizontal clay units are sharply defined and undulating. However both appear to have significant lateral and vertical variability.

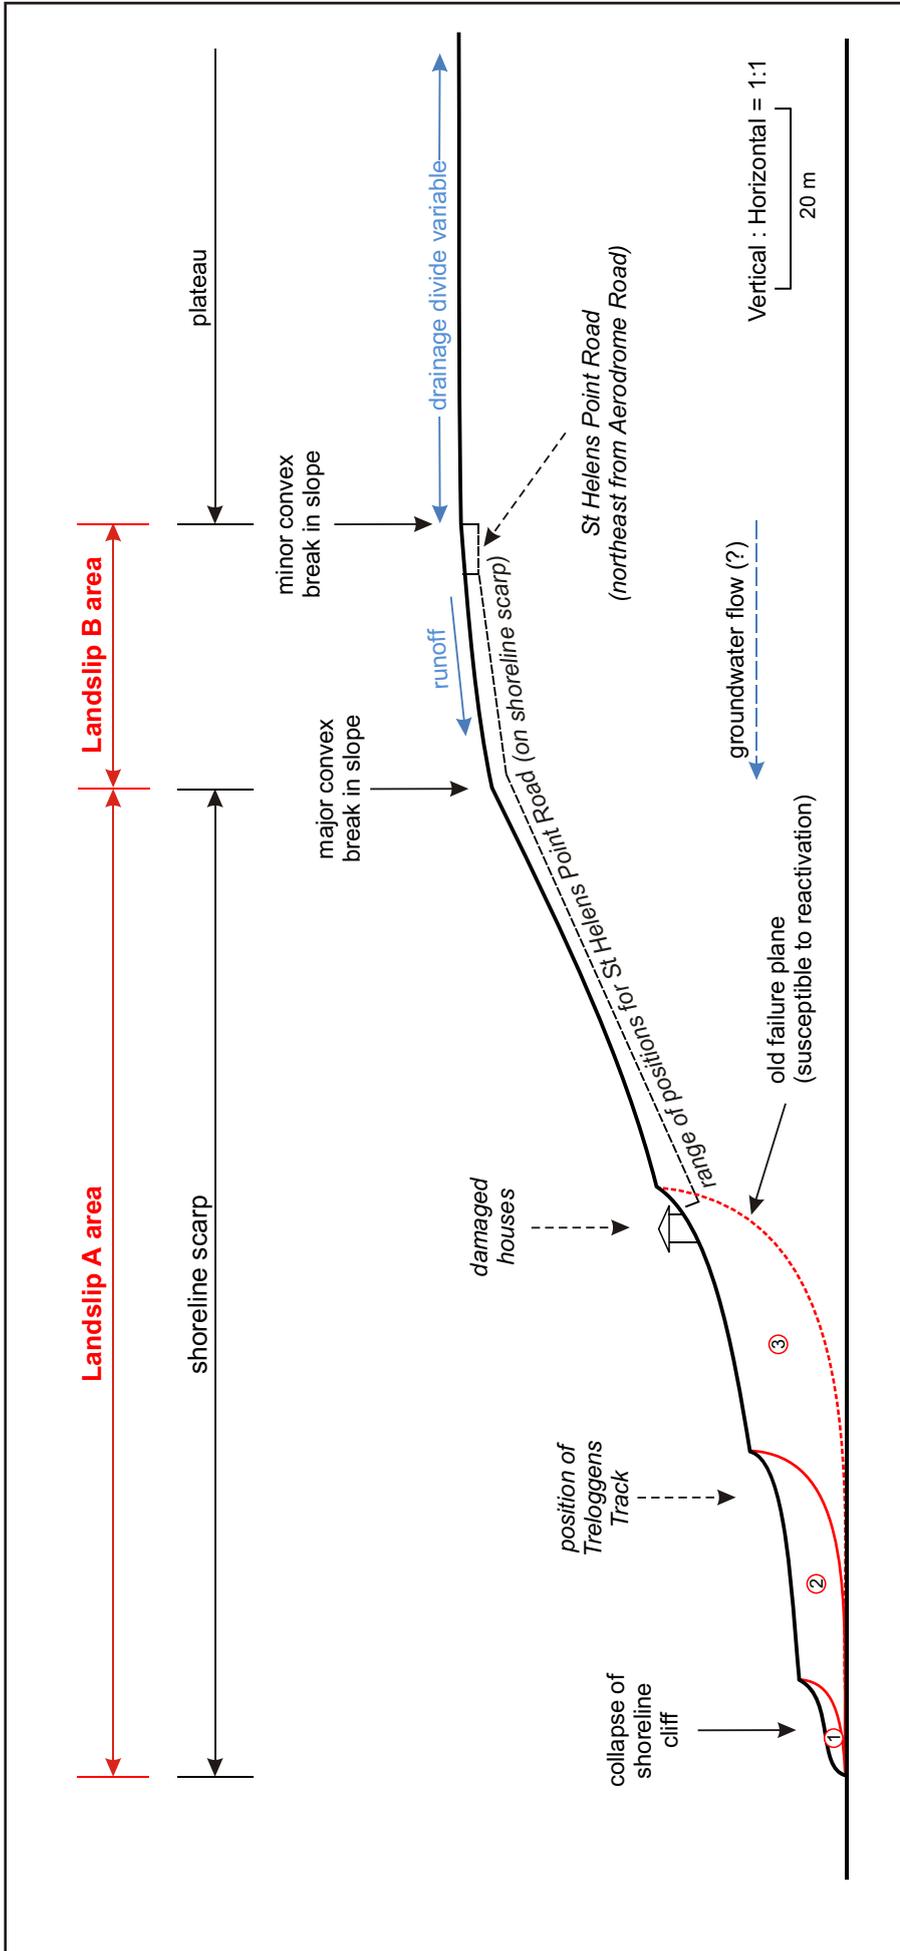
Figure 3

Typical slope profile with simplified hydrology for southwestern and central zones, southwest of Yellow Bluff. Landslides on the shoreline scarp within this area are typically semi-rotational slides. Typically there are failures observed in three slope positions of increasing size: ① — common landslides at the shoreline cliff are driven by shore erosion; ② — subsequent progressive failure advancing inland (southwestern zone), or long-lived active failures (central zone) with little shore erosion; and ③ — pre-existing old landslides that are susceptible to reactivation. The geological sequence here is not well understood as most outcrop is covered in slope deposits, but Tertiary clay does outcrop at the shoreline.

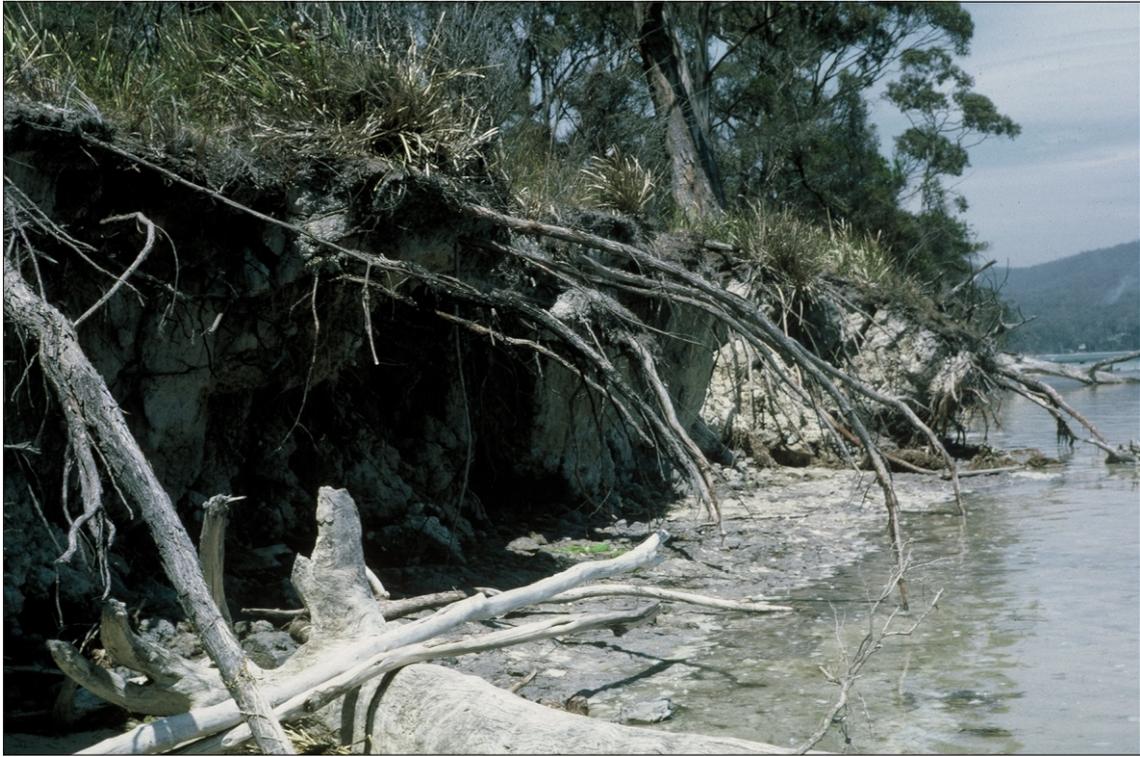
Photo 1

*Active erosion below Treloggens Track, southwestern zone
[landslide ID 5020?] — January 1971.*

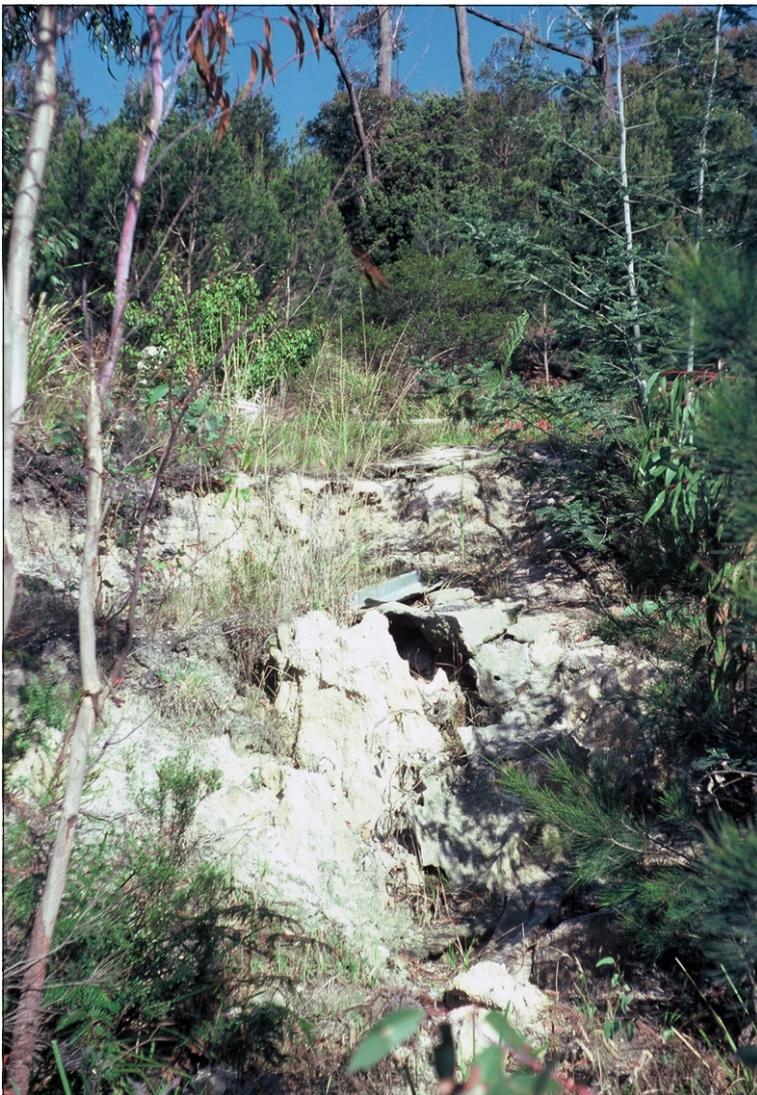
Photo 2

*Site of removed holiday house above
Treloggens Track (25 St Helens Point
Road) [landslide ID 1090] — 1978(?)*

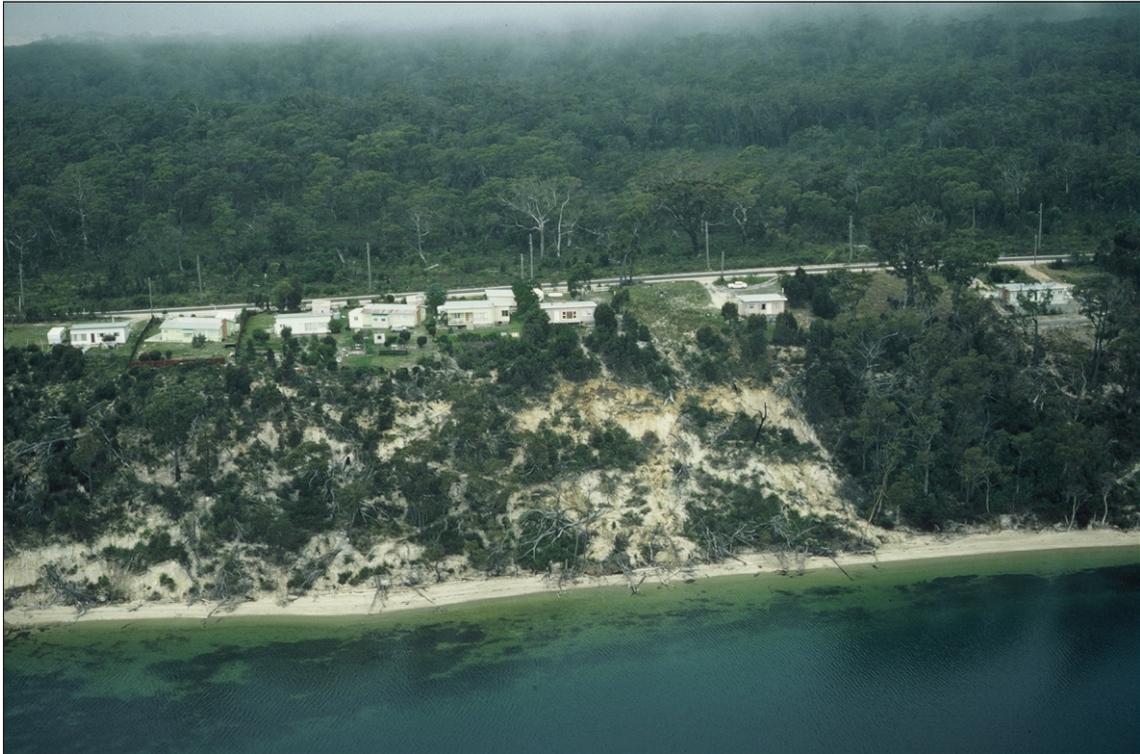
Photo 3

Cliffs near Yellow Bluff showing extensive failure where vegetation has been cleared (Yellow Bluff area, transitional zone) [landslide IDs 5094 and 5098] — 1978.

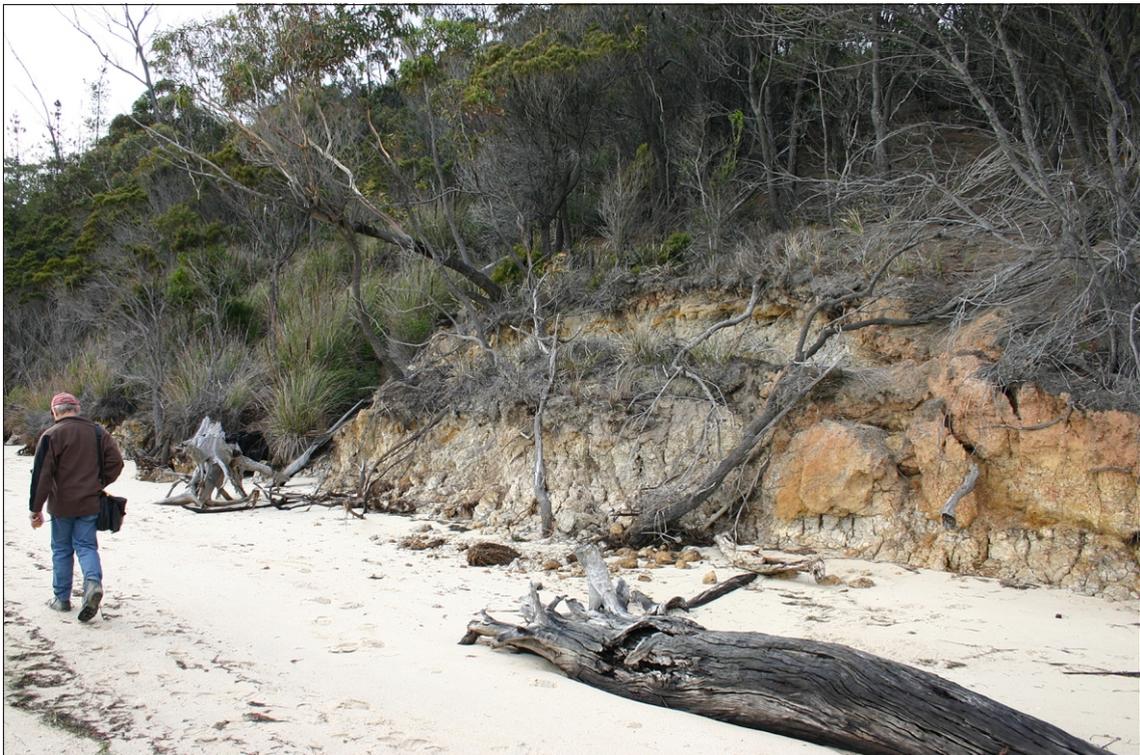
Photo 4

Erosion and collapse at the shoreline continues, with trees falling onto the beach. This removes support for the slope behind, causing a layer of material to slowly slide down onto the beach (southwest of Yellow Bluff, transitional zone) [landslide ID 5089] — 26 July 2007.

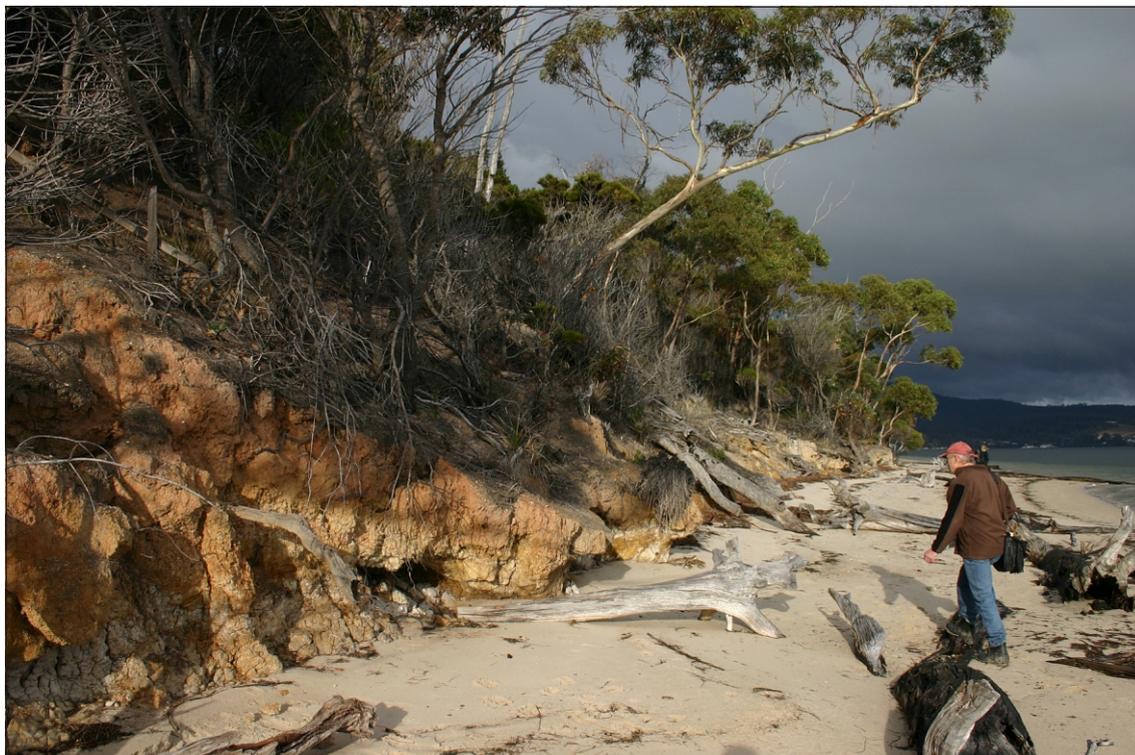
Photo 5

*Undercutting of the shoreline causing the ground to slide over the top (many trees on the beach)
(southwest of Yellow Bluff, transitional zone) [landslide ID 5089 and 5090] — 26 July 2007.*

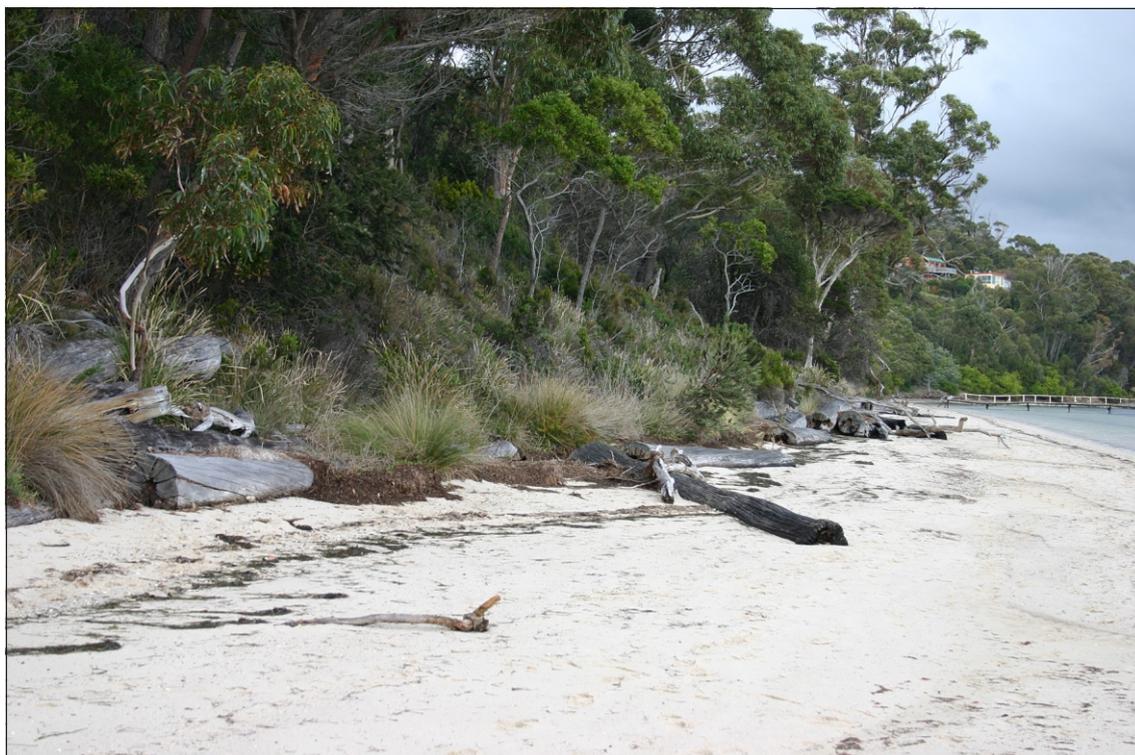
Photo 6

*Remains of 1980s shore protection works that formed a discontinuous log wall
(approximately below properties 79–89 on Treloggens Track, central zone) — 26 July 2007.*

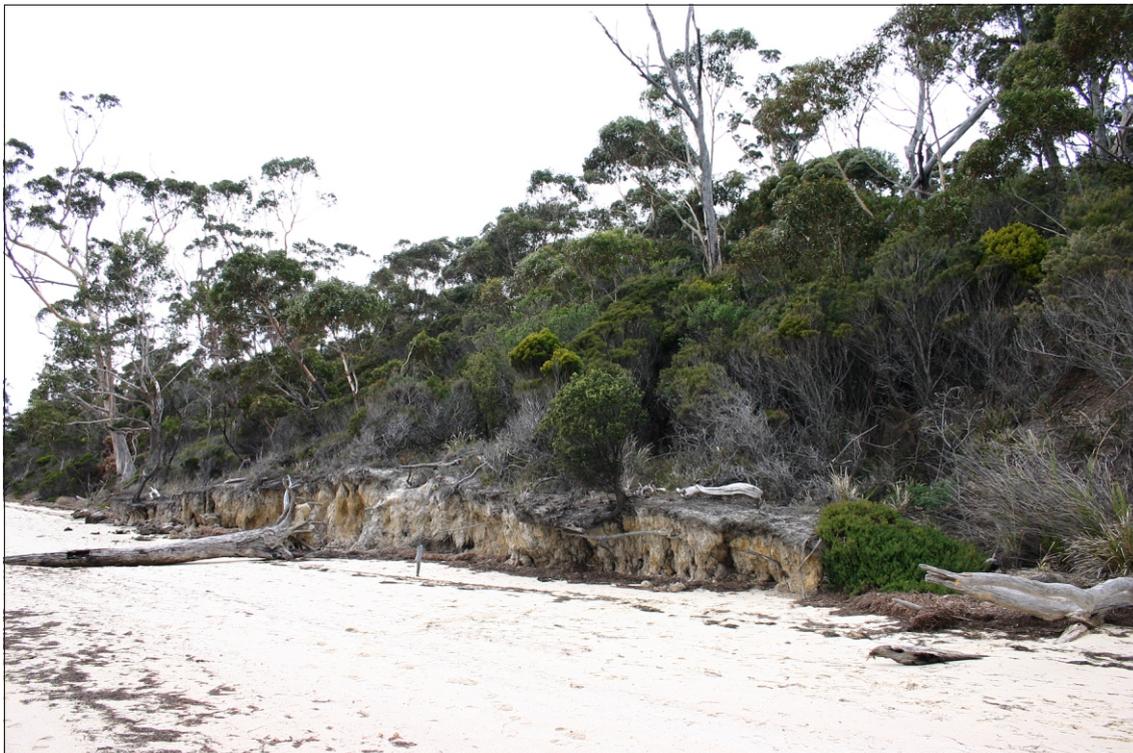
Photo 7

This landslide has continued to be active with ongoing erosion of the landslide toe (below northern end of Treloggens Track, central zone) [landslide ID 5082] — 26 July 2007.

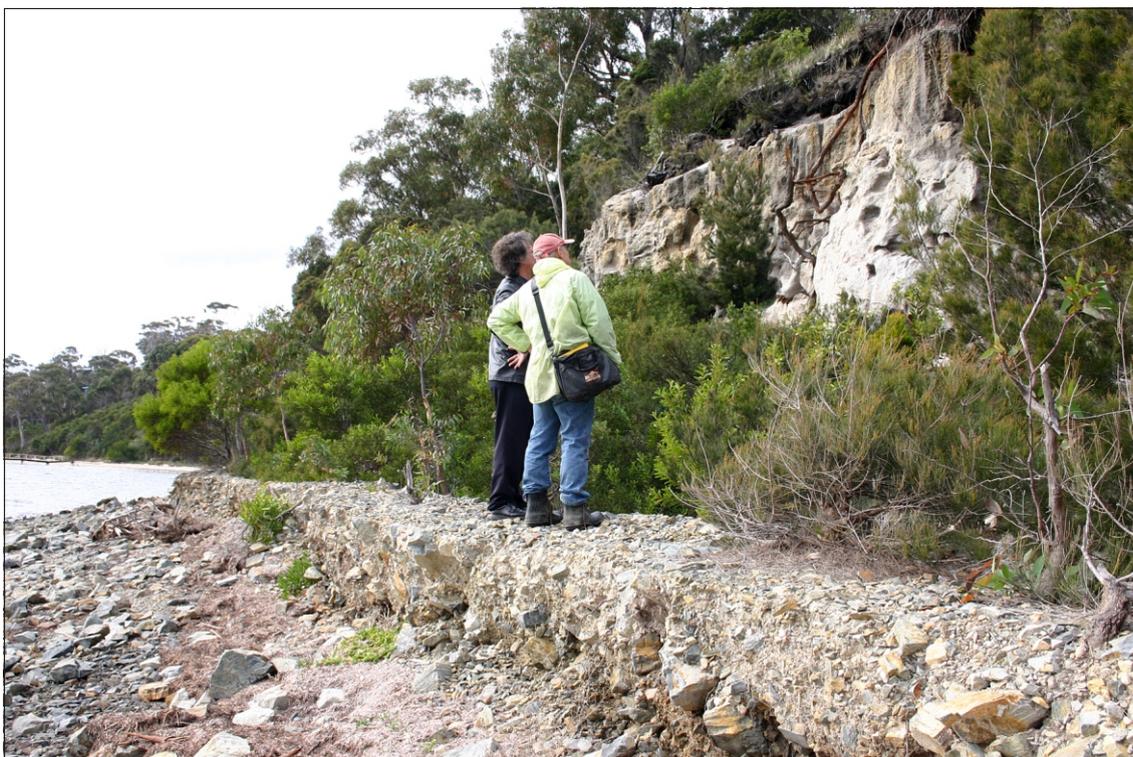
Photo 8

also observed here at the time of site visits in July 2007 (photo 8) and September 2012.

Shore protection works (constructed 1993–1994) are now significantly eroded (at cemented sand bluff, approximately below properties 41–45 on Treloggens Track) [landslide ID 1091, 5049] — 26 July 2007.

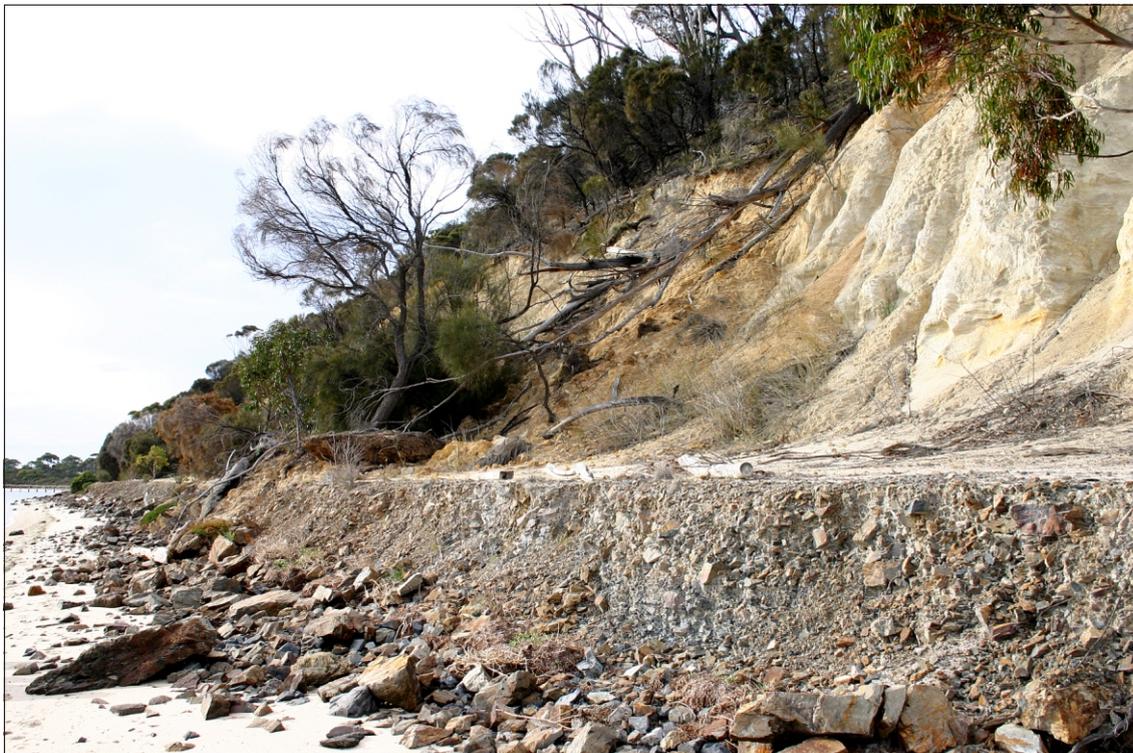
Photo 9

Landslides and flows are occurring despite the 1993–1994 shore protection works (particularly in the Yellow Bluff/Chimney Heights area, northeastern zone) [landslide ID 5136] — 26 July 2007.

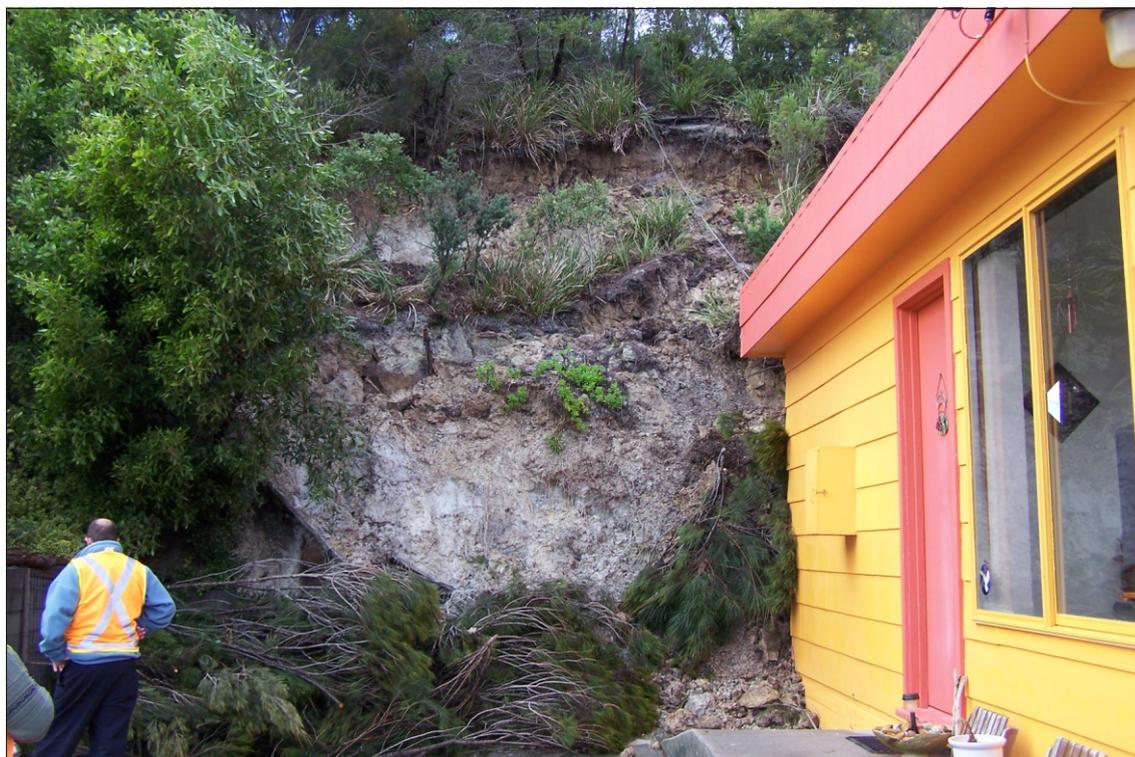
Photo 10

The heavy rainfall of 12–13 April 2011 caused landslides on cut slopes immediately above St Helens Point Road. There were some minor failures along parts of the road cutting where collapse had occurred previously, but the most dramatic landslide was that which occurred behind the house at 64 St Helens Point Road (photo 10). The steep cutting behind the house collapsed and the landslide (4921), about 14 m across, came to rest against the back of the house. Another smaller landslide (4922) resulted from the collapse of the driveway cutting at the same address, which blocked access to the property. Only minor damage occurred and the landslide debris was subsequently removed, but these failures could potentially have been very dangerous for the occupant.

Landslide [ID 4921] up against a house, and another [ID 4922] blocks the driveway, following a heavy rainfall event (cutting above 64 St Helens Point Road, southwestern zone) — 14 April 2011.

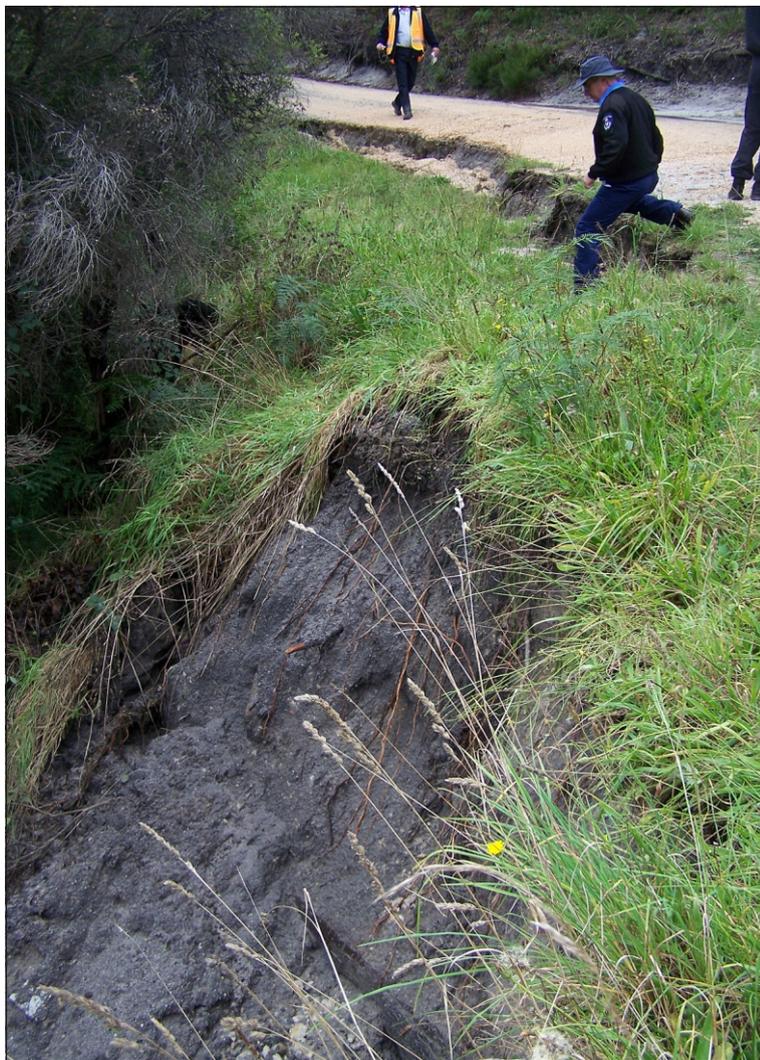
Photo 11

Landslide [ID 4924] affecting Treloggens Track (below properties 75–77, central zone) — 14 April 2011.

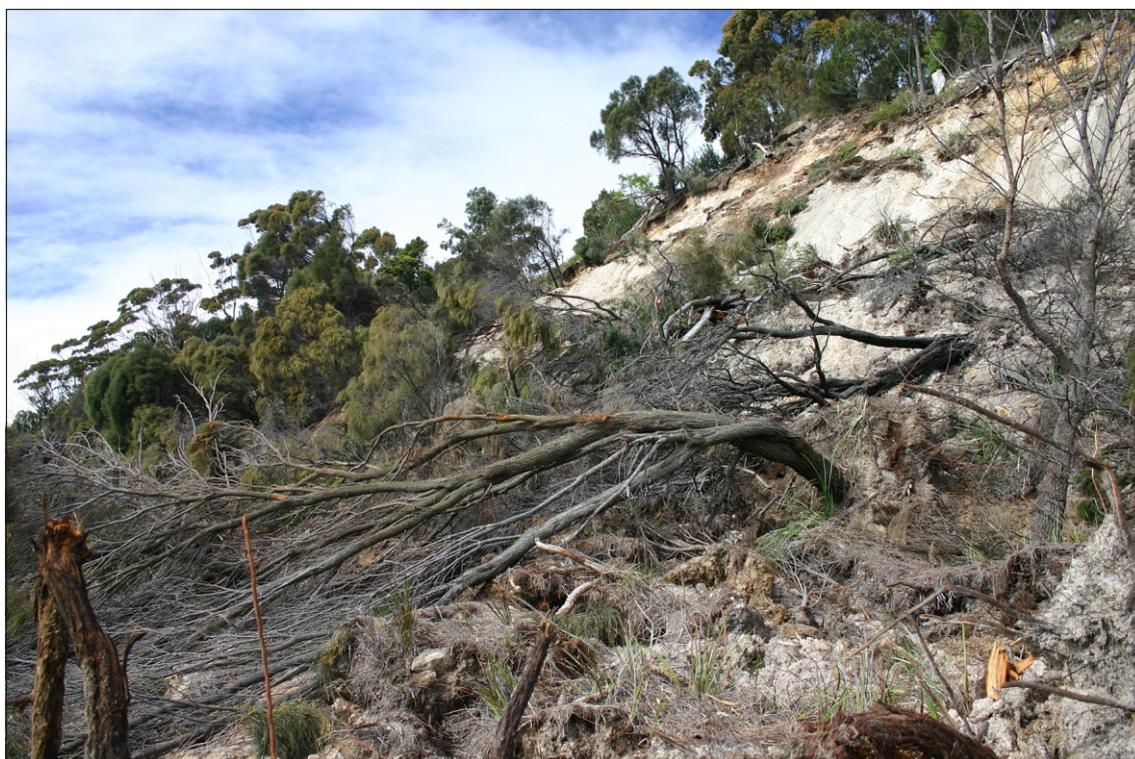
Photo 12

Major landslides caused by a heavy rainfall event following two particularly wet years (Yellow Bluff/ Chimney Heights area, northeastern zone) [landslide ID 5108] — 14 April 2011.

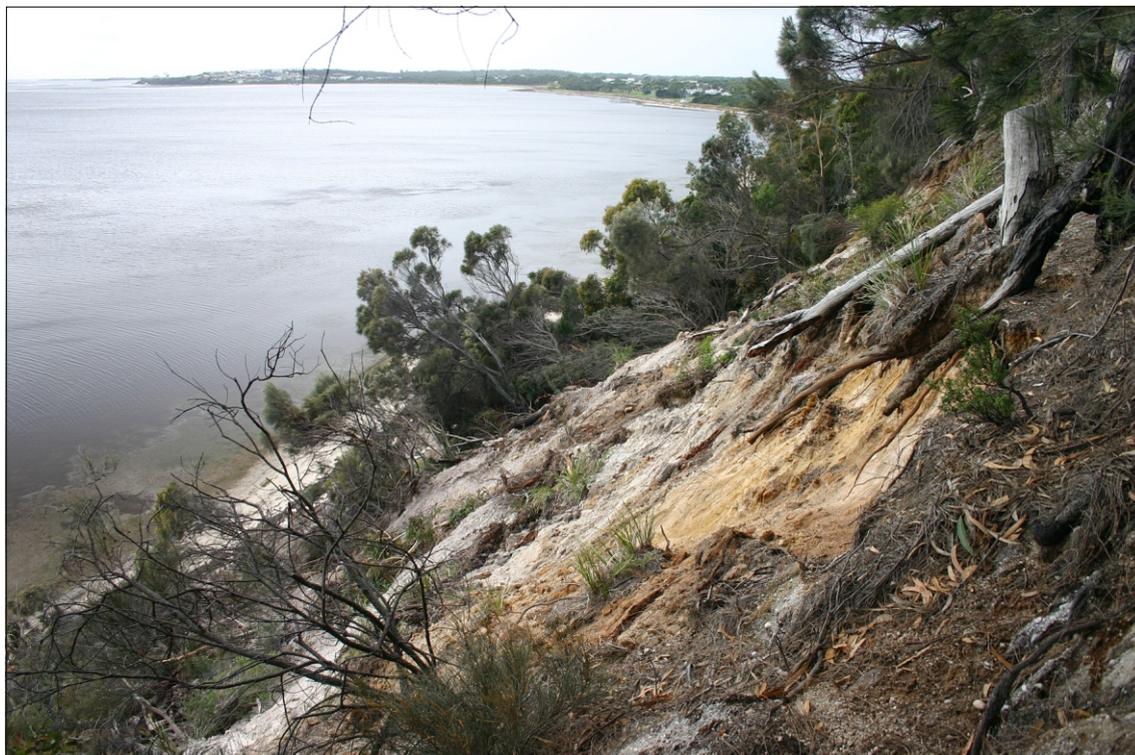
Photo 13

Major landslides now extend upslope into the rear of private properties in this area (Yellow Bluff/Chimney Heights area, northeastern zone) [landslide ID 5108] — 14 April 2011.

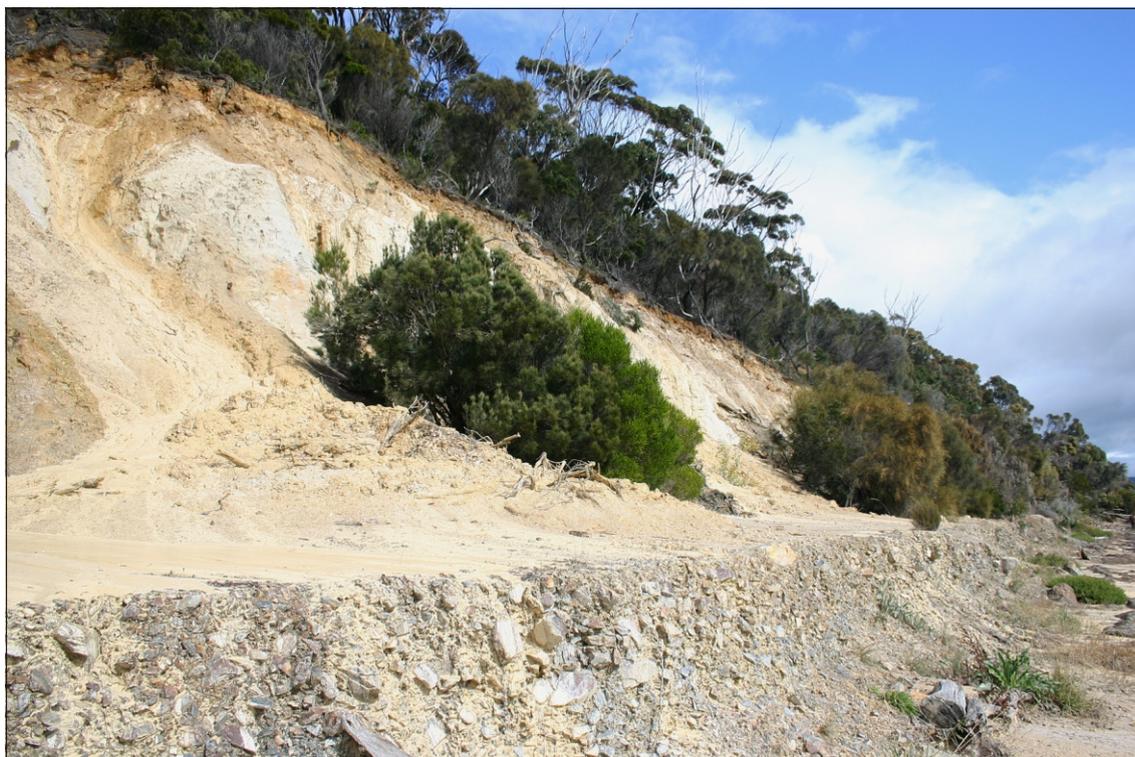
Photo 14

Series of earth flows over the 1993–1994 shore protection works following a heavy rainfall event (Chimney Heights area, northeastern zone) [landslide ID 5141 in the foreground] — 14 April 2011.

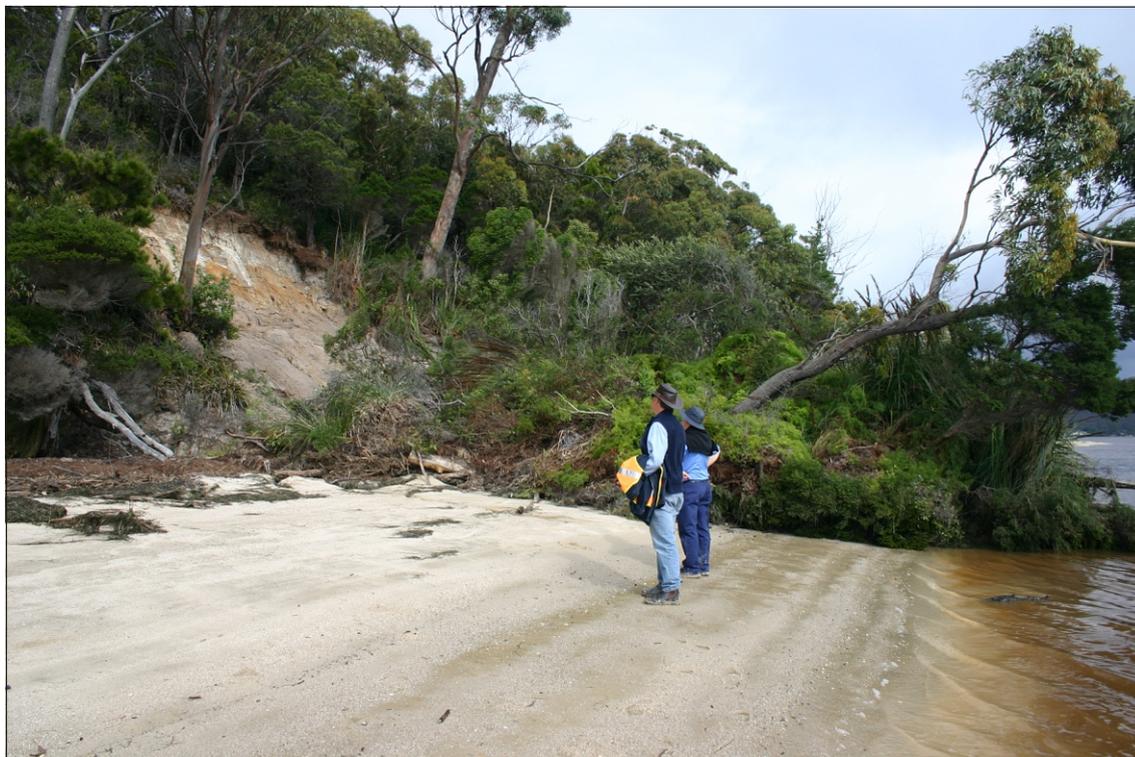
Photo 15

Unusual landslide involving complete separation and rapid movement of a block across the beach following heavy rainfall event (southwest of Yellow Bluff, transitional zone) [landslide ID 5093] — 14 April 2011.
