SHAFT CONDITIONS

AUGUST 1988

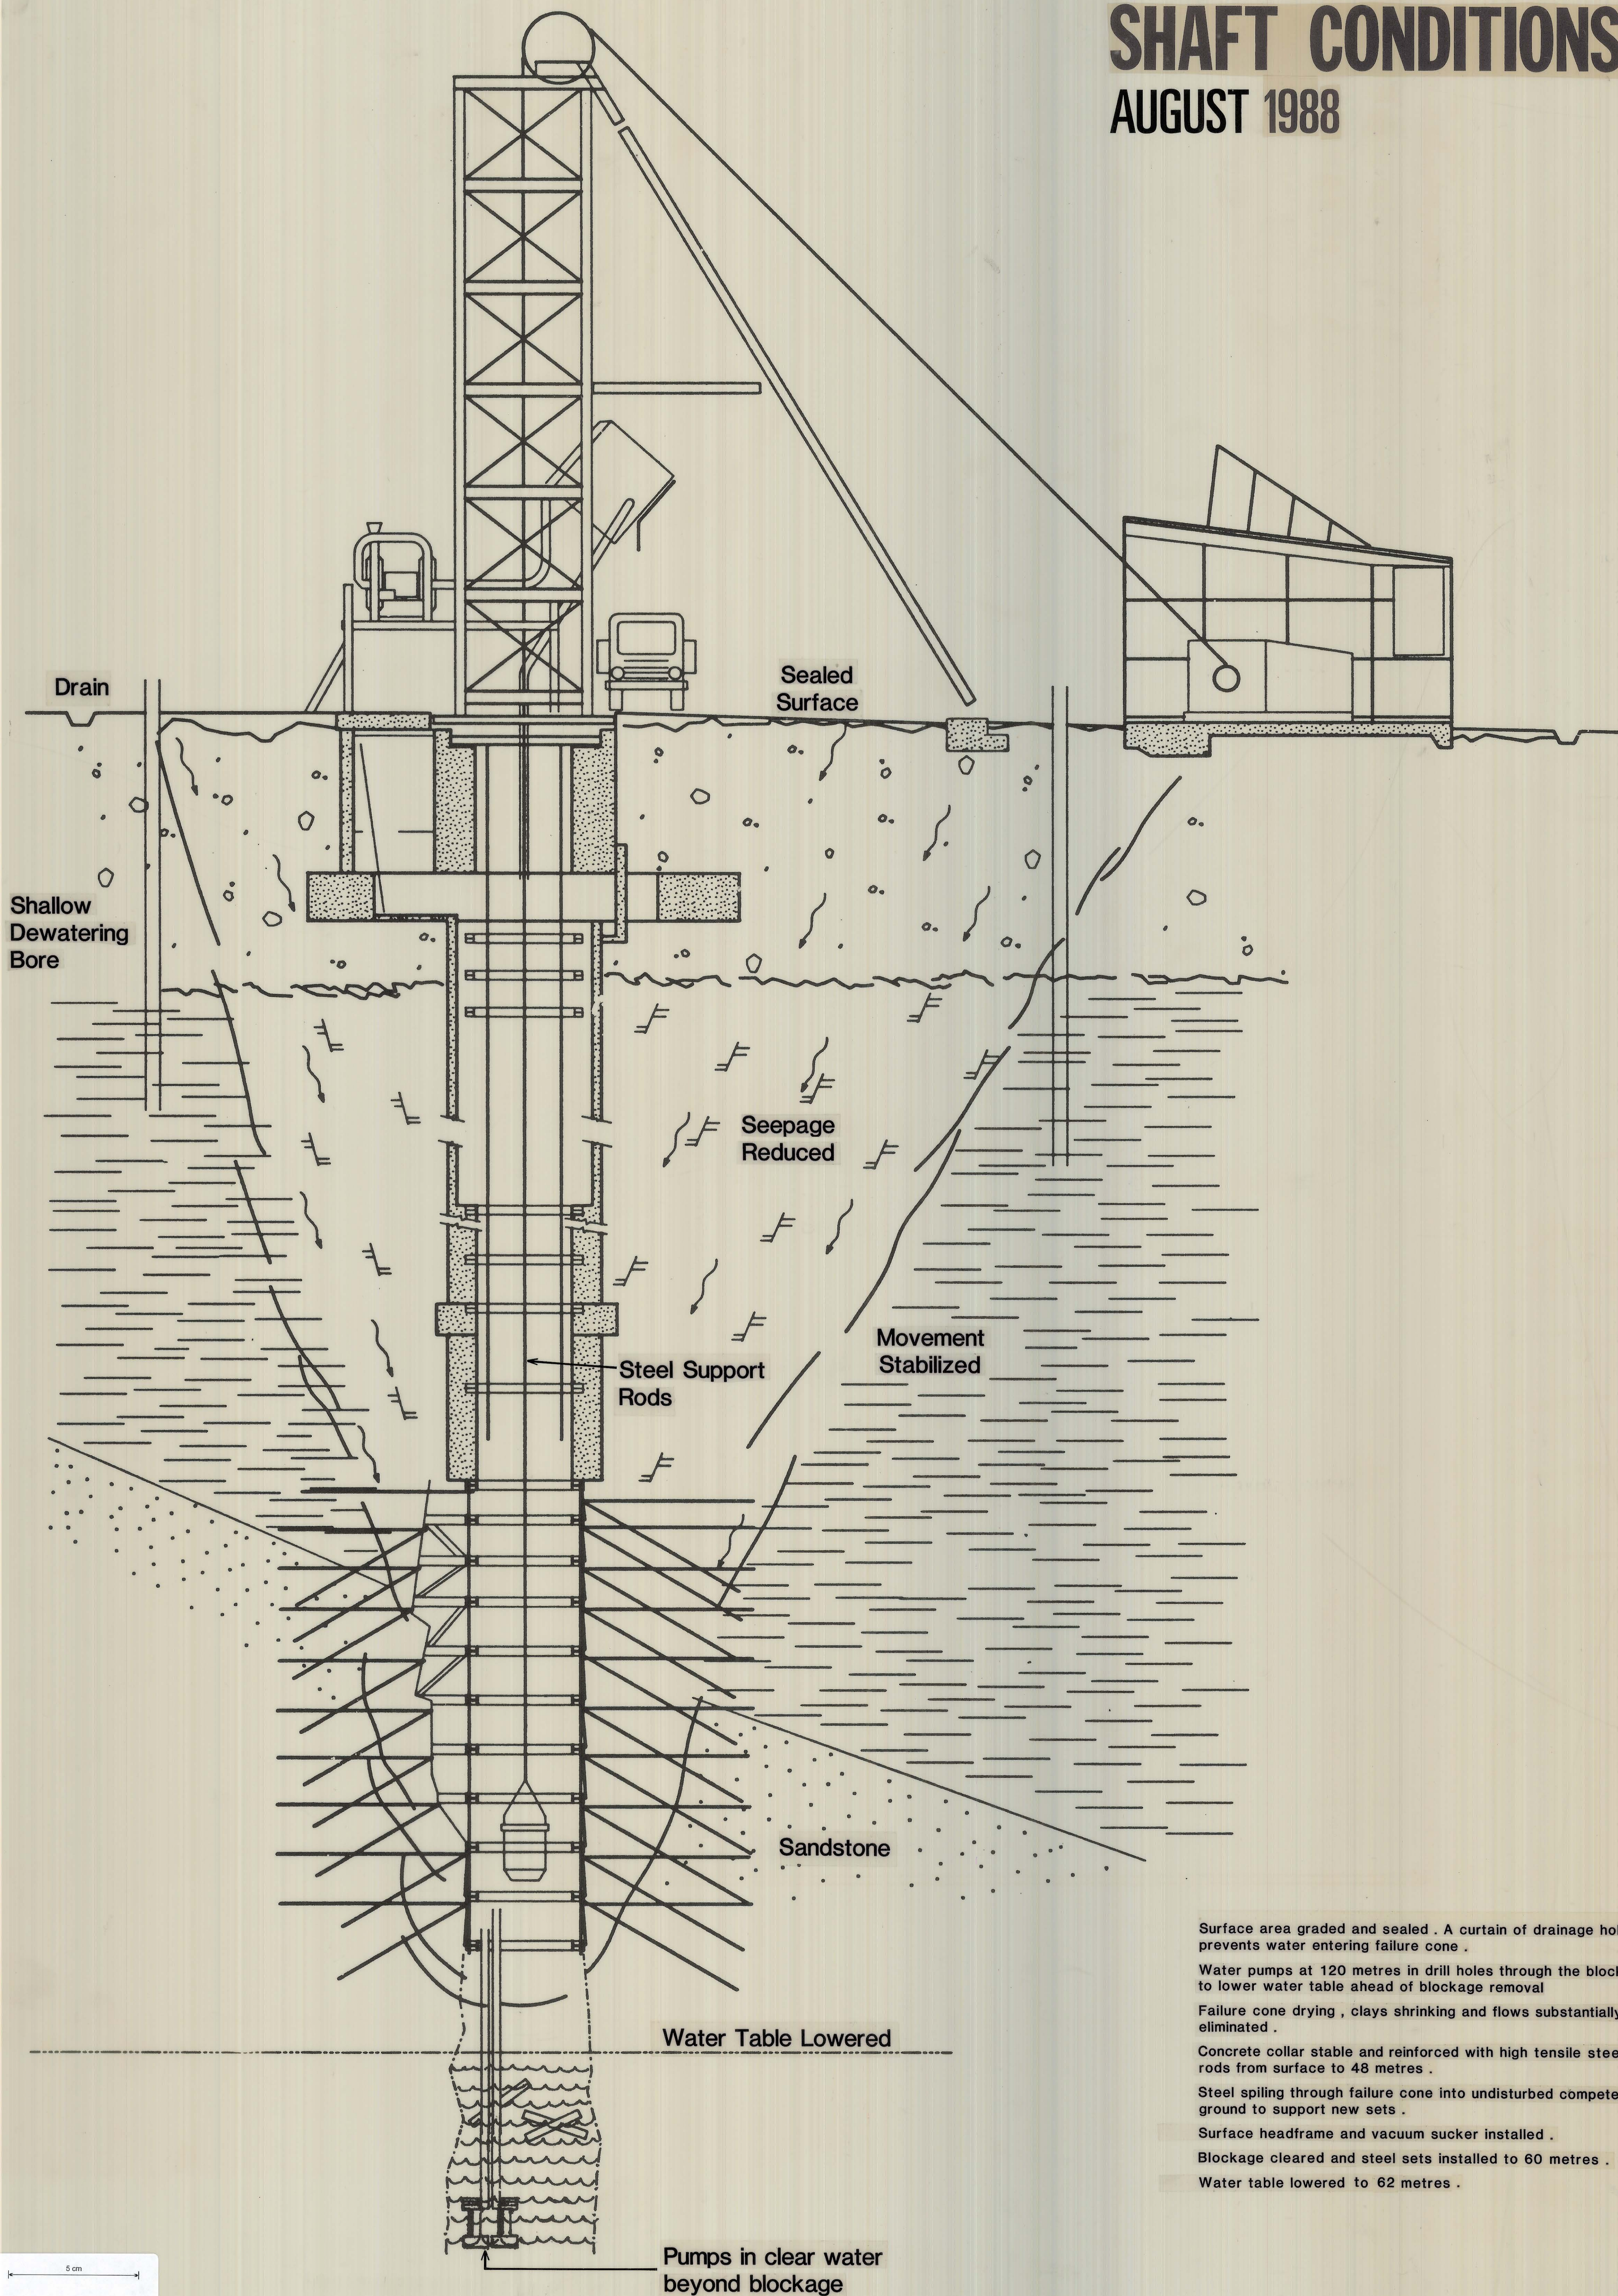
Surface area graded and sealed . A curtain of drainage holes prevents water entering failure cone .

Water pumps at 120 metres in drill holes through the blockage to lower water table ahead of blockage removal

Failure cone drying , clays shrinking and flows substantially eliminated .

Concrete collar stable and reinforced with high tensile steel rods from surface to 48 metres .

Blockage cleared and steel sets installed to 60 metres .

Water table lowered to 62 metres .

Steel spiling through failure cone into undisturbed competent ground to support new sets .

Surface headframe and vacuum sucker installed .
