SHAFT CONDITIONS

JUNE 1987

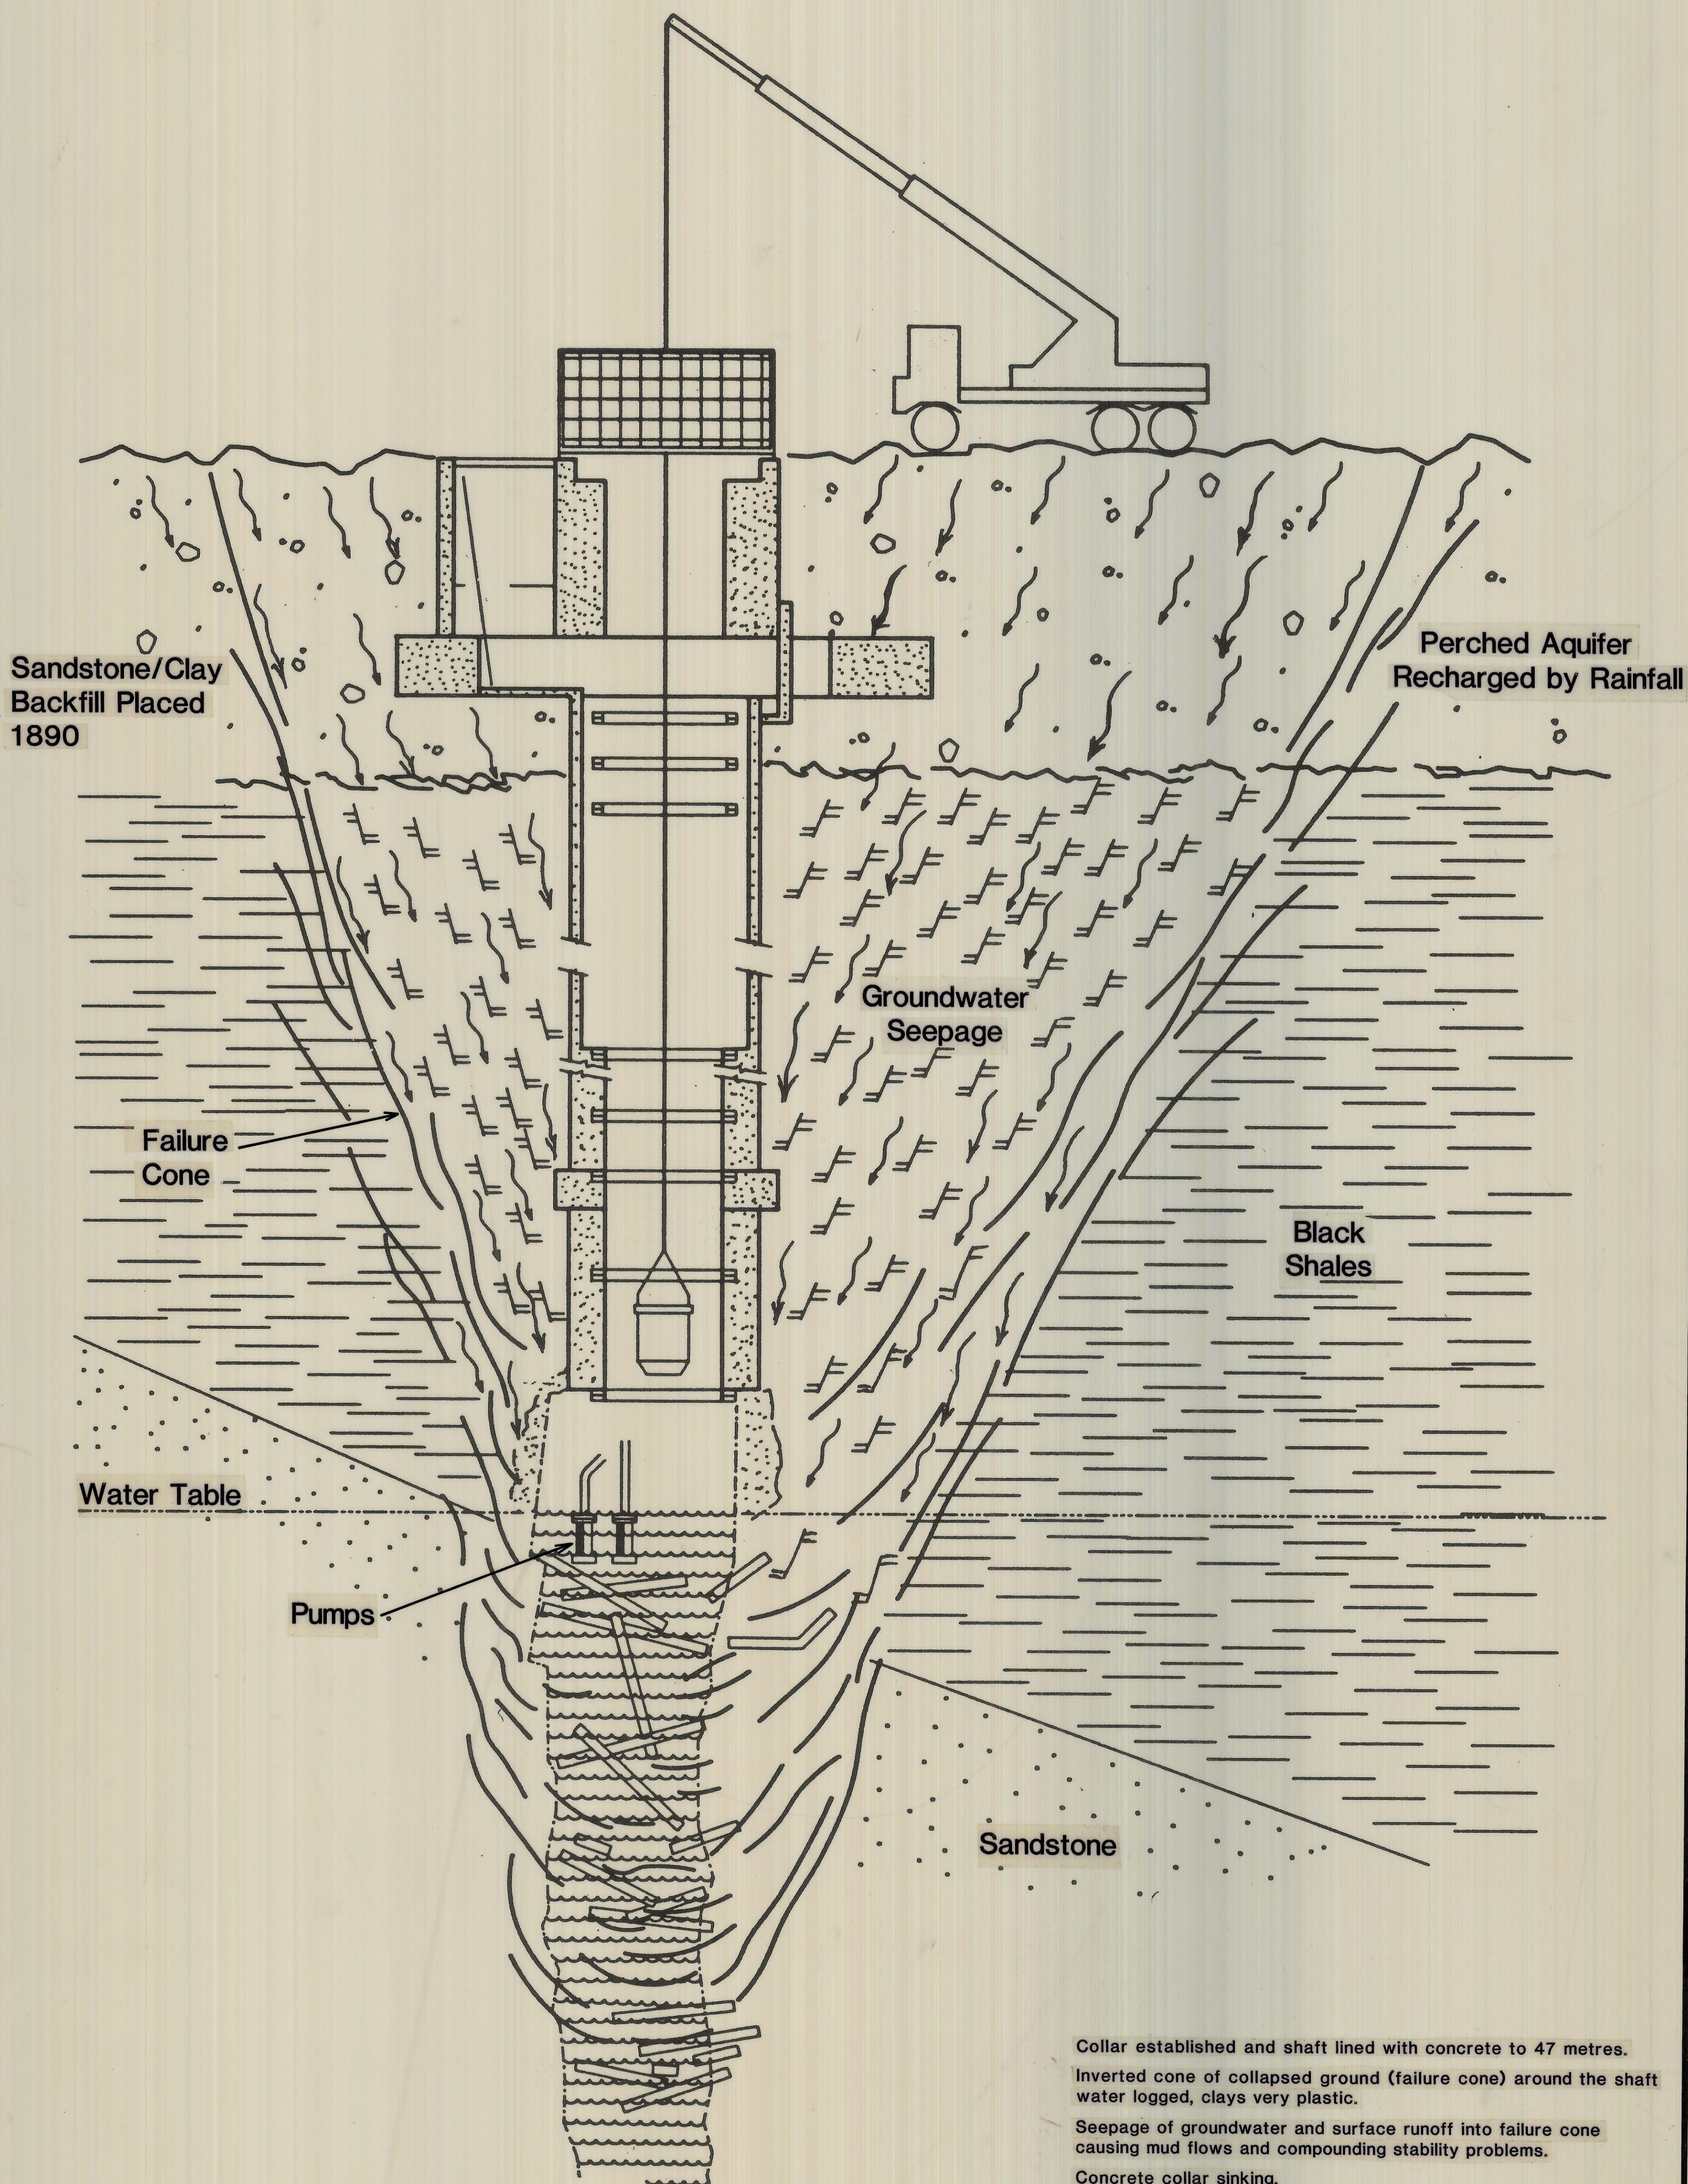
Collar established and shaft lined with concrete to 47 metres.
 Inverted cone of collapsed ground (failure cone) around the shaft
 water logged, clays very plastic.
 Seepage of groundwater and surface runoff into failure cone
 causing mud flows and compounding stability problems.
 Concrete collar sinking.
 Water pumps at 52 metres above shaft blockage interfere with
 clearing work.
 Blockage cleared to 52 metres, steel sets and concrete to 48
 metres.
 Water table lowered to 52 metres.
