## Cornwall Coal

### Blackwood 6 Landslide Risk Assessment

Prepared for  
**Cornwall Coal**

Date  
**3 May 2021**

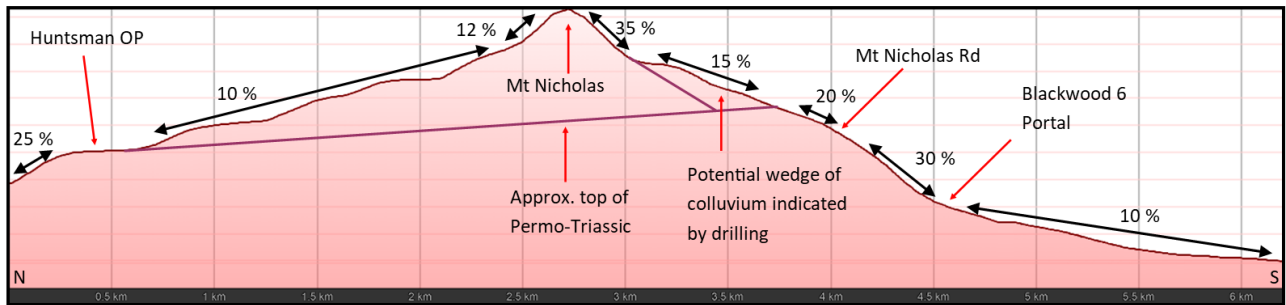
Figure 1: N-S profile of the Nicholas Range through the Blackwood 6 portal area at 590600 mE

at approximately 5°. The most likely base for the dolerite on the south side of the Nicholas Range is close to 525 mRL. It is highly likely that the interface between the base of the dolerite and the top of the sediments is a local aquitard resulting from baking of the sedimentary interface in a process of thermal metamorphism at the time of emplacement of the dolerite sill. The majority of the trapped ground water will flow to the north towards Huntsman. A profile of the Nicholas Range through the easting of the Blackwood 6 portal area at 590600 mE shows that whereas the northern slope from the base of exposed dolerite is a relatively gentle 10 % before it drops off towards the Avenue River immediately north of the Huntsman Open Pit, increasing to 12 % in exposed fresh dolerite at the summit. On the south side however, the exposed dolerite presents a 35 % slope above a wedge of colluvium resting at 15 %. The slope increases to 20 % below the top of the Permo-Triassic sediments and again to 30 % below Mount Nicholas Road before flattening to 10 % down slope from the Blackwood 6 portal area to the Break O'Day River flood plain (Figure 1).

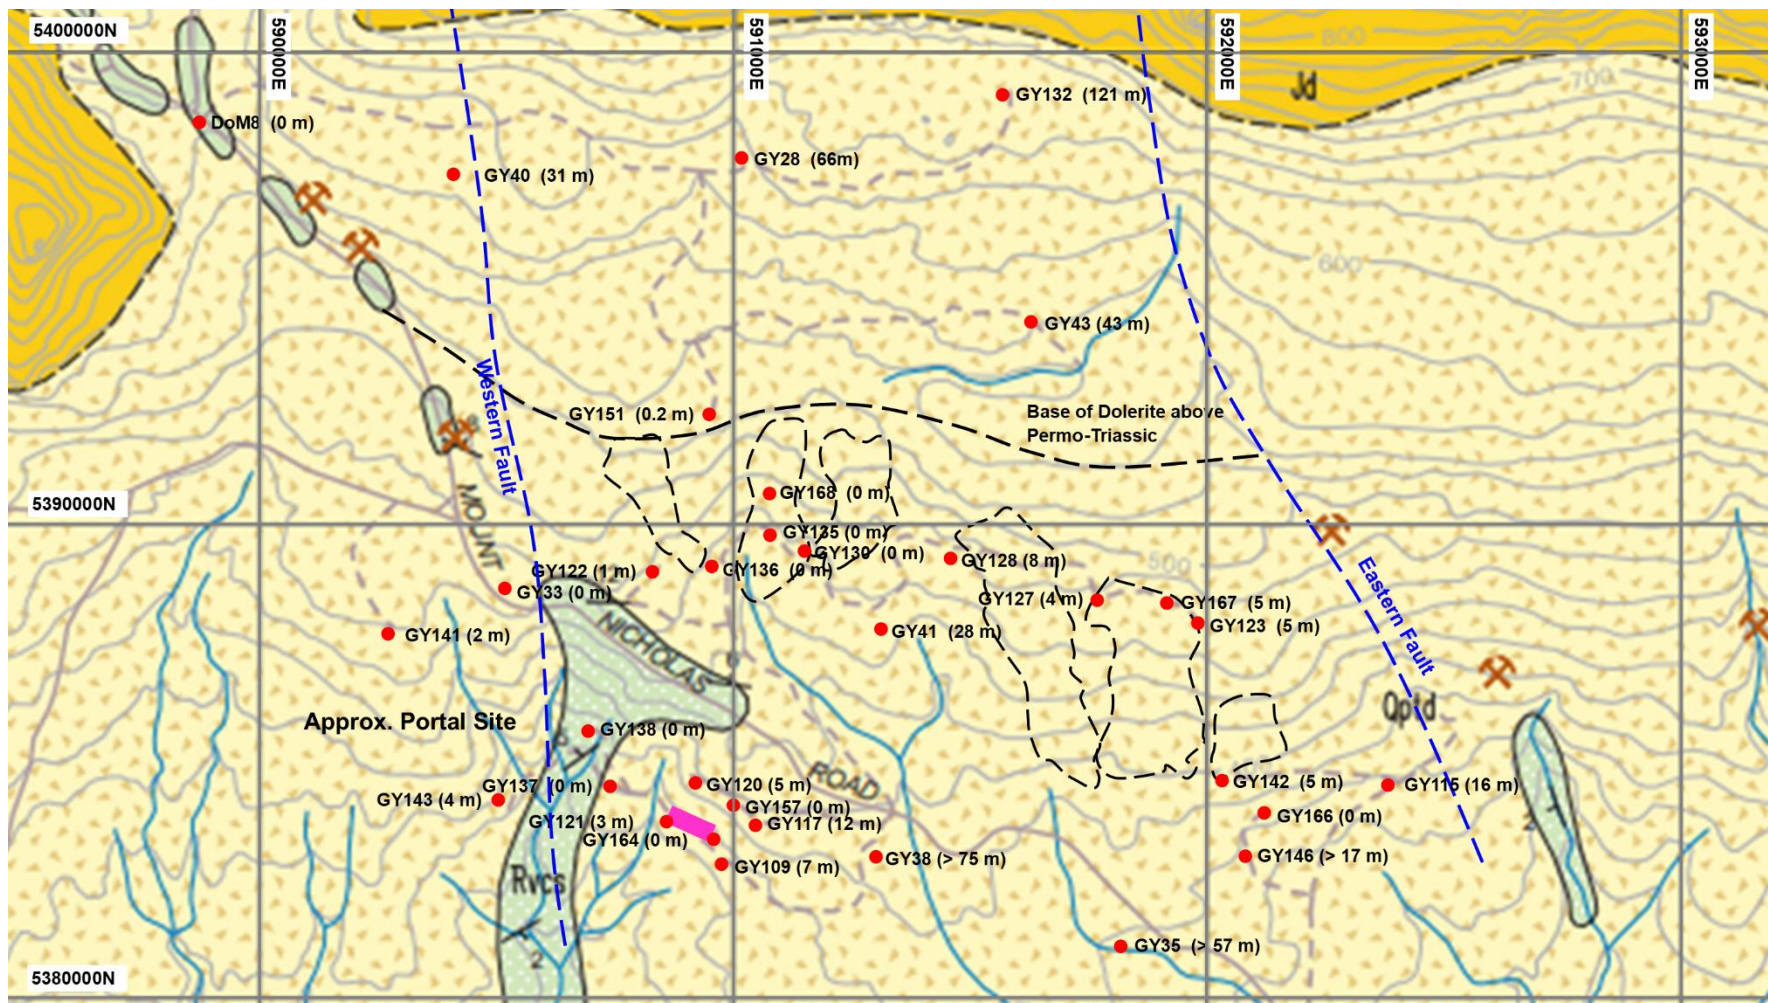
Figure 2: Geological map of the Blackwood 6 area showing 1980's drill holes and the location of past landslides. The magenta shape coincides with the proposed portal cut.

An investigation of available data in the vicinity of the proposed Blackwood 6 Portals suggests that the landslide risk is relatively low. Data from diamond drilling and modelling by The Shell Company of Australia Limited (Shell) in 1982 and subsequent work by Palaris in 2010 has been reviewed in making this determination. The drilling is plotted over the regional 1:25,000 geological mapping in Figure 2 for reference.

By contrast, the slopes at the head of Millstream Creek in the vicinity of the proposed portals it is so steep that the colluvium has been washed away and the State 1:25,000 geological map records Triassic sediments exposed along its length in that area (Figure 2). It is not known how recent that exposure is, but it is perhaps noteworthy that outcropping Triassic sediments follow the path of the Mount Nicholas Road, having been exposed by the road cutting, and a number of culverts beneath the road direct water to Millstream Creek (Figure 4).

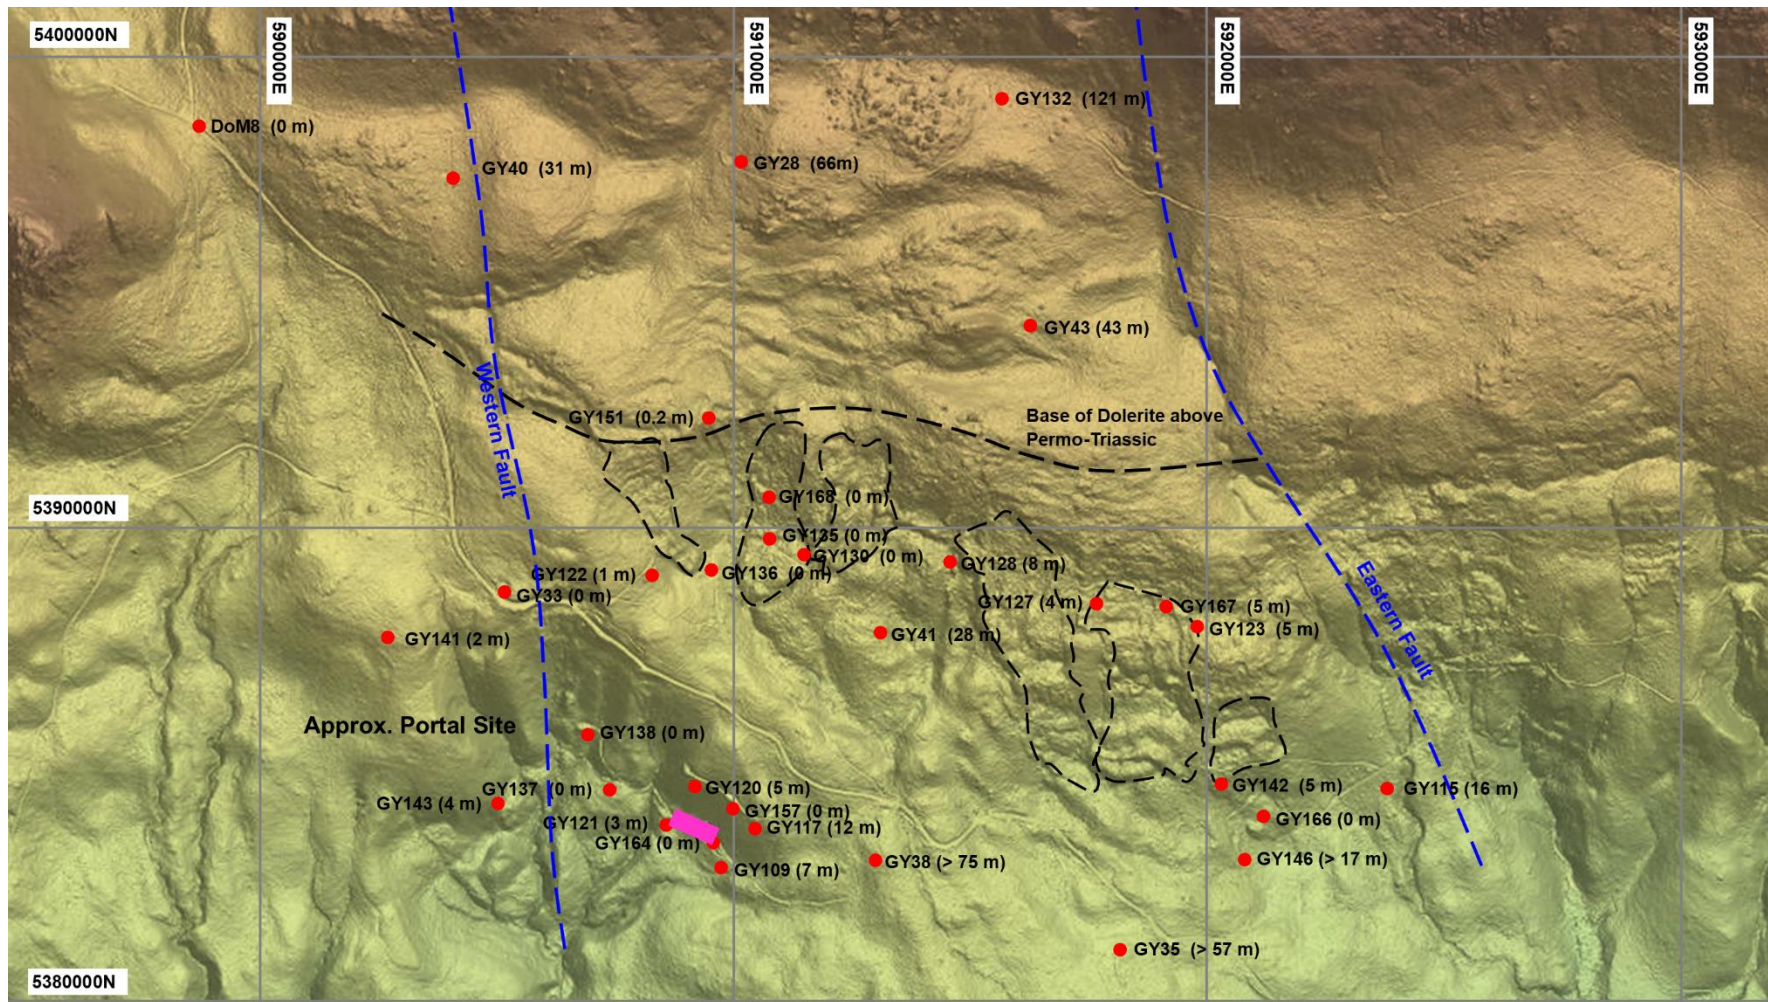
Figure 3: LiDAR image of the Blackwood 6 area showing 1980's drill holes and the location of past landslides. The magenta shape coincides with the proposed portal cut.

The foregoing discussion does not mean that there are no relatively recent landslides in the vicinity of Blackwood 6 and as illustrated in Figure 3 there are at least six obvious examples and a few more subtle which are not highlighted. All occur in just below the base of the dolerite and terminate above Mount Nicholas Road. This cluster of landslides appears to be directed towards the east into the vicinity of the historical Mt Nicholas township rather than towards the Blackwood 6 site, and none of them currently extend within 100 m of the north side Mount Nicholas Road. Established trees on the north side of Mount Nicholas Road are all standing vertically indicating little or no ground movement (Figure 6).

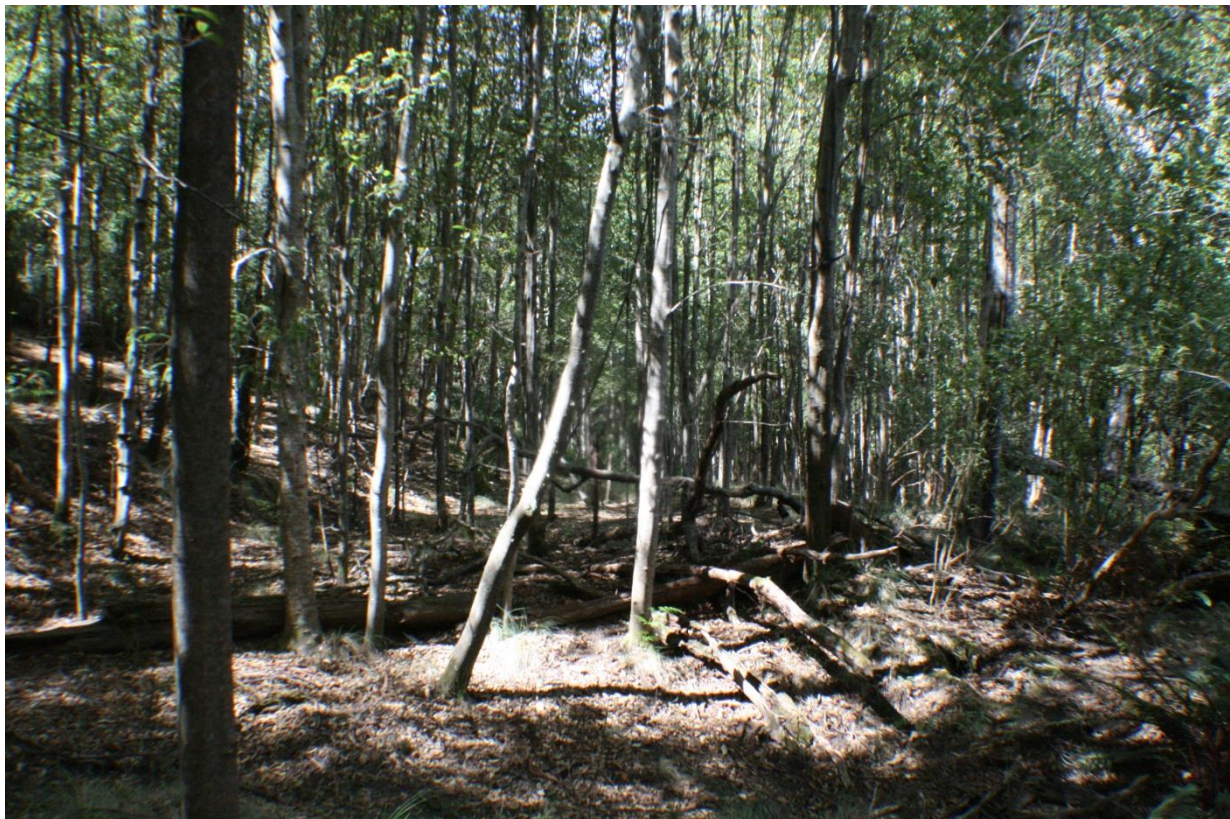
*Figure 5: General area of the proposed portal near the site of GY143.*

Between the creeks, colluvium depths of a couple of metres are typically recorded. Fortunately, the cover of colluvium up slope of the proposed Blackwood 6 Open Cut is either colluvium free or has a very thin cover (Figure 5).

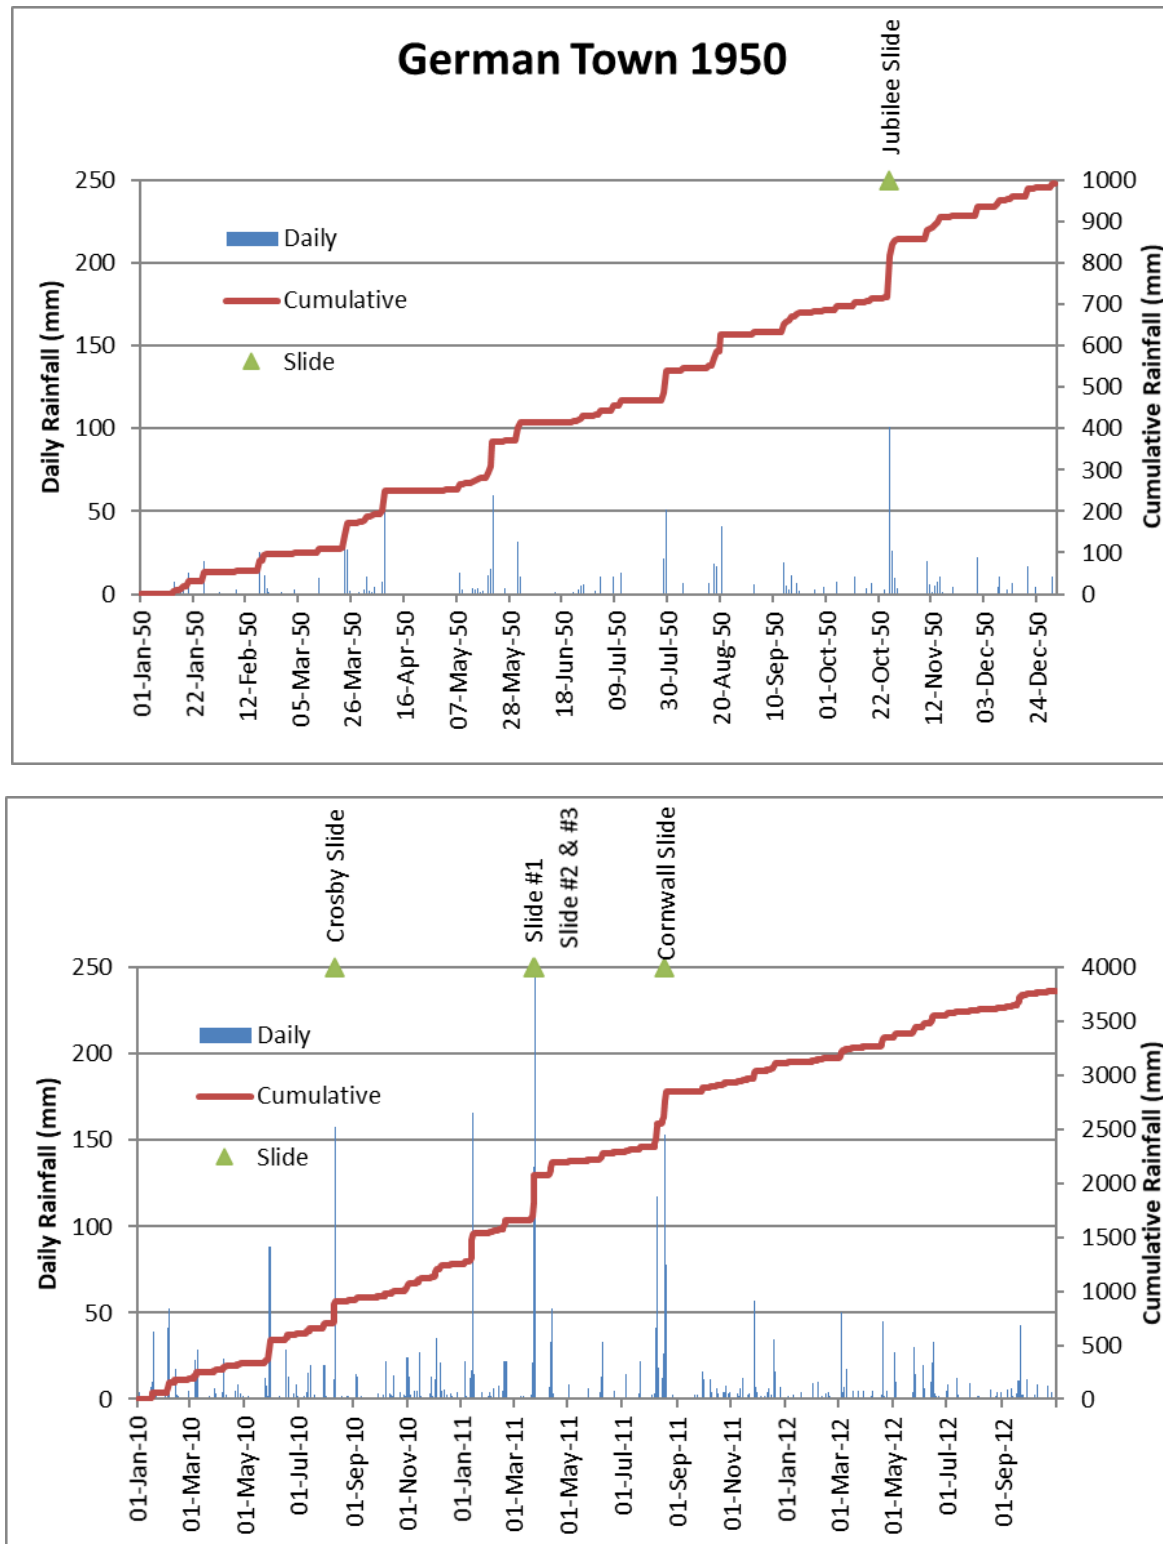
Figure 9: Coincidence of landslides with short term cumulative rainfall in excess of 100 mm.

Previous work by pitt&sherry (2013) demonstrated that significant landslide events on the Nicholas Range occur than the short term cumulative rainfall (24 hours) exceeds 100 mm. This was found to be the case for the Jubilee Slide near German Town in 1950 and four events in the Blackwood 4 – Cornwall are from August 2010 – August 2011 (Figure 9).

The reverse case was not demonstrated. That is, large volume rain events over a number of days did not trigger landslides if the 100 mm per day threshold was not met. It was for that reason that an evacuation trigger was set at 85 mm in 24 hours.
