**SUBJECT:** Site Inspection. Heli-supported drill site. Quinn Creek

**DATE:** Conducted 28/5/2020

**FILE NO.:** EL 13/2019 Hydro Tasmania

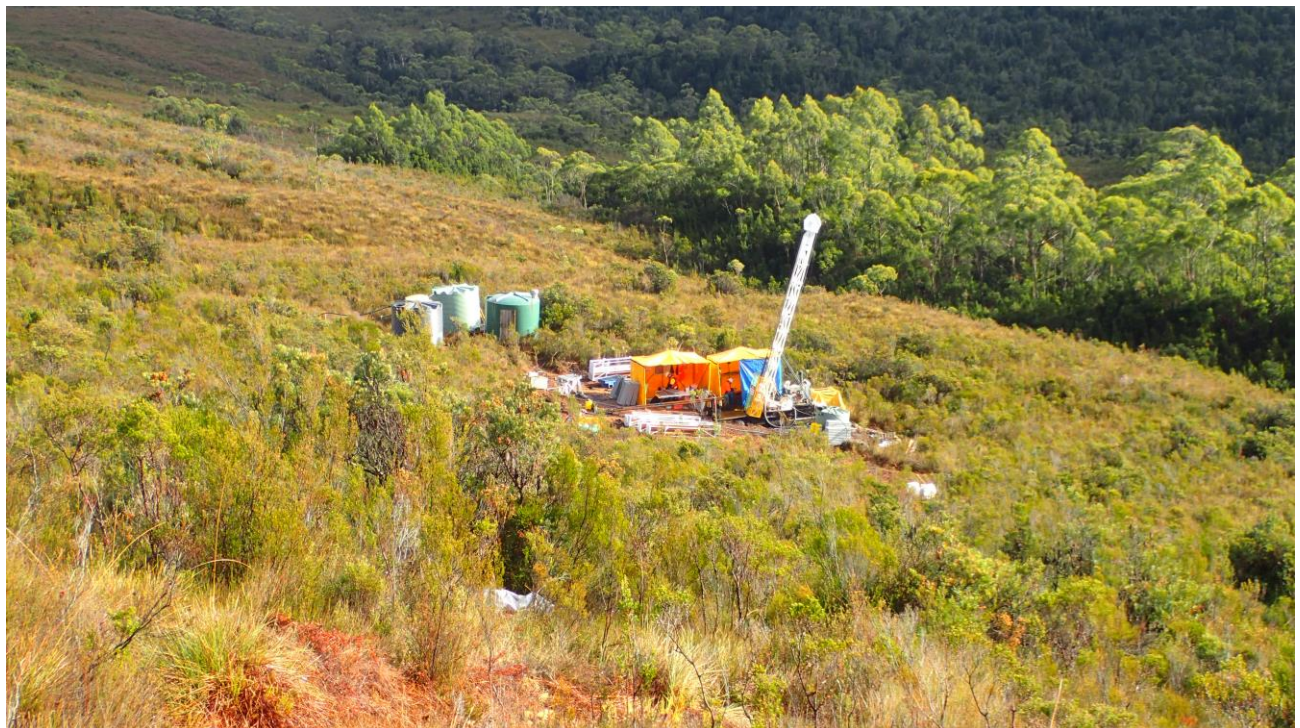
Looking northwest, from foot access track towards site. Beyond is Quinn Creek and Red Hills Creek junction and the Anthony Road is out view, top of image.

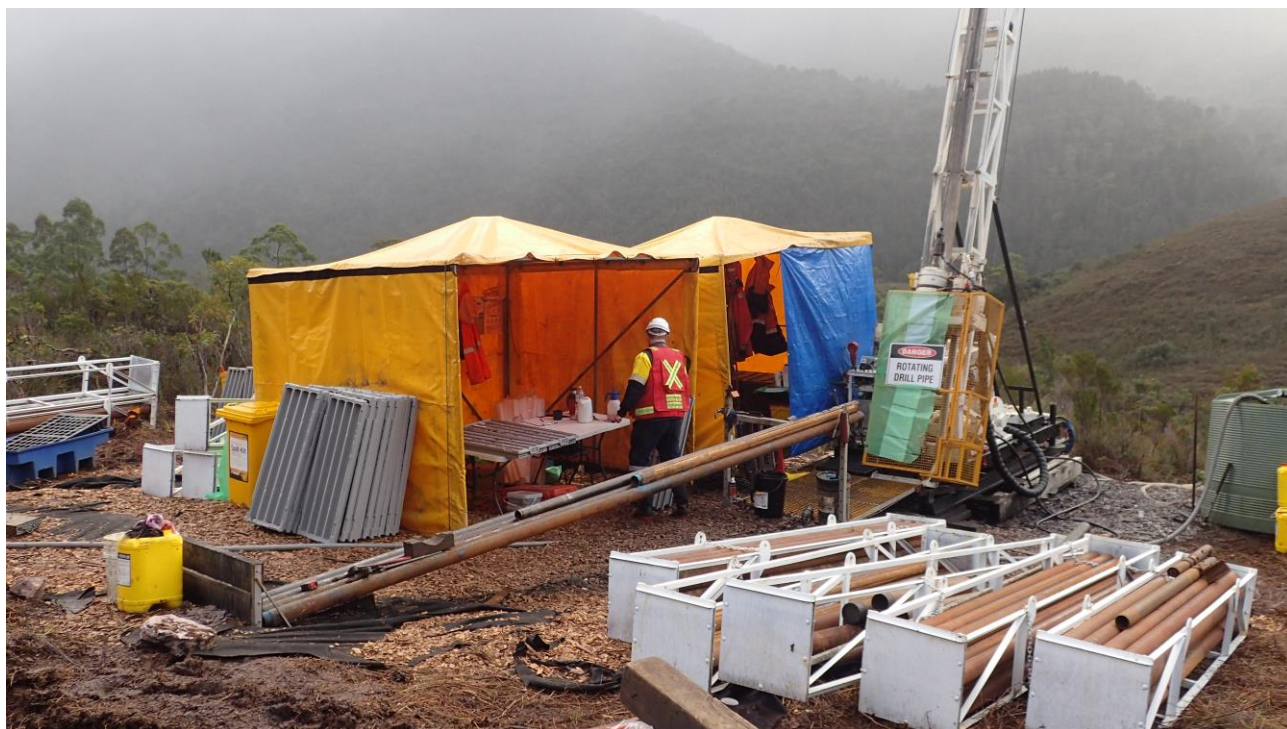
Rig/work area underlain with geotextile and top dressed with woodchips in order to minimise peat compaction and soil contamination. Small sandbagged area, downslope from collar, established for a sump/silt filter. No water return - lost after 30m. Effective hand dug diversion drain on topside of pad.

Looking north over section of the site. Note use of heavy duty geotextile and woodchips under the working area.

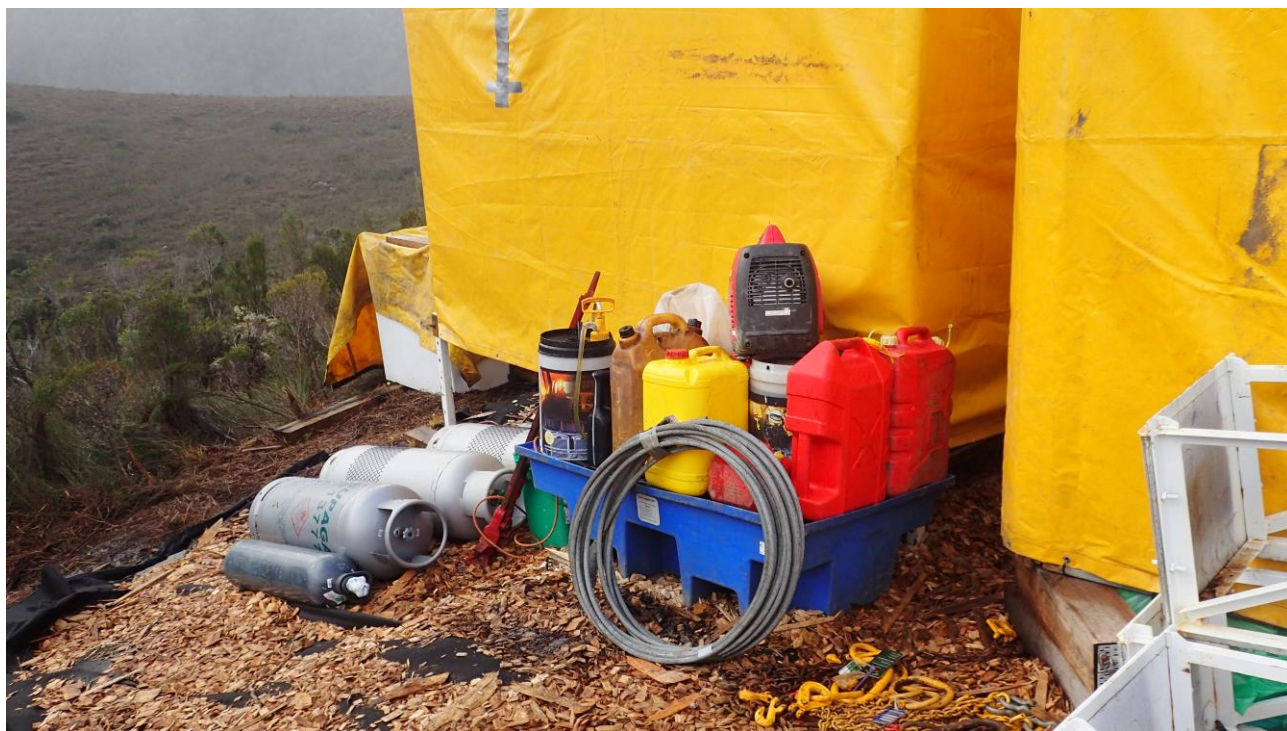
Fuel pod contained in a heli-portable metal bund vessel. Oils, lubes, etc. on a bund, but required a cover as rain had filled this holder to capacity. Self-contained toilet unit and emergency module (converted poly water tank) provided. New deck timbers and clean sundry equipment noted.

Bund for sundry lubes etc. Note open to weather and required cover to be placed over it (actioned). Note tidy housekeeping.

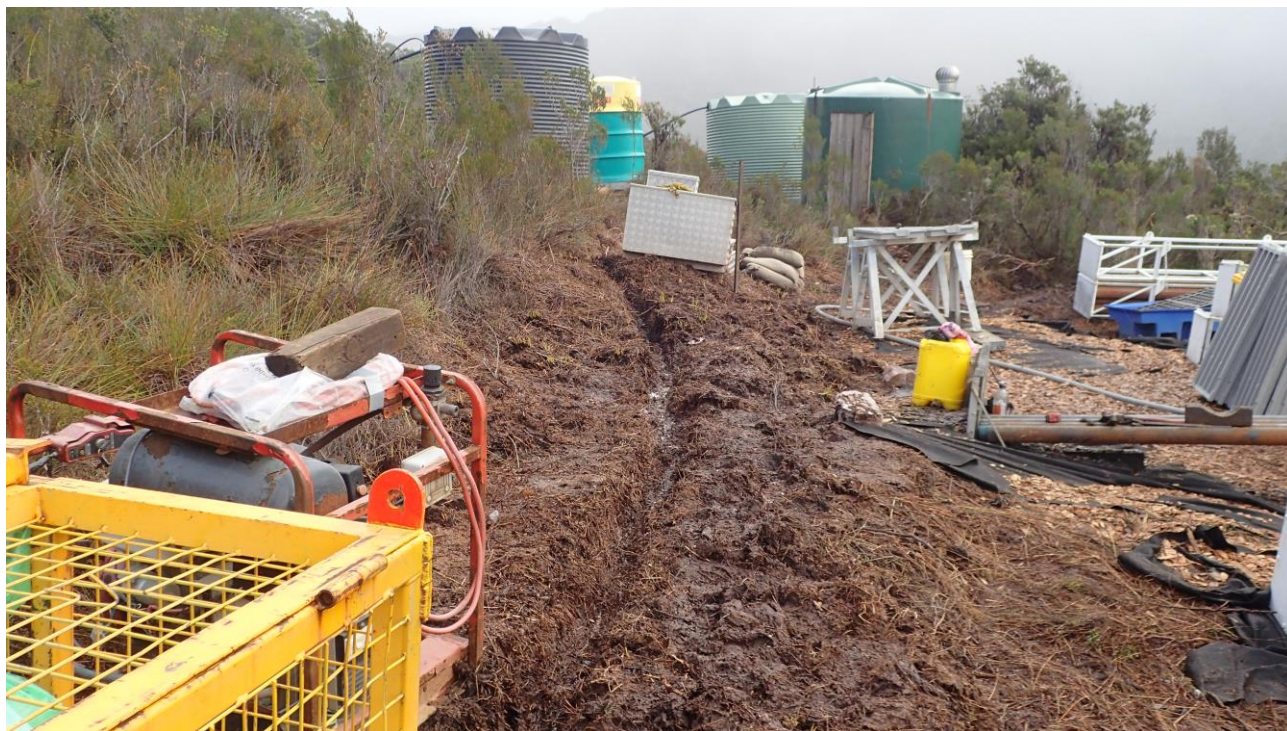
Hand dug trench on the topside of drill pad. Effective in reducing water flowing over the working area (for improved safety and environmental outcomes).

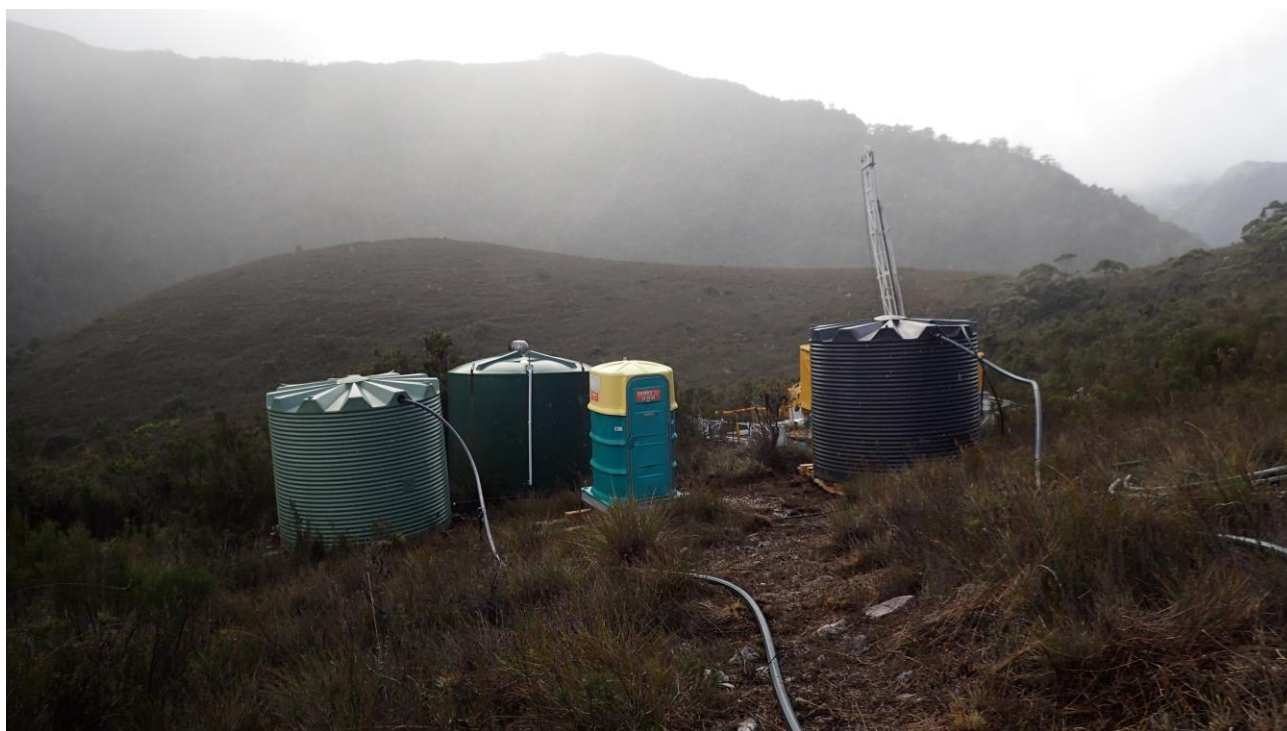
Wet a time of inspection, but water for drilling has been in short supply. Tanks are gravity fed from watercourse with a small catchment. Note the inclusion of an emergency shelter and separate toilet unit.

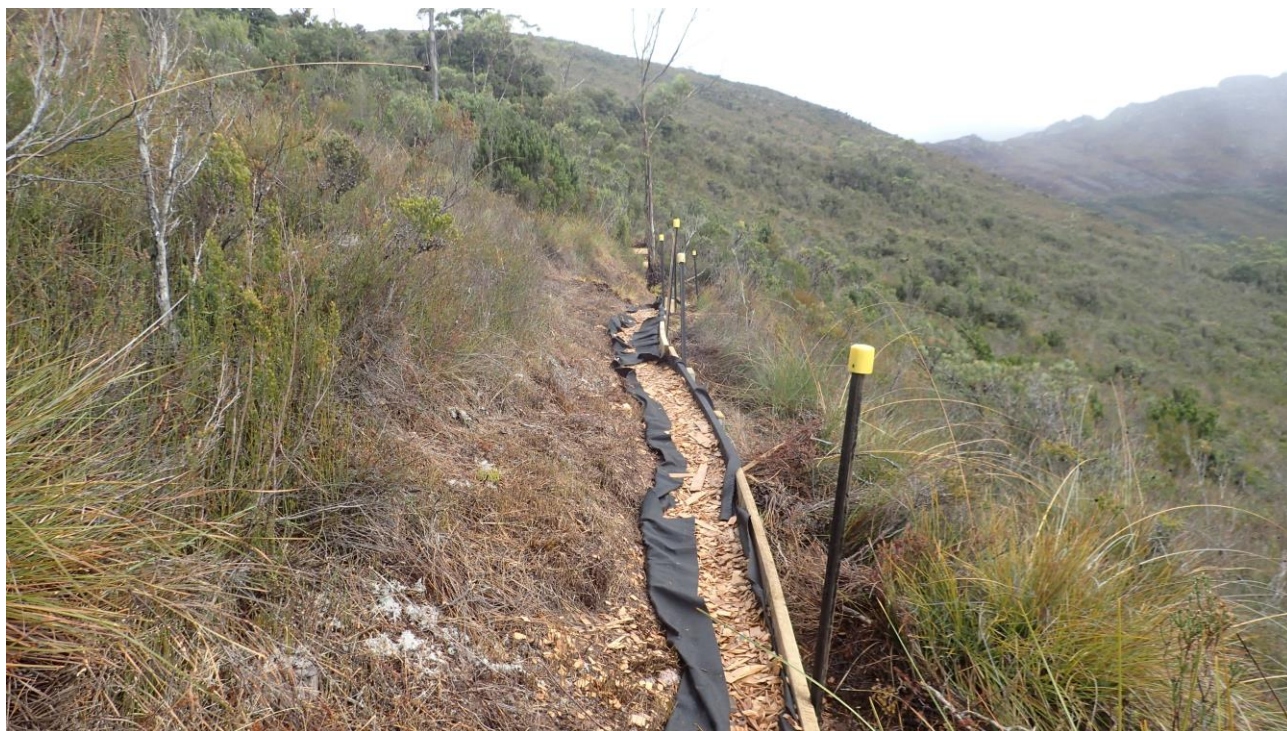
Strategic use of treated pine timbers, geotextile mat and woodchips on walking route has set a high standard in terms of lowering the risk from trip/slip hazards and from minimising the degradation of vegetation/topsoil of trampling underfoot from daily use. Phytoclean footbath in use at track commencement. Hygiene station could be supplemented with a boot scrub and routine change-out of used solution?

Example of use of treated pine timbers, geotextile mat and woodchips on walking route.

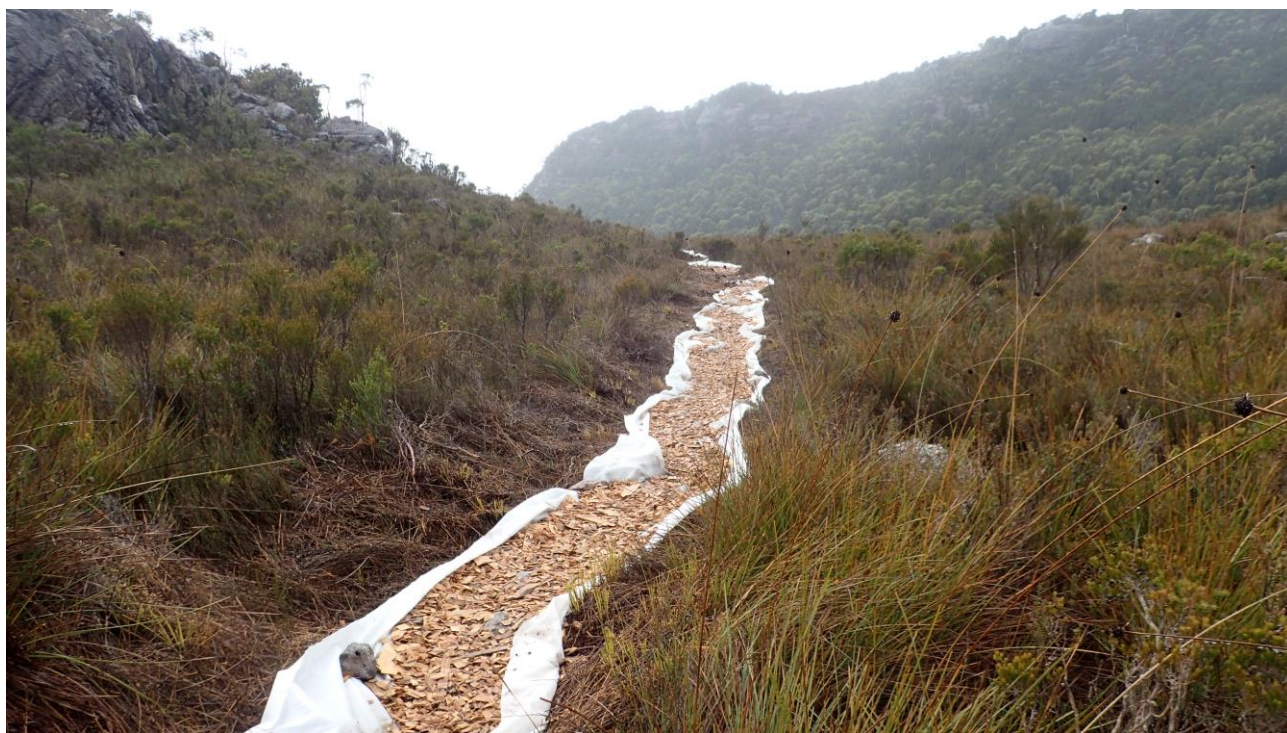
Example of reducing impact from trampling, to some of the more vulnerable sections of the foot access track.

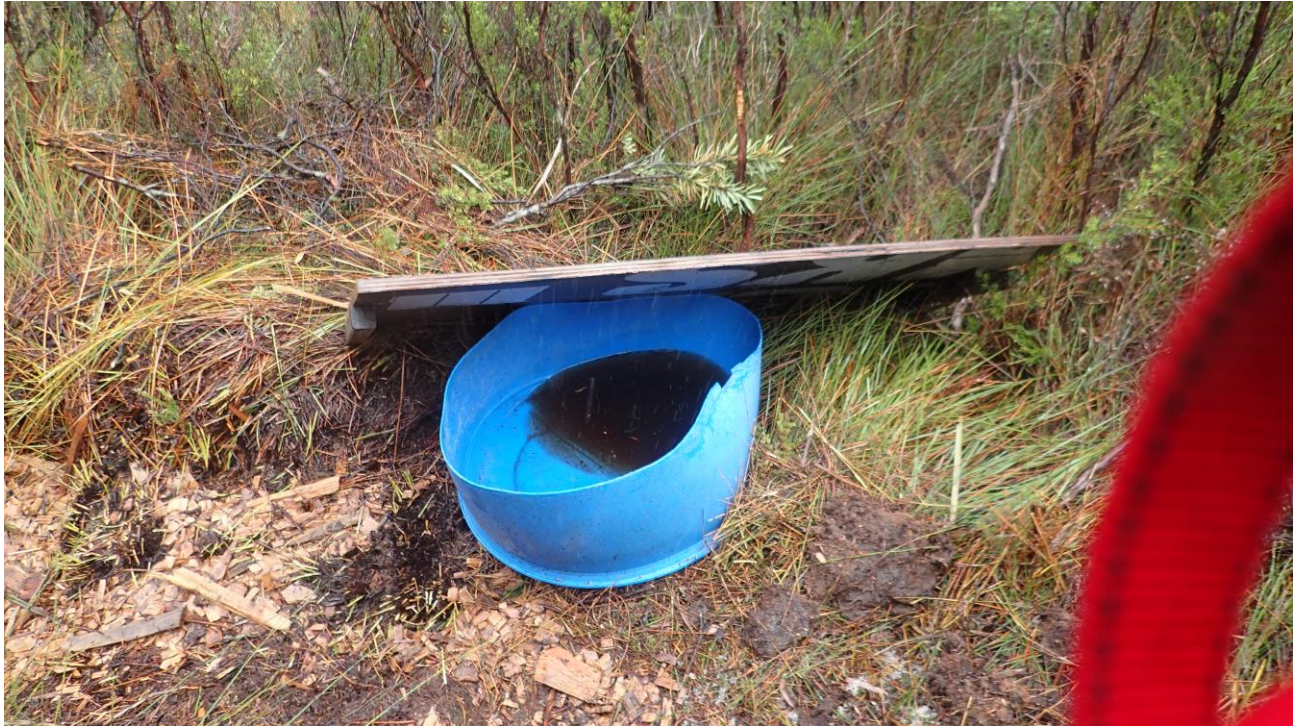
Phytoclean foot bath at commencement of walking track. Investigate need (or otherwise) of routine change-out of solution and addition of a boot scrub matt to this hygiene station.

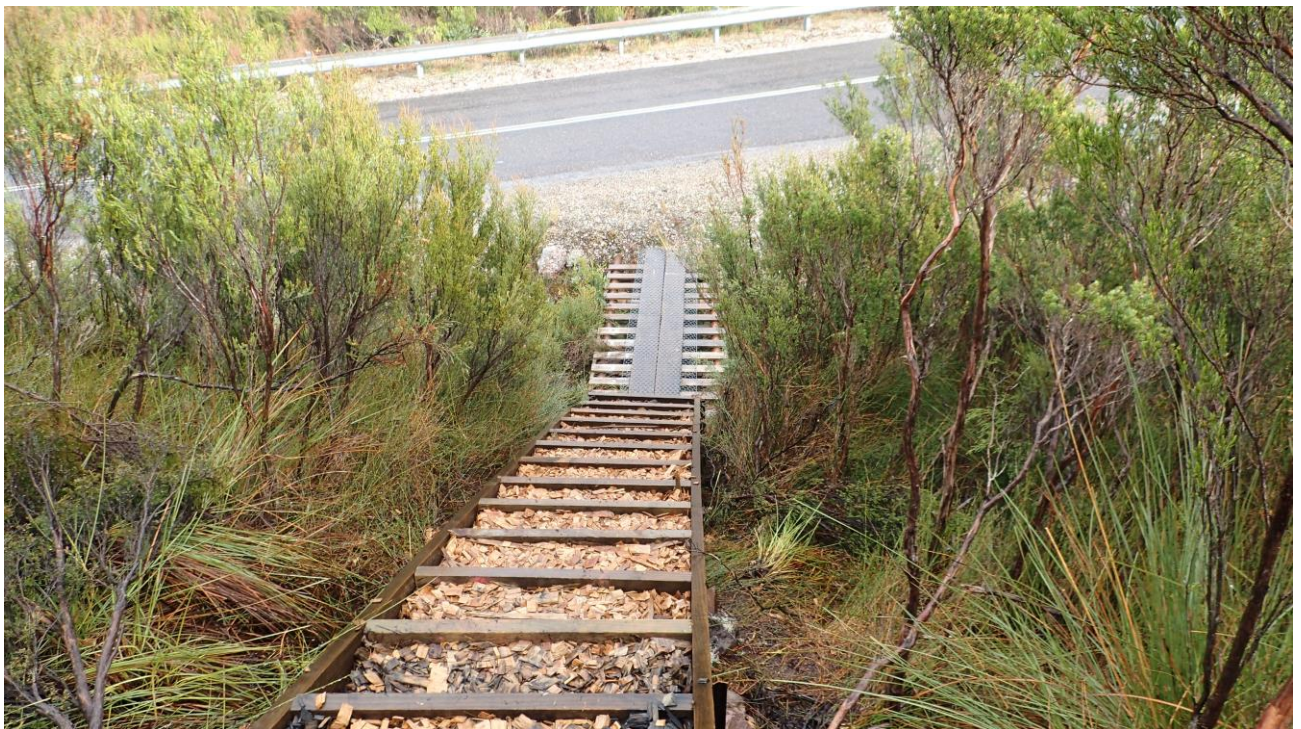
Reducing slip and fall hazard at ingress/egress point of foot track from the Anthony Road.
