Archaeological Survey Report 2001/01

An archaeological survey of the Langloh Colliery site, Hamilton, Tasmania

By A. E. Webster

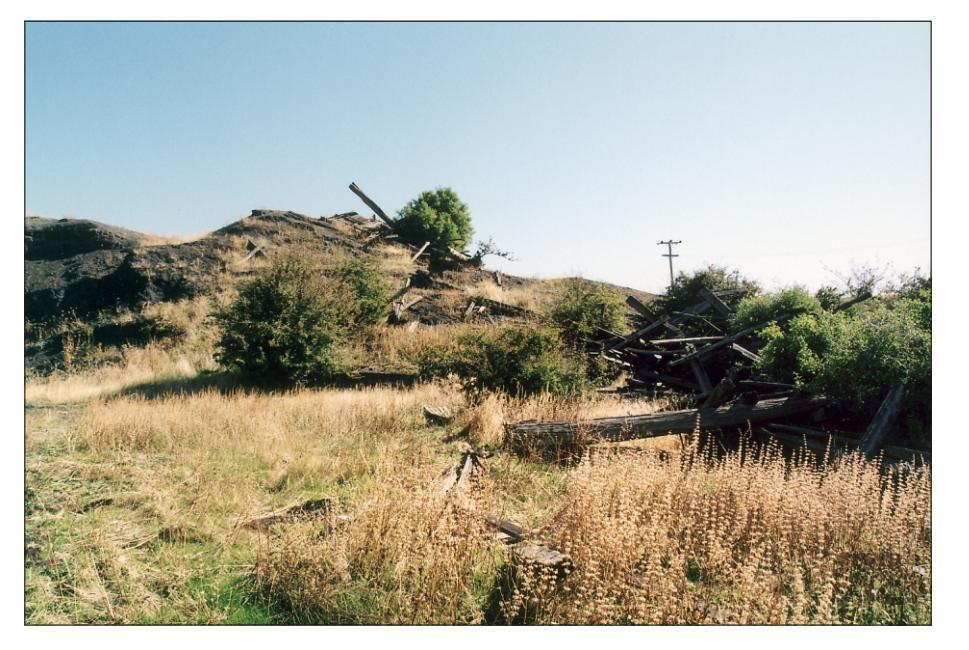
Site of the collapsed coal bin, crusher and loading gantry structure (in Box Thorn to right and on the slopes of the dump in the centre of the view). The crusher, screens and other components lie in the timber rubble to the right of the view. The structure was pulled over intentionally to reduce the risk to local children (refer to fig. 3). [MRT 3209]

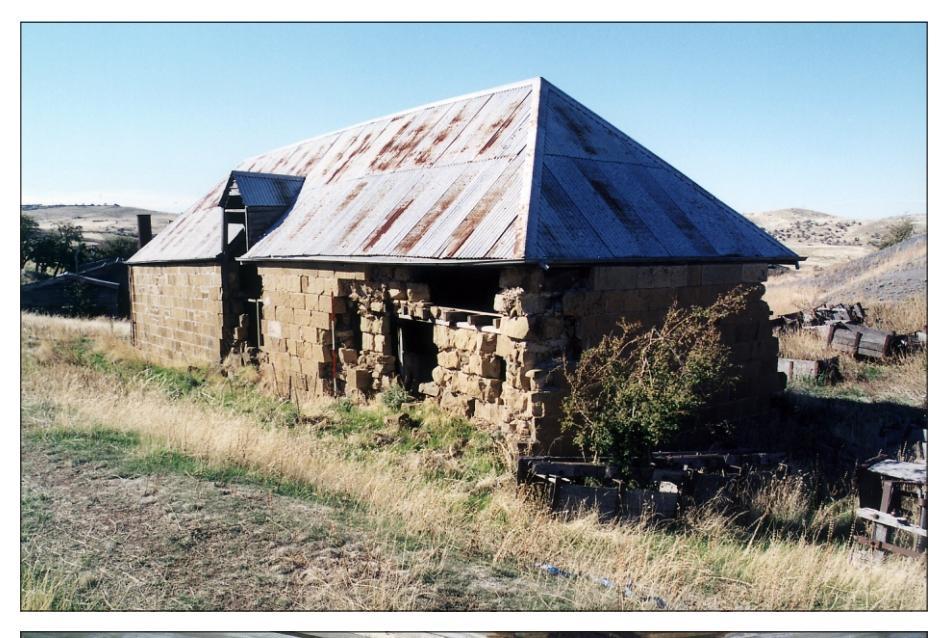
The building is relatively sound but has suffered due to the removal of the outer facing of good quality ashlar masonry on the eastern facade (see Figure 40 below). Lintel beams over a former doorway on the eastern facade are deeply pitted with borer. The eastern wall will eventually collapse. The corrugated iron roof is in very good condition.

Sandstone stables looking northeast. Note the section of the wall where sandstone blocks have been removed. Scale bar is in half metre intervals. [MRT 3234]

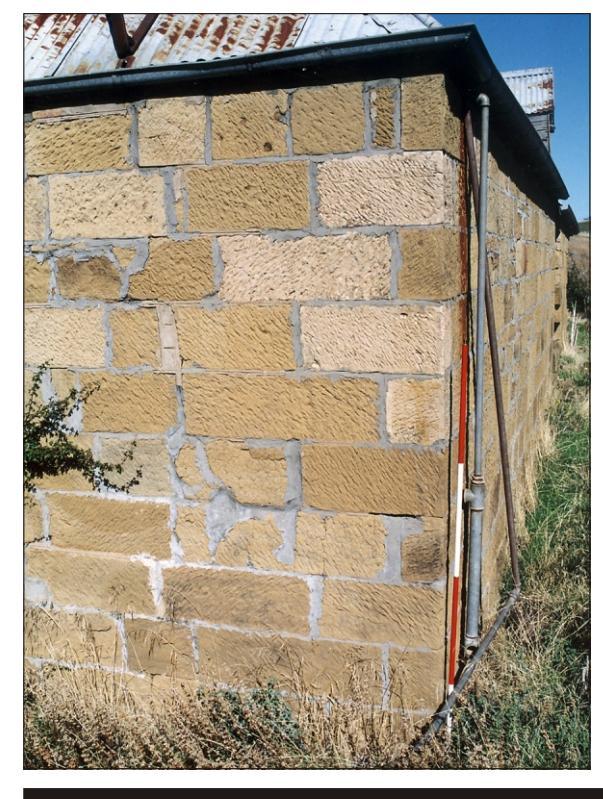
Figure 37

Detail of mortar on the northern end of the stables, possibly waterproofing for the showers which were located inside this wall. The re-mortaring may also have been done to repair damage to the stonework caused by the excess moisture from the showers. Scale bar is in half metre intervals. [MRT 3260]

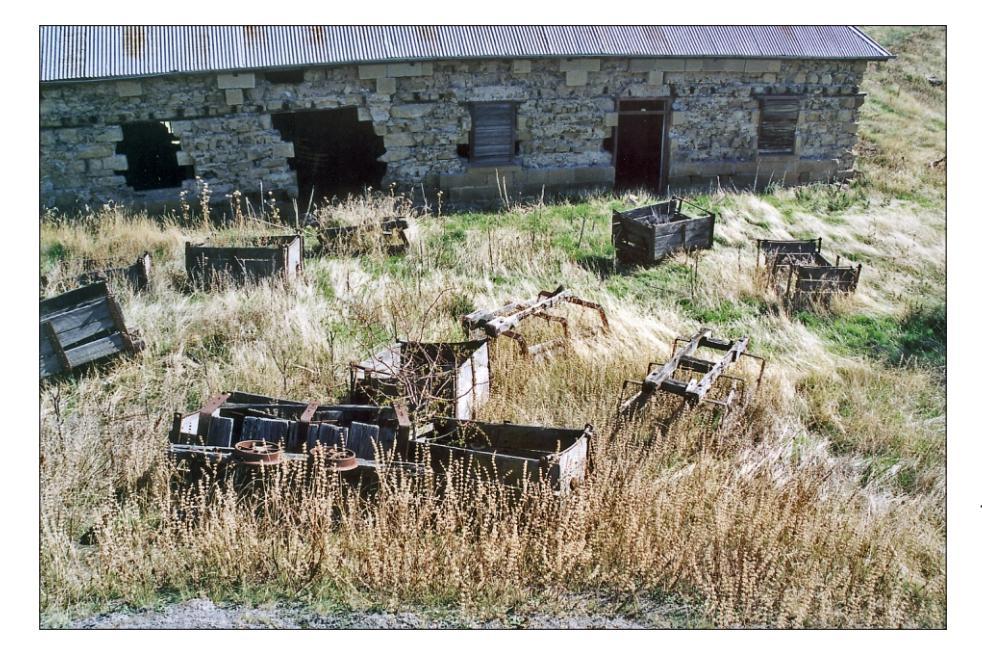
Figure 39

Detail view showing the relationship of the coal trucks to the eastern side of the stables. Refer to Figure 3. Photo taken from the mullock dump and is looking west. Note the almost complete removal of the outer layer of ashlar masonry on the eastern wall of the stables. [MRT 3273]

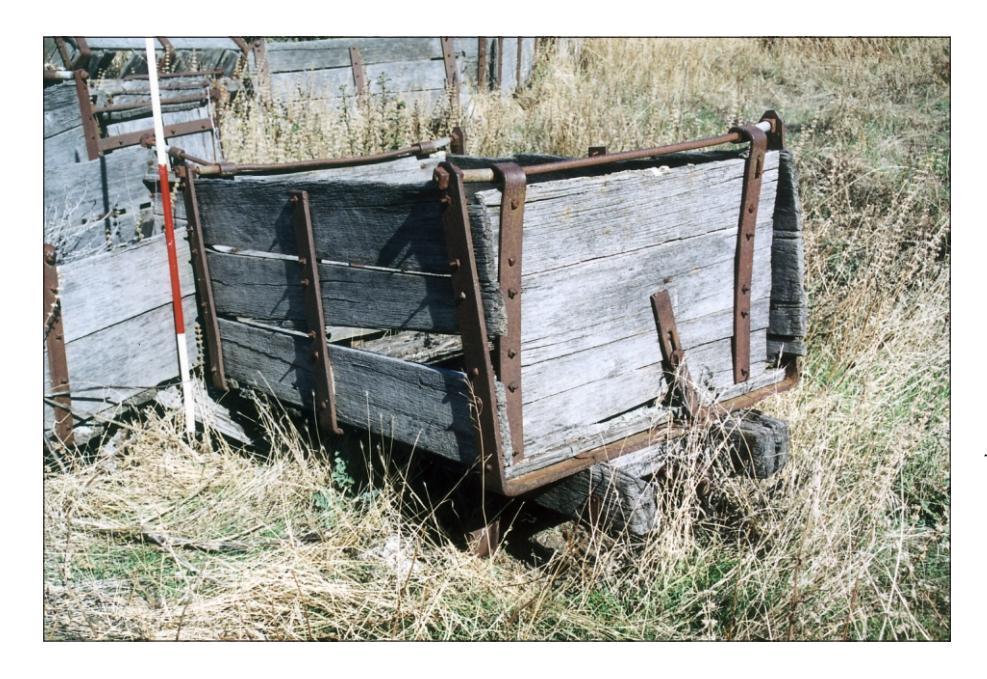
Detail view of one of the wood and iron coal trucks adjacent to the stone stables. Note the stout iron framing, and the wooden lining and chassis. These trucks are in quite good condition and their number and state of preservation make them a valuable feature of the site. Scale is in half metre increments. [MRT 3275]

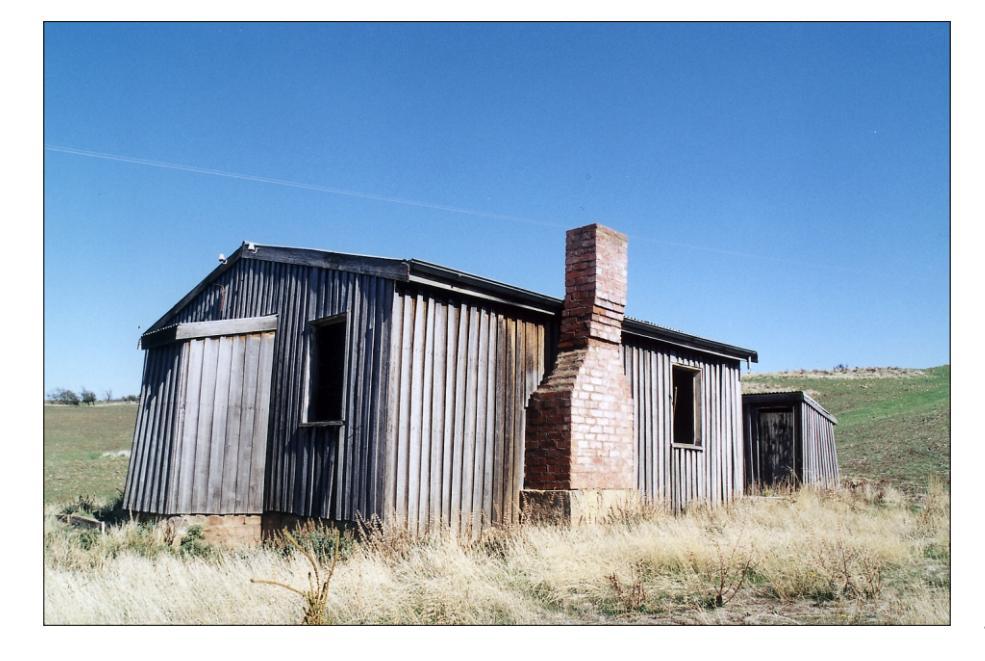
Figure 49

The cottage appears to be structurally sound and apart from the internal damage to wall linings by grazing animals (that shelter inside during cold weather), is in good order. There is a thick crust of dung and mud on the timber floors and there is also an occasional decomposed sheep carcass inside. Little furniture or fittings remain inside. Electricity was once connected to the house, as the connection point is visible on the gable (fig. 49).

Site feature I looking southwest. Note vertical weatherboard cladding and brick chimney and foundations. [MRT 3215]

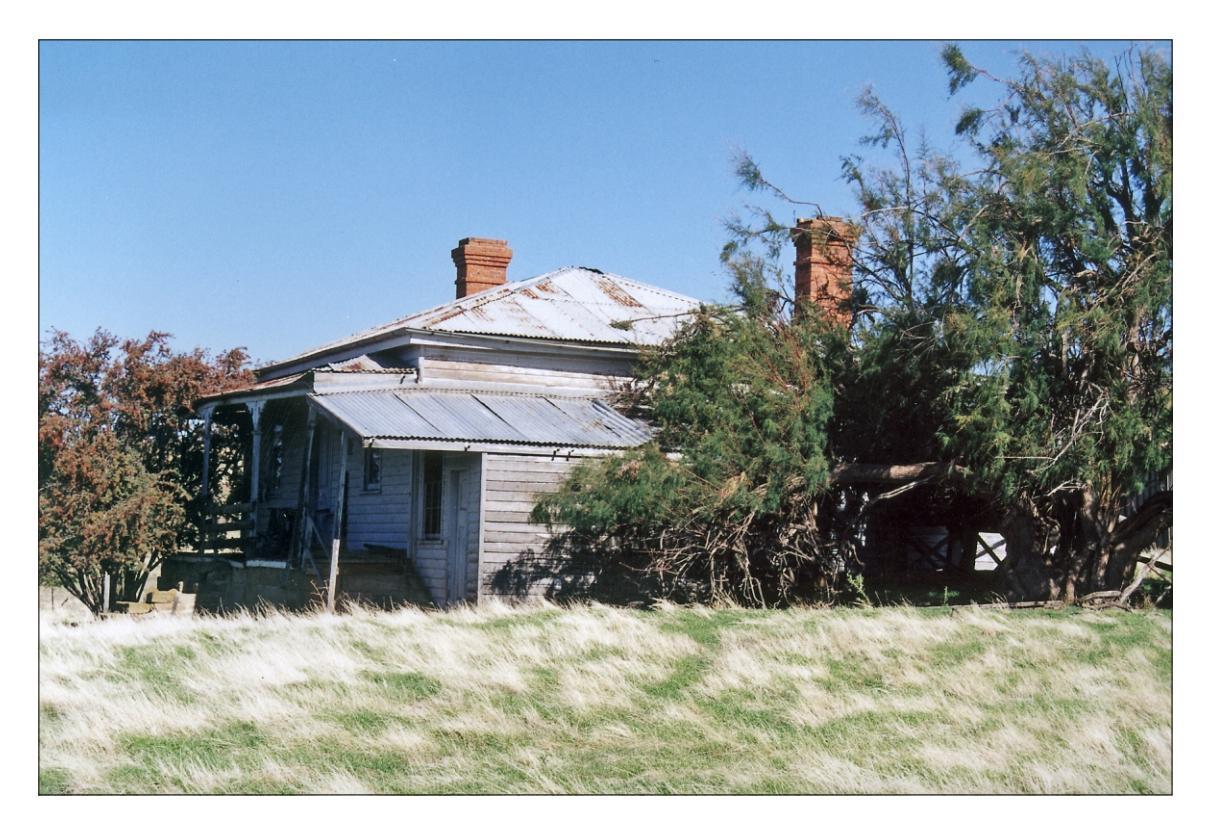
Figure 51

The structure has suffered from the effects of stock roaming freely within. Although apparently structurally sound, the internal linings are damaged and the timber floors are thickly encrusted with dung, mud and occasional decayed sheep carcasses. The sandstone steps leading to the verandah are fractured and partially collapsed.
