August 2025

# Annual Report

## Rehabilitation of Mines 2024-25

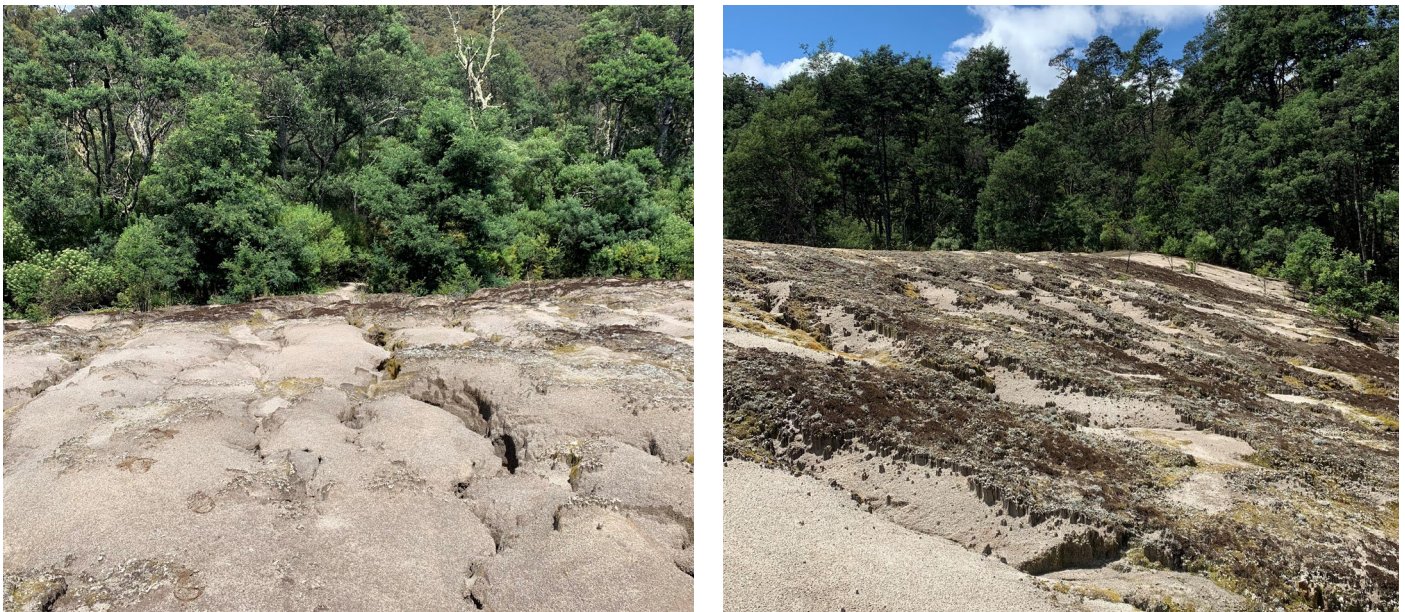
Figure 2. Erosion mitigation required on the Anchor dam wall (October 2024).

Despite underlying stability, significant rill erosion is evident on the dam face. In October 2024, granulated fertiliser was spread on the batter slope of the dam wall to promote the establishment of lichen and moss for stability (Figure 2). The site was inspected in February 2025 and little change was observed. MRT will investigate further options involving surface coverings and revegetation for potential funding by the RTF in 2025/26.

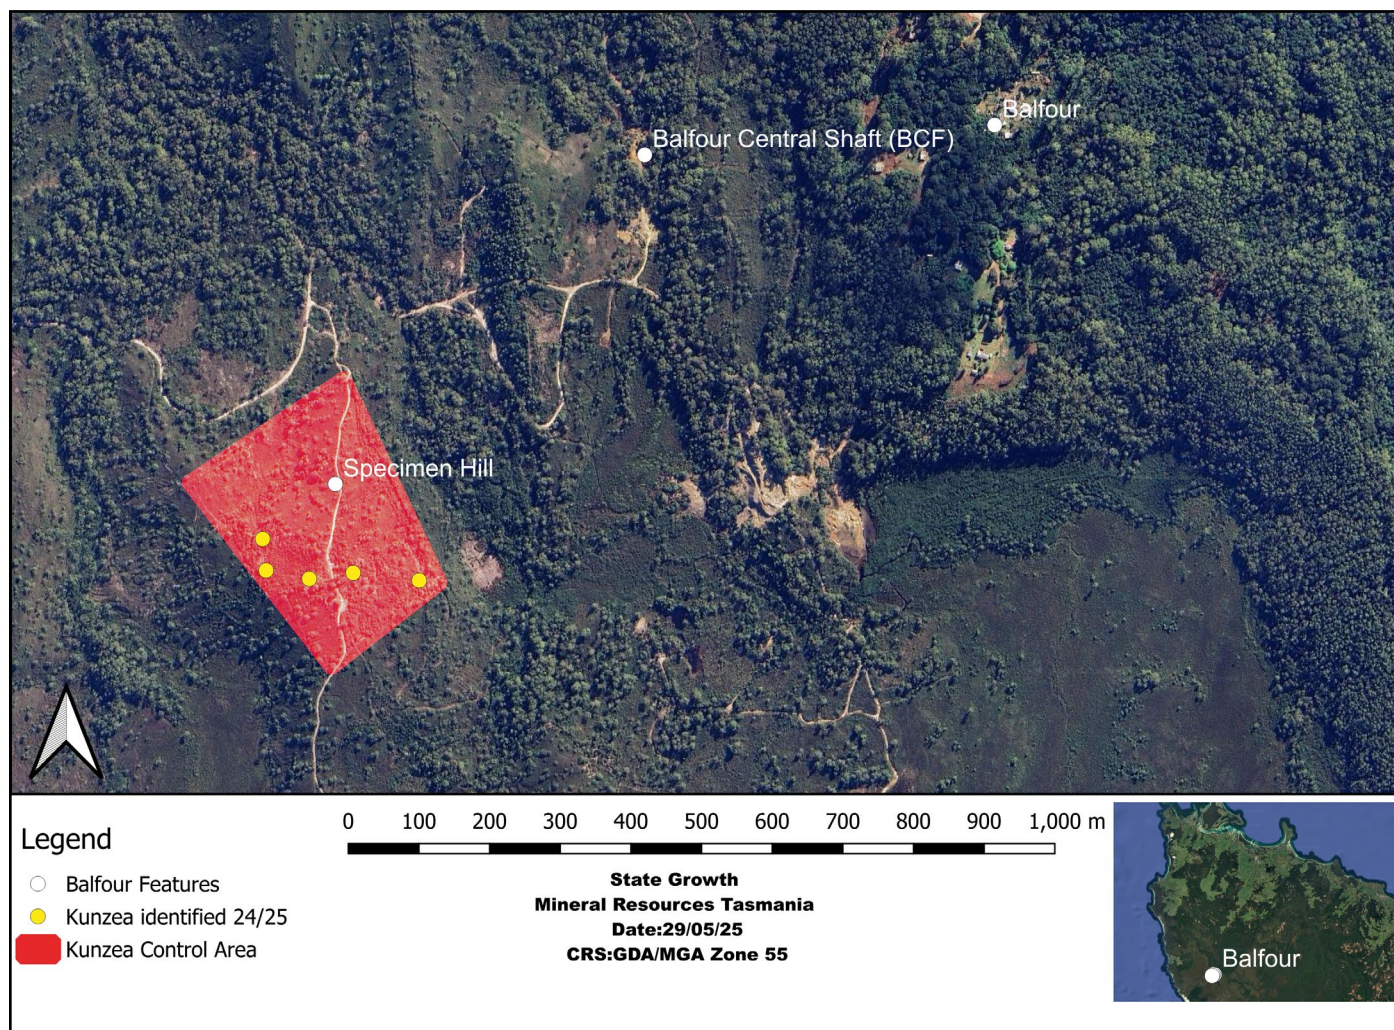
In December 2024, the removal of *Kunzea ambigua* from historical revegetation sites continued on Specimen Hill in the proximity to Balfour. *Kunzea ambigua* is locally endemic to northeastern Tasmania. Removal of this species has been ongoing since 2019, with observations significantly reduced during the 2024 effort (Figure 3). Follow-up weed monitoring is scheduled for November 2025, coinciding with the onset of flowering.

Figure 3. Specimen Hill *Kunzea sp.* control area, December 2024.

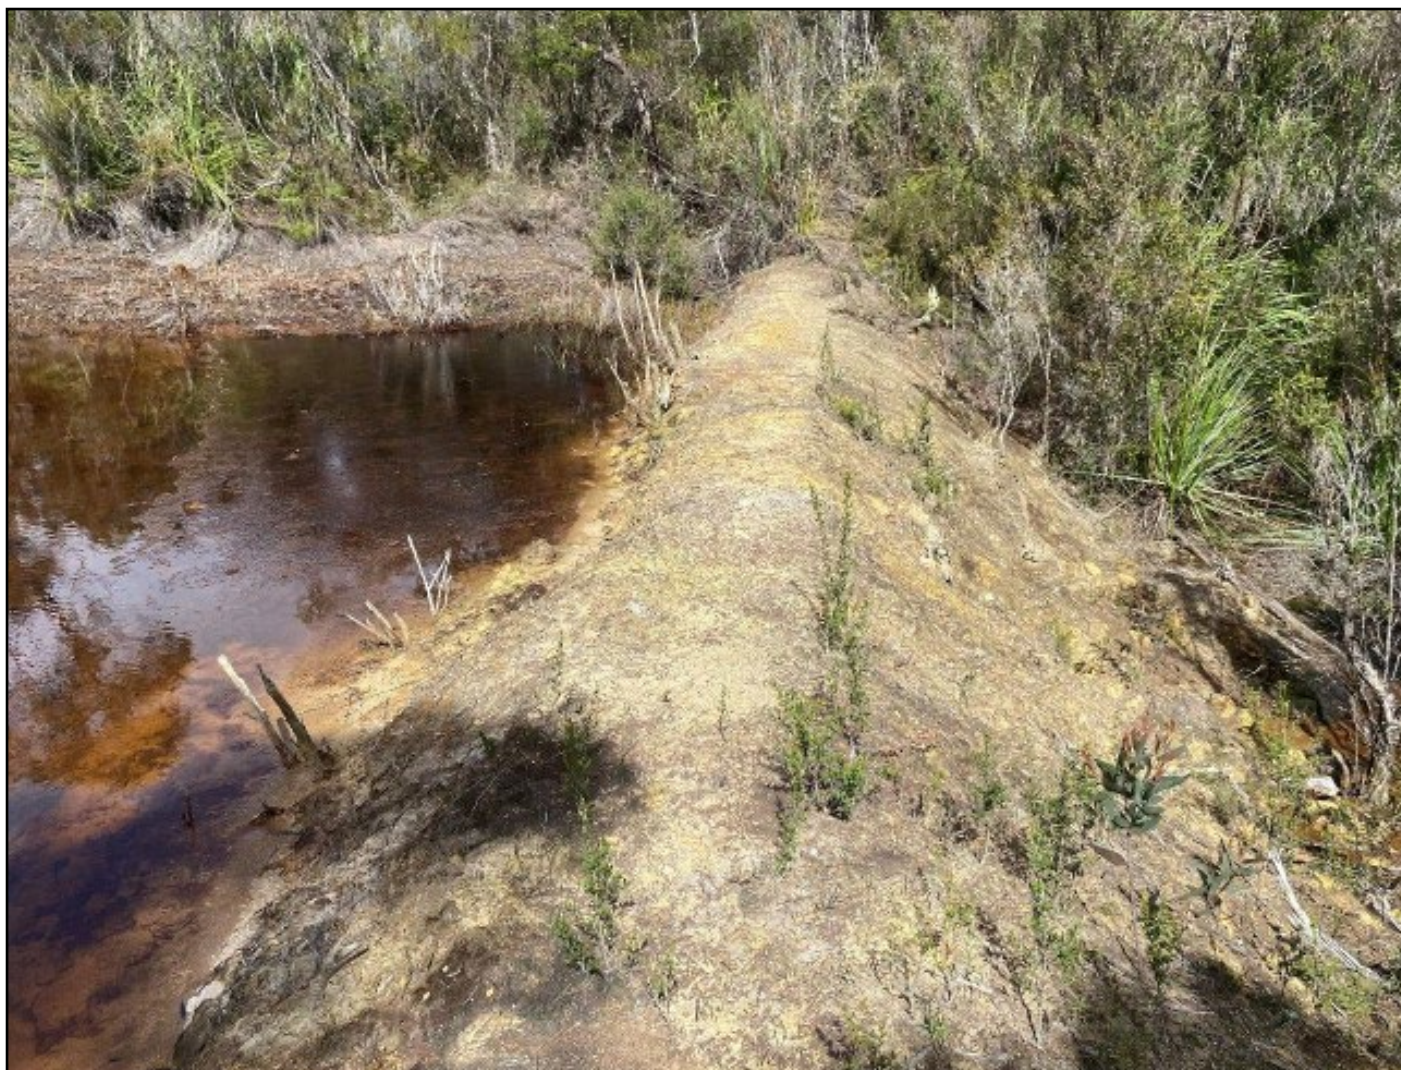
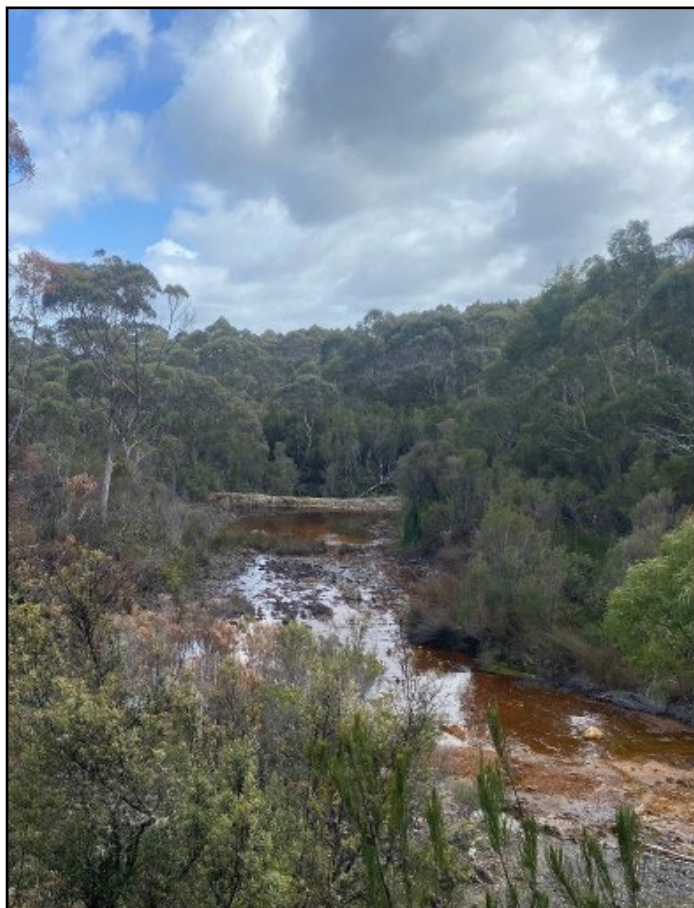
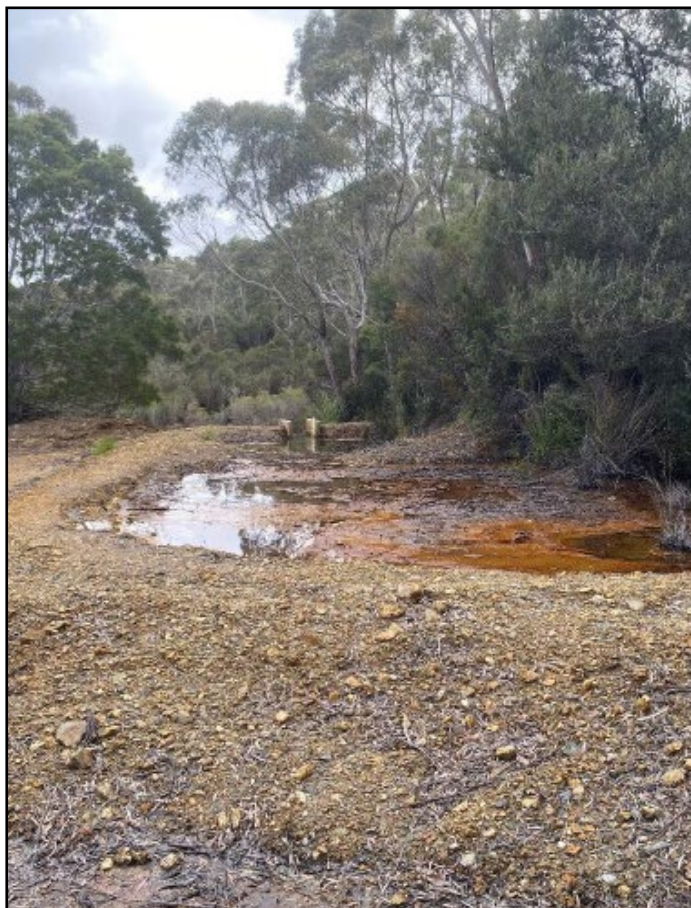
Mineral Resources Tasmania, funded through the RTF, has undertaken several studies to inform decision-making around the ongoing management of the Balfour Central Shaft (BCS) site. Proximal to the BCS is the repository dam which retains a significant volume of metalliferous sludge. The condition of this dam is very important as failure of the dam could result in the release of metalliferous sludge from storage, negatively impacting the downstream environment. A dam inspection in 2022 showed that the dam was in poor repair and does not meet the current standards of dam construction. Continuous dam surveillance is required to meet ANCOLD guidelines.

Figure 4. Balfour Site features including sludge dam (bottom left), Balfour Central Shaft (bottom right) and dam embankment wall (top), January 2025.

The RTF has commissioned GHD to complete a design and bill of quantities for the upgrade of the embankment wall in order to mitigate risk of failure and long-term need for dam safety surveillance (Figure 4). The design program is forecast for completion in September 2025, with potential for commissioning and commencement of on ground works within the financial year. Concurrently, further options are being considered for the long-term rehabilitation of the Balfour site.

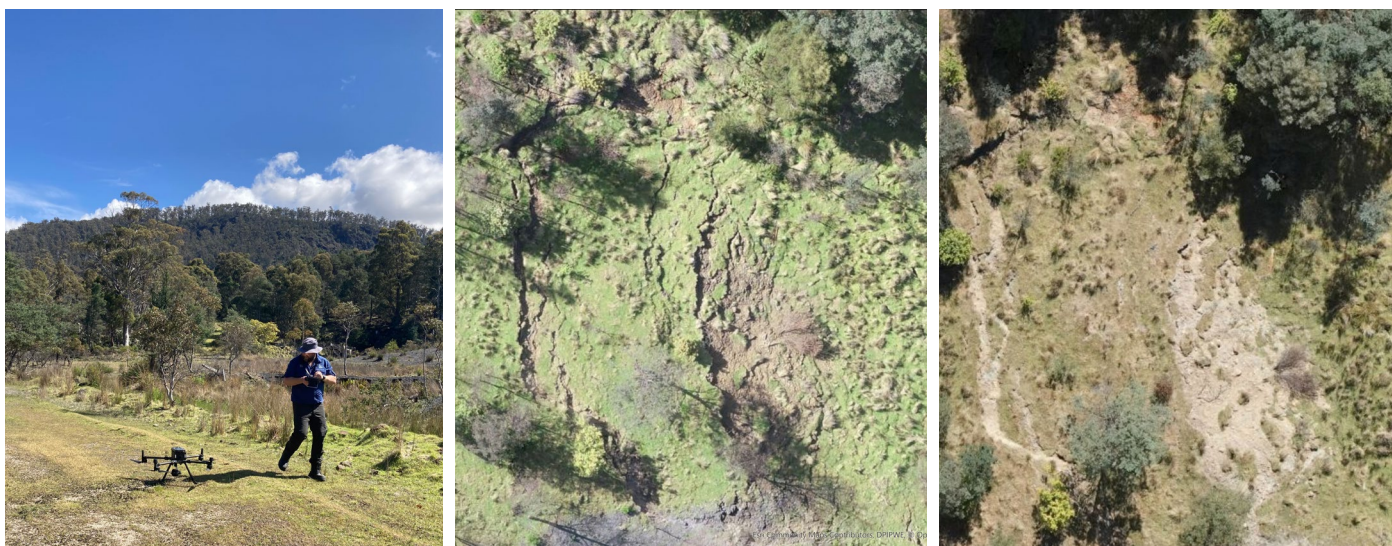
Landslide monitoring at Merrywood Coal Mine, initiated in October 2022, is ongoing as part of a statewide active landslide study led by the MRT Geohazards team (Figure 5). The program integrates drone imagery, geological, meteorological, and site-specific data to assess subsidence patterns in relation to environmental and climate factors. Surveillance in October 2024 included the inspection of previously installed tell-tales, confirming ongoing displacement, particularly near shear lines at the landslide crest. While the landslide currently poses minimal risk to public safety due to its remote location, MRT will maintain regular monitoring as part of its broader geohazard risk management strategy and to inform ongoing rehabilitation at the site.

Figure 5. Comparison of photogrammetry from November 2022 (Centre) to March 2023 (right).

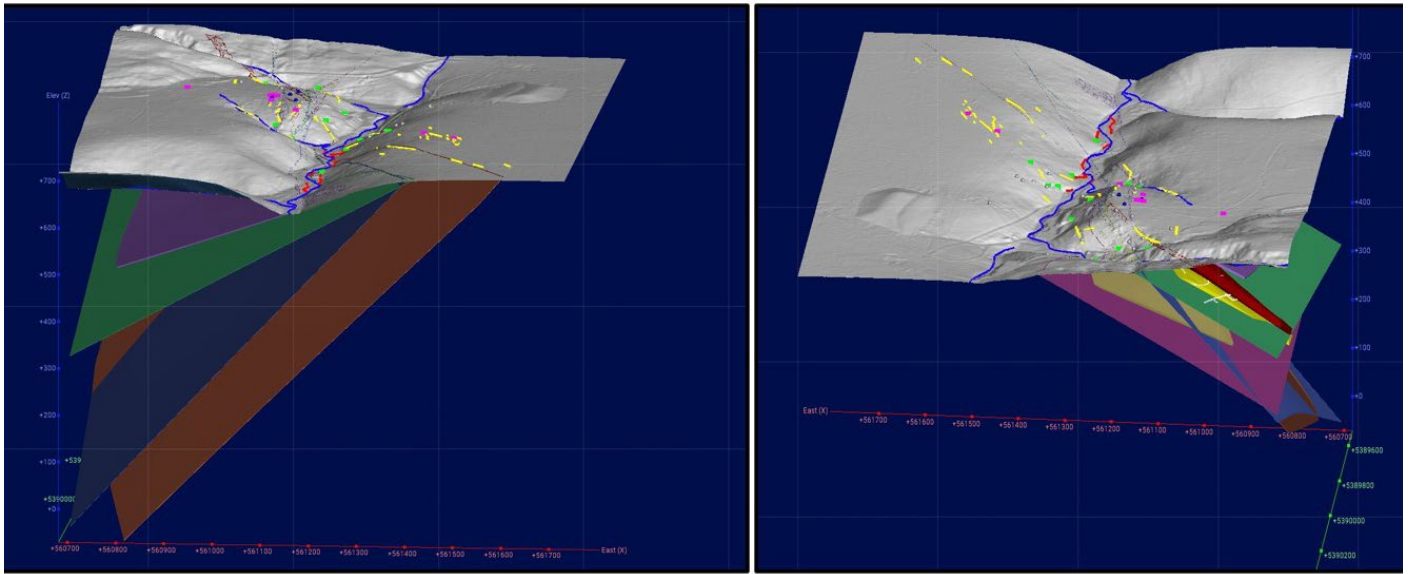
Since the early 2000s, the RTF has been funding ongoing remediation works at the Storys Creek Mine, including the relocation of precipitate and jig tailings, construction of an anoxic limestone drain (ALD), limestone spreading, and adit capping. Implementation of these activities has seen demonstrable improvements in water quality and its suitability for downstream agriculture and livestock use, however MRT are still working to improve water quality in the immediate vicinity of the milling precinct, particularly addressing the discharge from adits flowing into Side Creek just above its confluence with Storys Creek. In July 2024, the RTF received a report summarising the results of extensive on-site activities commissioned in 2022, which included bore design and installation, a hydrological assessment, and a detailed feature survey of the area. In addition, this report provided a 3D model demonstrating how historical workings have created high permeability zones for groundwater infiltration into the mineralised veins and local groundwater system (Figure 6).

Figure 6. Conceptual hydrogeological groundwater model (not to scale) (Hydro Earth, 2024).

The report recommended priority features for remedial action, recommending drainage diversion and surface capping to reduce surface water penetration. MRT will look to progress this program in FY 25/26. Key focus points for progression involve:

- Scope for functional repair of ALD;
- Analysis of surface microtopography for the optimisation of drainage placement and design;
- Identification of source material proximal to historical mine site to overcome load limit constraining transportation via main access road;
- Approvals for sourcing capping material and quotation for processing and supply;
- Development scope for the capping and revegetation of priority surface features.

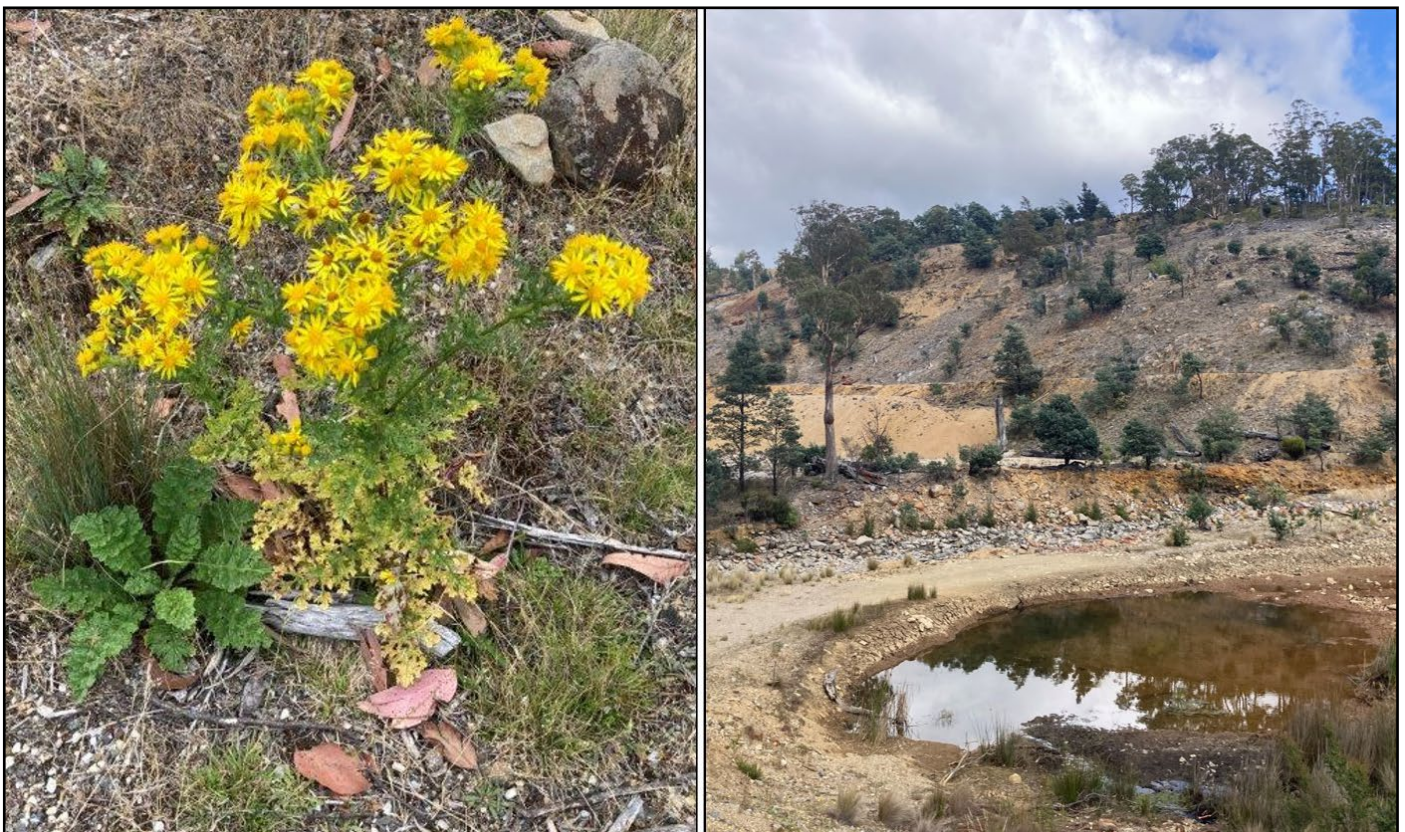
Ragwort is a declared weed under the *Tasmanian Biosecurity Act 2019* and has an associated statutory weed management plan recommending eradication as the most appropriate management objective. The RTF funded an autumn weed control effort, which was completed in April 2024 (Figure 7). The intent of the effort was to eradicate first year rosettes in order to reduce the number of likely flowering individuals in summer 2025/2026. Weed mapping will be scheduled for early December 2025 and follow-up control is proposed for January 2026.

Figure 7. Ragwort (*Senecio jacobaea*) and main face of milling precinct where greatest population was surveyed, January 2025.

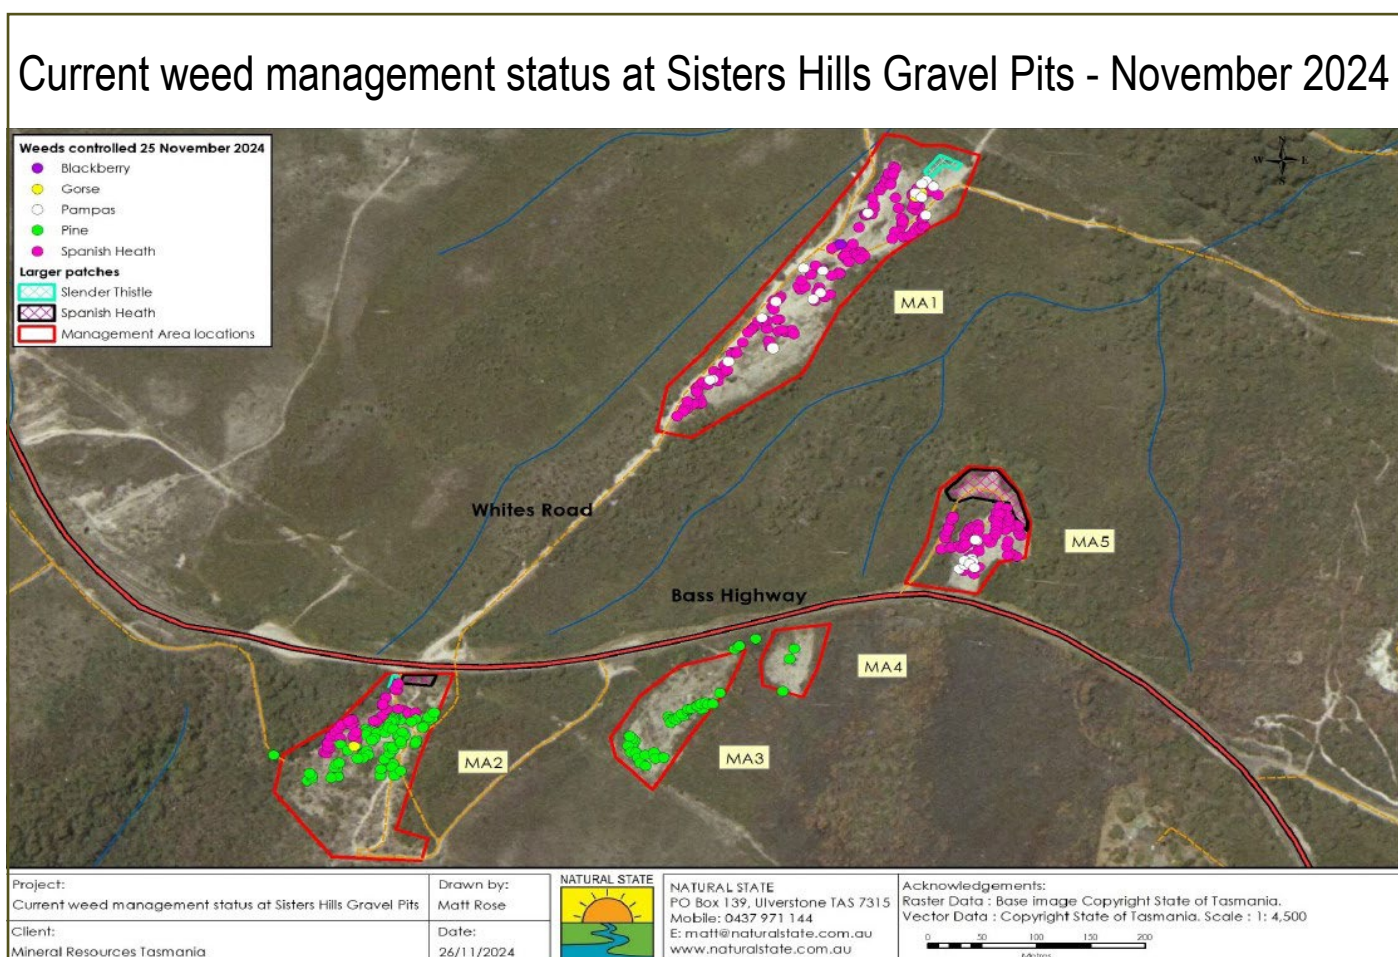
Remediation of the Sisters Hills quarry has been ongoing since 2010. Natural State has been responsible for the implementation of the Sisters Hills Weed Management Plan, commissioned by the RTF in 2018 (Figure 8). In November 2024, Natural State continued with the program undertaking progress mapping and weed control. The 2024 survey indicated successful eradication of Blackberry (*Rubus fruticosus*), Blue Butterfly Bush (*Buddleia* sp.), Spear Thistle (*Cirsium Vulgare*) and Montibetia (*Crocasmia* sp.) across the sites. A continuation of the programs in 2025/26 is recommended to manage recruiting Pine (*Pinus radiata*), Pampus grass (*Cortaderia selloana*) and Spanish Heath (*Erica lusitanica*).

Figure 8. Future target species and focus areas for ongoing management, Sisters Hills, November 2024.

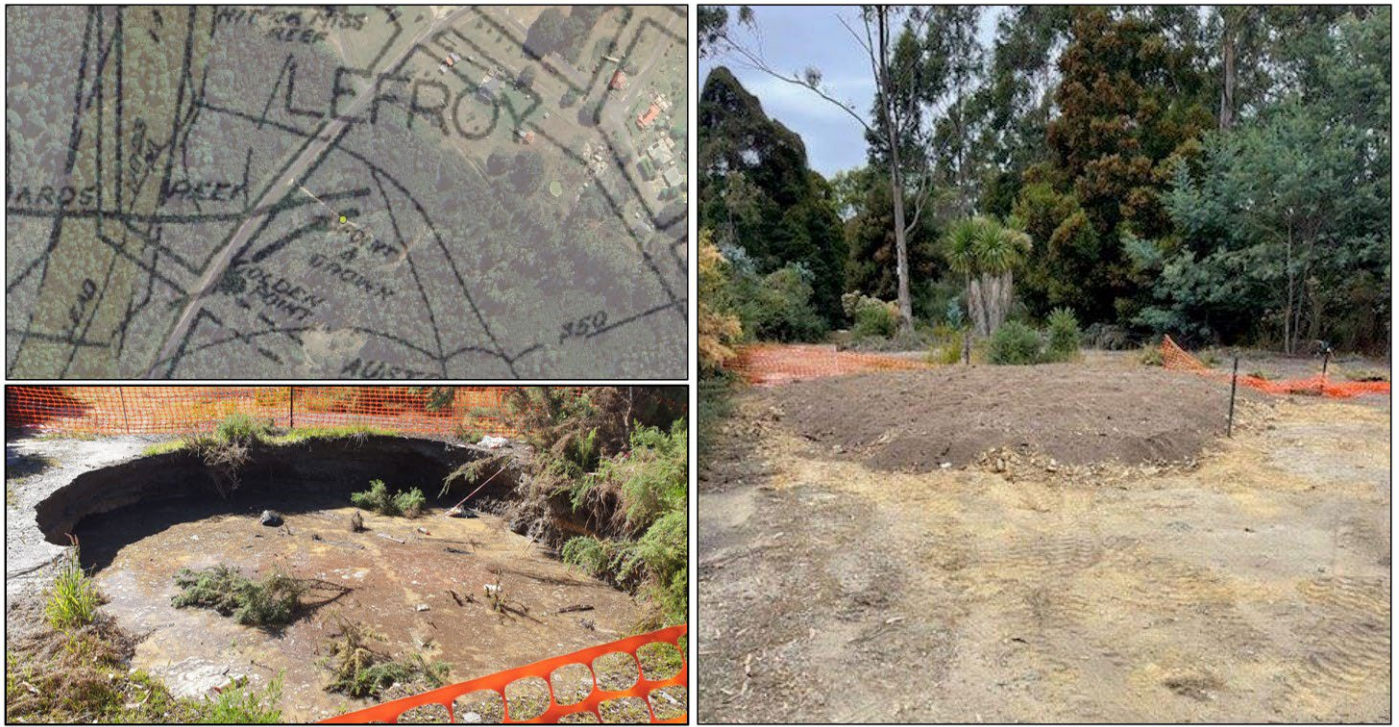
The Tasmanian Parks and Wildlife Service (PWS) reported a surface collapse in proximity to the Lefroy township in October 2024. Historical mining records indicated that the ground subsidence was likely associated with the Point and Crown shaft and workings. Remediation works involving excavation, back filling with clean fill, and leveling were completed in March 2025 (Figure 9).

Figure 9. Historical workings overlay (top left), sinkhole (bottom left), and remediation works (right), Lefroy, 2024/25.

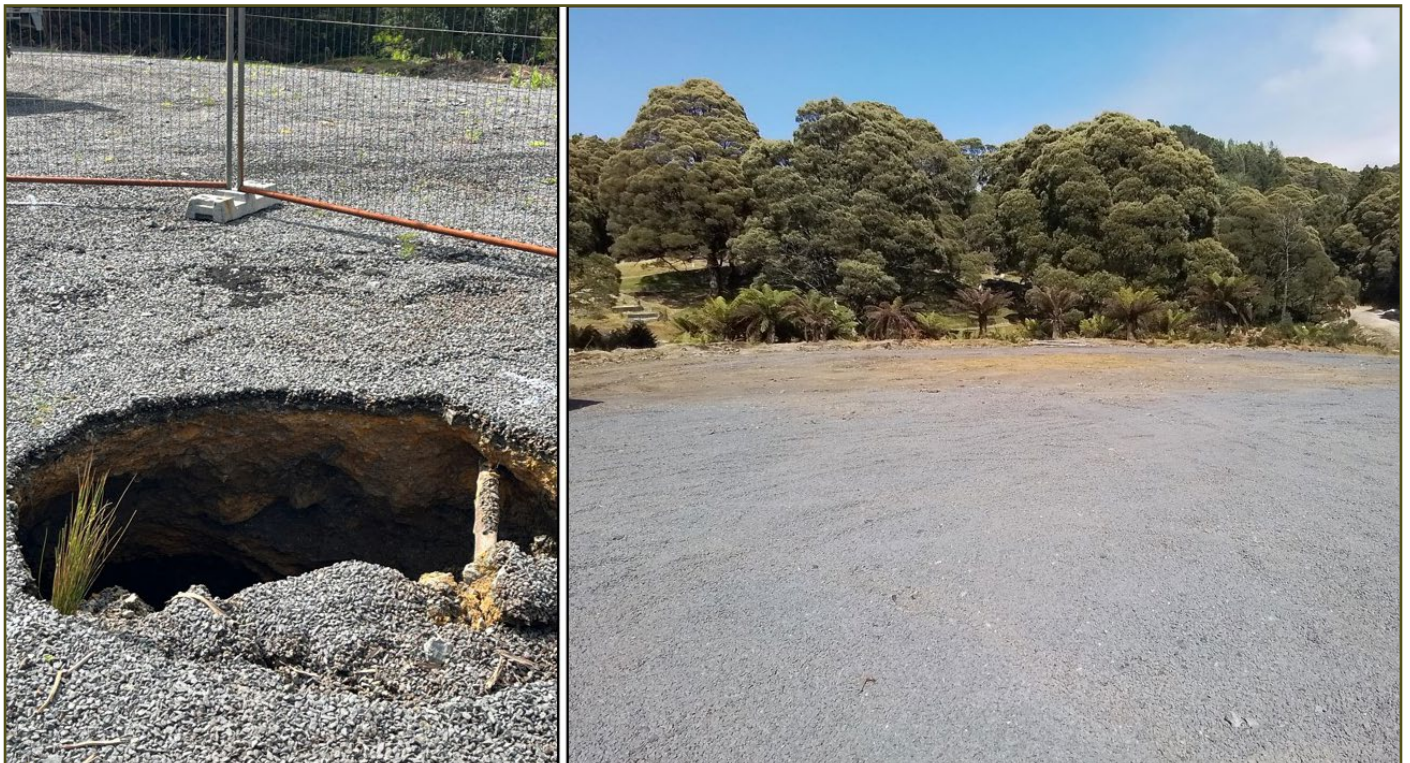
Mineral Resources Tasmania were contacted by the West Coast Council regarding subsidence at the Zeehan cemetery car park (Figure 10). Historical records indicated a likely association with Queen No. 2 shaft and drives. MRT provided the West Coast Council with advice regarding best practice approach for remediation and the RTF contributed partial funding for remediation works. Work was completed in February 2025.

Figure 10. Sinkhole (left) and completed remediation (right), Zeehan Cemetery, March 2025.

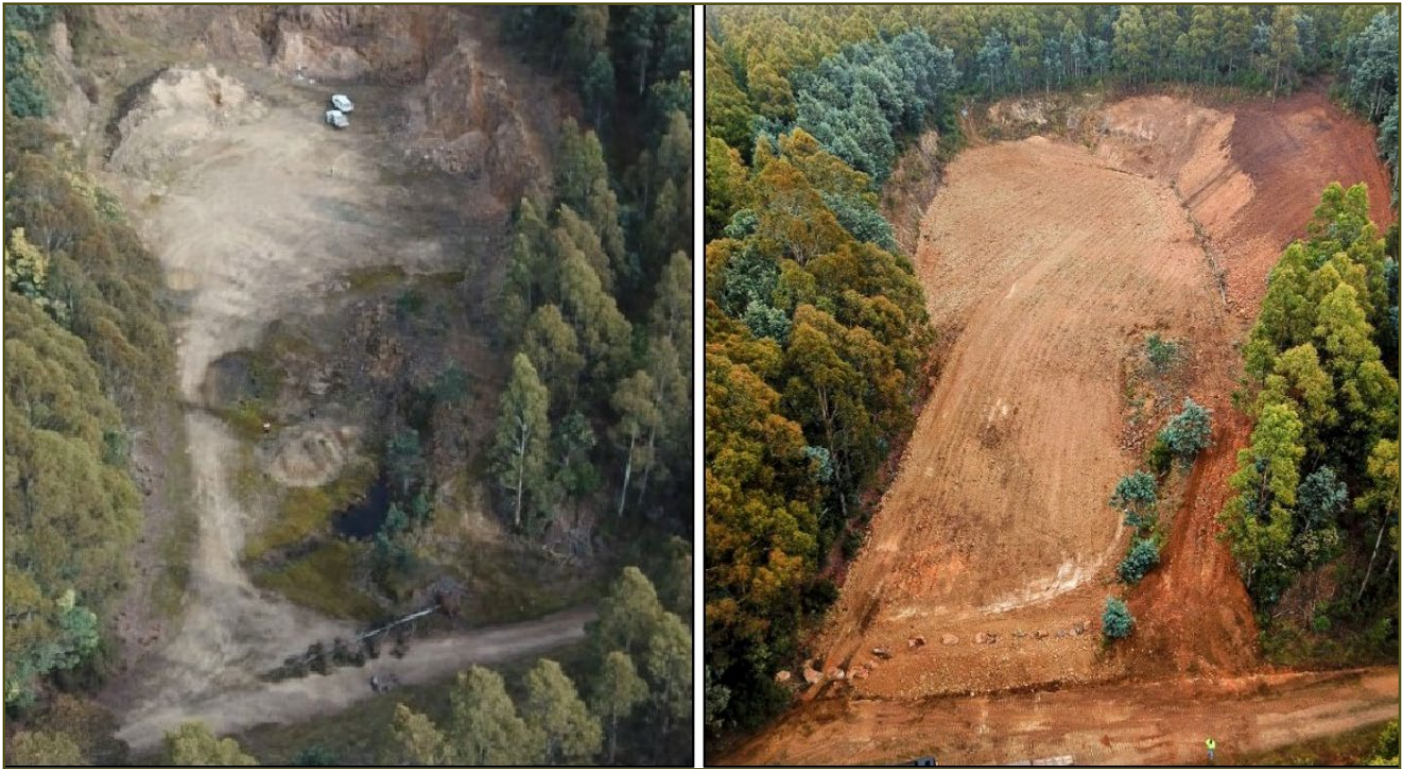
Rehabilitation of a former quarry at Rothalls Road was completed in April 2025. Rehabilitation actions were delivered according to the Rothalls Road Rehabilitation Plan and the EPA quarry code of practice. Comparative As of the quarry site pre and post rehabilitation earthworks are provided in Figure 11. MRT will continue to monitor the site biannually to assess the stability of earthworks and vegetation establishment with the intent to return the site to the regional management authority once safe, stable, and non-polluting.

Figure 11. Comparison of Rothalls Road Quarry pre (left), and post (right), rehabilitation.

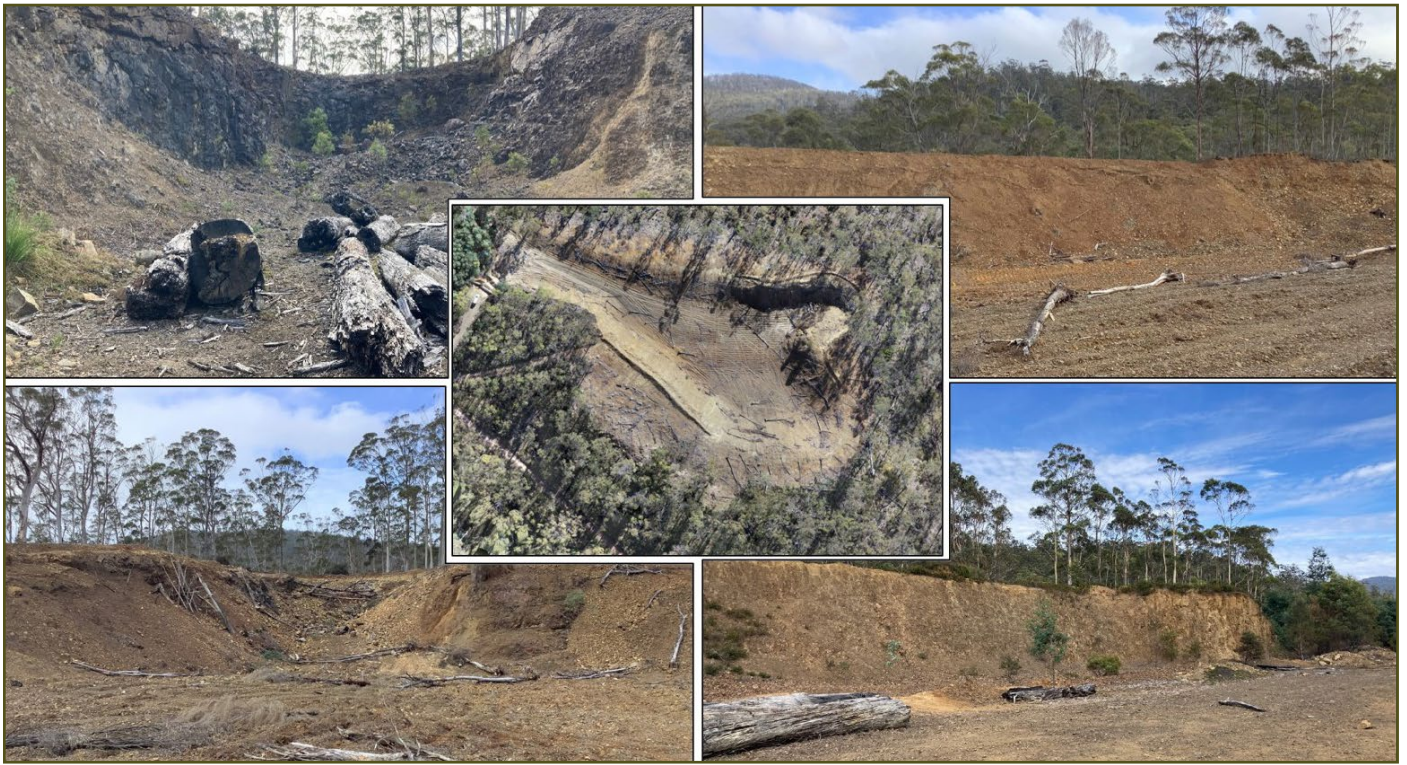
On inspection, all sites remain safe, stable, and non-polluting, however additional time is needed for vegetation to establish and mature.

Figure 12. Comparison of Chestermans Sugarloaf quarry pre and post rehabilitation.

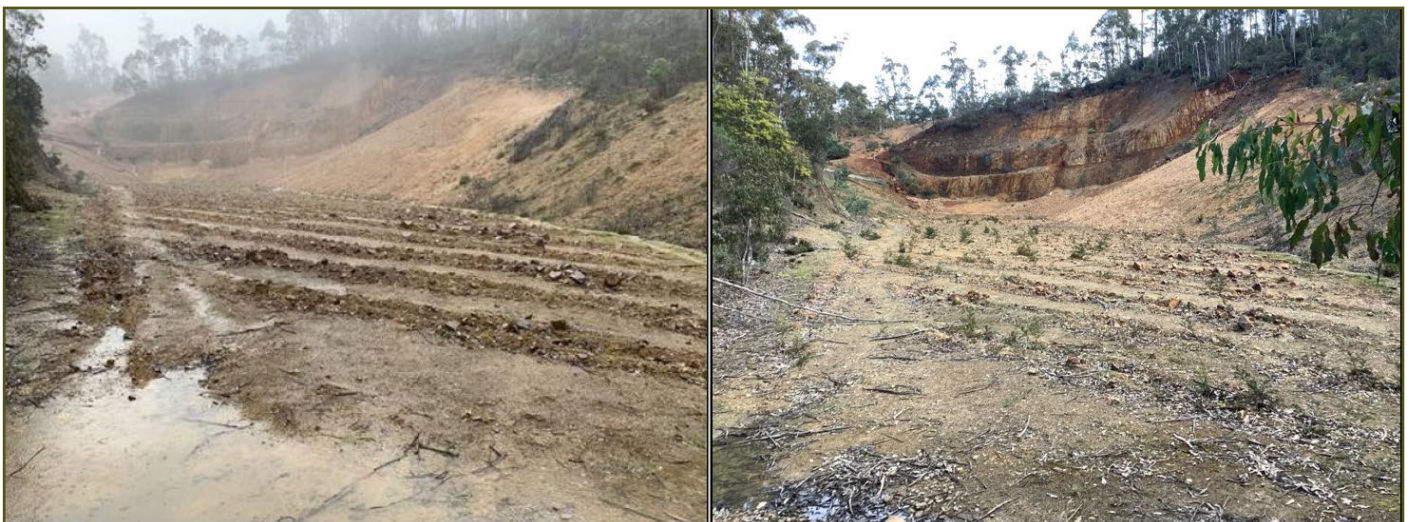
Figure 13. Comparison of Lake River Rd. Quarry indicating establishment of vegetation in rip lines.

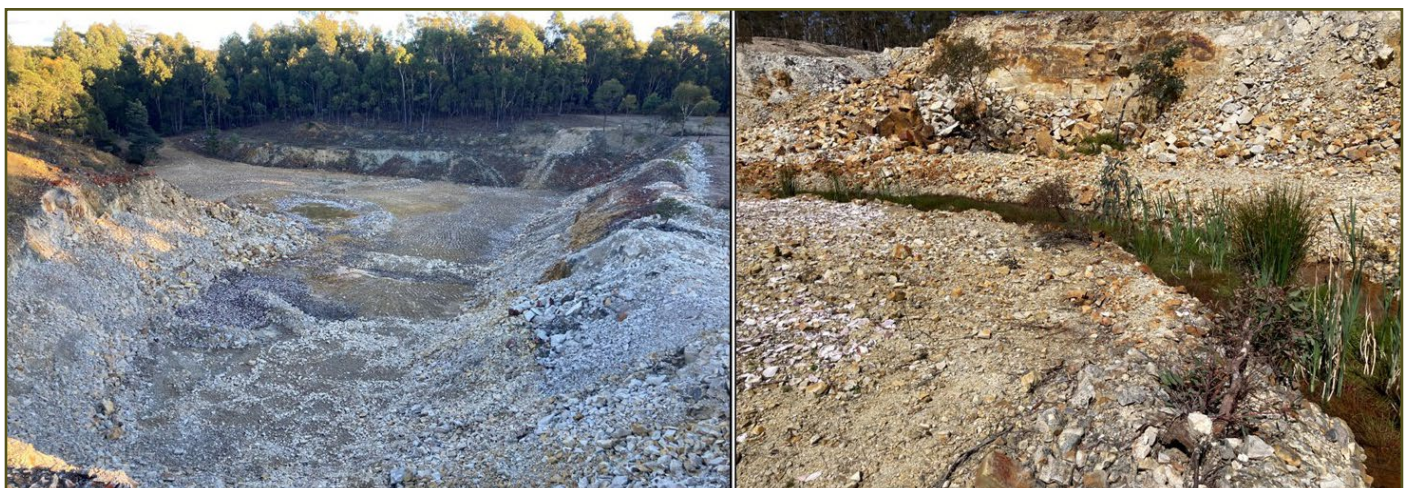
Water quality monitoring commenced at Hogans Rd. in 2017 due to identification of AMD leaving the site. Sampling conducted in 2024 indicated significant improvement in key indicators such as pH, conductivity and metal concentrations with vegetation now establishing in the outflow channel (Figure 14). At the catchment level, 2024 water monitoring indicates that parameters for pH and metals fall within the freshwater ANZECC trigger values for 95% aquatic species protection.

Figure 14. Shell grit established during rehabilitation (left) and aquatic vegetation in quarry outflow (right), October 2025.

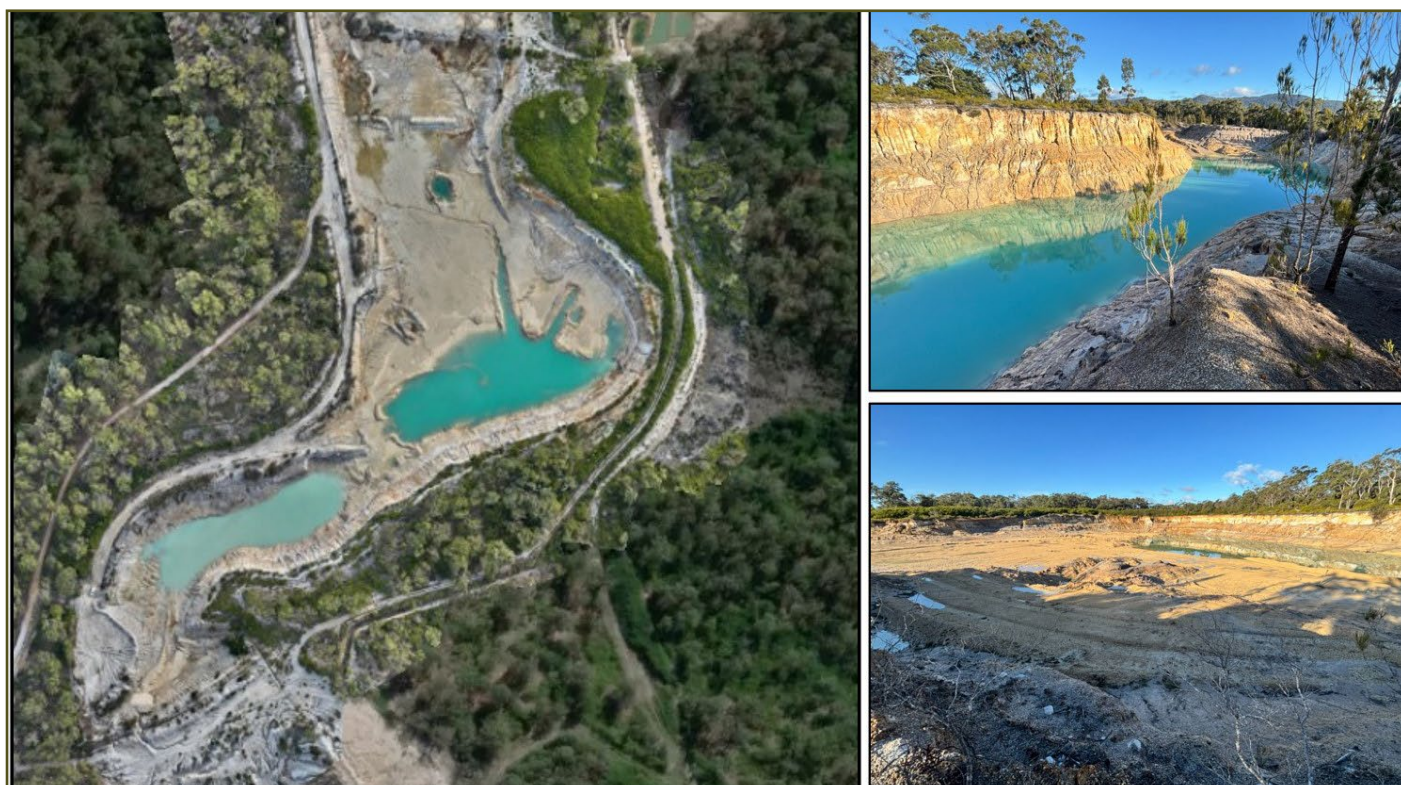
MRT carried out a dewatering campaign in May 2025 (Figure 15) funded through contributions from the RTF, facilitating water quality analysis, as well as pump mobilisation, hire, and maintenance. Operations were conducted in full compliance with permit conditions, and water sampling indicated that the receiving Ringarooma River was not adversely impacted, with physiochemical properties and metals remaining within acceptable concentrations.

Figure 15. Outcome of dewatering activities on Scotia Main Pit, May 2025.
