TR16-177

31. Report on a dam site on Curries River near Lefroy.

P.C. Stevenson

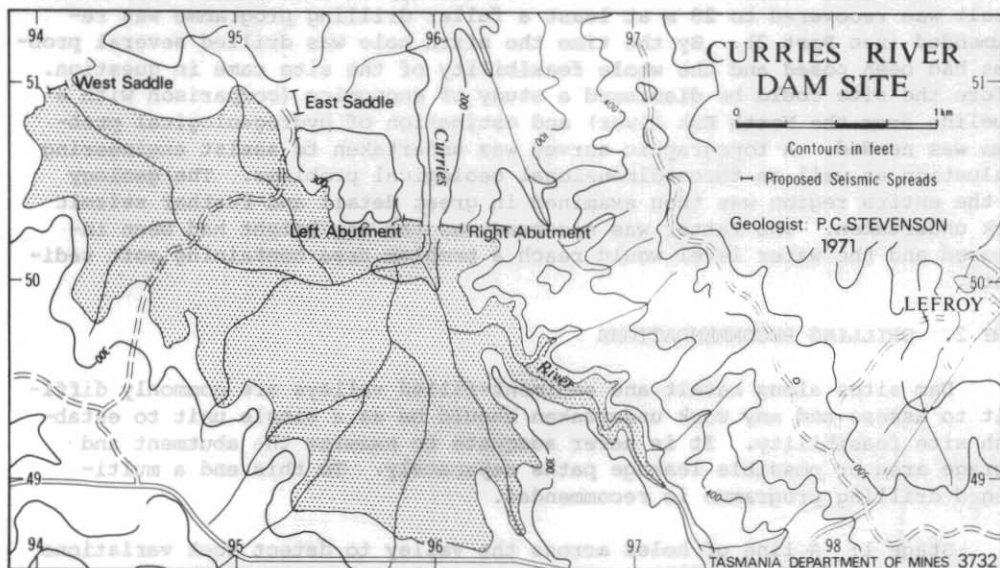
Figure 54.

The abutments are in weathered Mathinna slate and quartzite. The depth of weathering is not known, but at the abutments small gold prospect costeans have turned up weathered but still cohesive slates. The weathering product is a stiff silty clay which is normally hard when dug.

The river runs in a narrow strip of alluvial clay and gravel between the abutments, but a thick growth of tea-tree prevented any examination of this. There is every reason to suppose that slate underlies this thin cover.

Two low saddles are evident assuming a 25 m water level in the storage area. The eastern saddle, closer to the dam site, appears to be floored with a sandstone phase of the Mathinna beds and almost certainly does not contain non-indurated sediments. Much of the storage area has a thin cover of windblown sand now tied by vegetation. The western saddle has a cover of this material, so that no solid rock can be seen.

Seismic spreads on the abutments and on the saddles are recommended to confirm the degree and depth of weathering. Trenching by Gradall in all three locations might yield more information than conventional diamond drilling, in view of the nature of the geology. Diamond drill holes will only be required for water pressure testing.
